Final Report

B787-9, 9V-OJF

**Nose Wheel Detached During taxi
Incheon Airport, Korea**

TIB/AAI/CAS.222

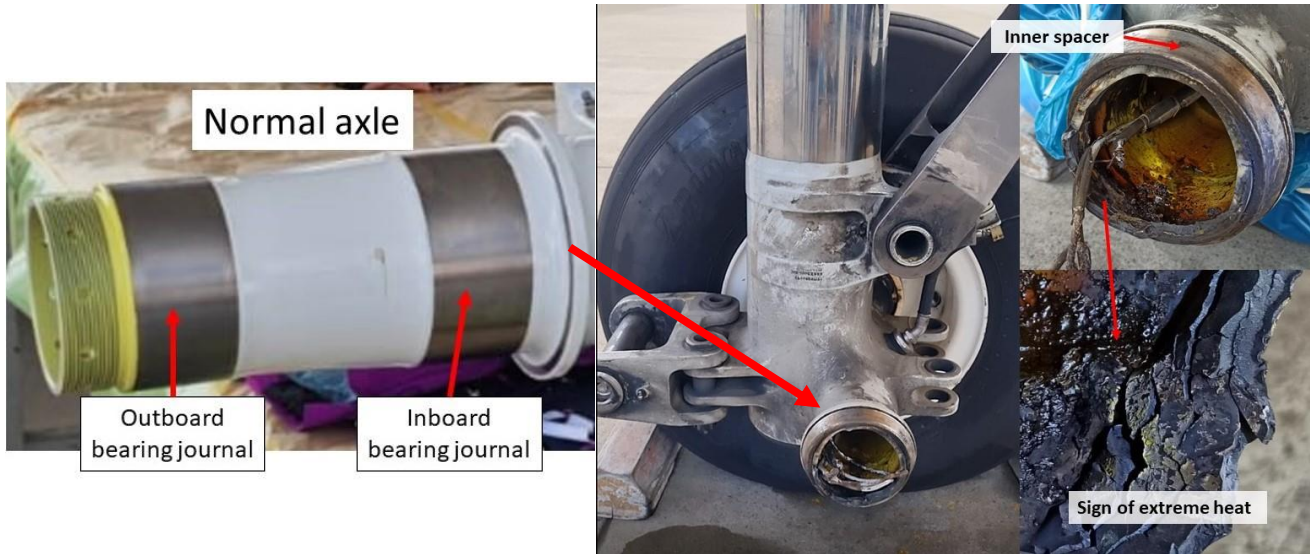
- 1.2 Injuries to persons
 - 1.2.1 There was no injury to any person.
- 1.3 Damage to aircraft
 - 1.3.1 Nose landing gear (NLG)
 - 1.3.1.1 The left axle of the NLG sheared off at the inboard location but the inner spacer was still in place (see **Figure 2**). The black charred appearance of the fractured axle face at between the 6 and 8 o'clock positions indicated exposure to extreme heat.

Figure 2: Sheared NLG axle

- (d) Nital etch inspection of the sheared LH axle cross section at the fractured location revealed the presence of under-tempered martensite (UTM) and over-tempered martensite (OTM), indicating exposure to high temperature due to the heat generated by the seized inboard bearing.

(b) The high temperature affected the microstructure of the base material at the fractured area of the sheared axle. The heat also caused the cadmium plating in the inner diameter of the sheared axle to melt. The melted cadmium migrated into the grain boundary of the base material causing cadmium embrittlement, thus resulting in intergranular fracture of the axle.

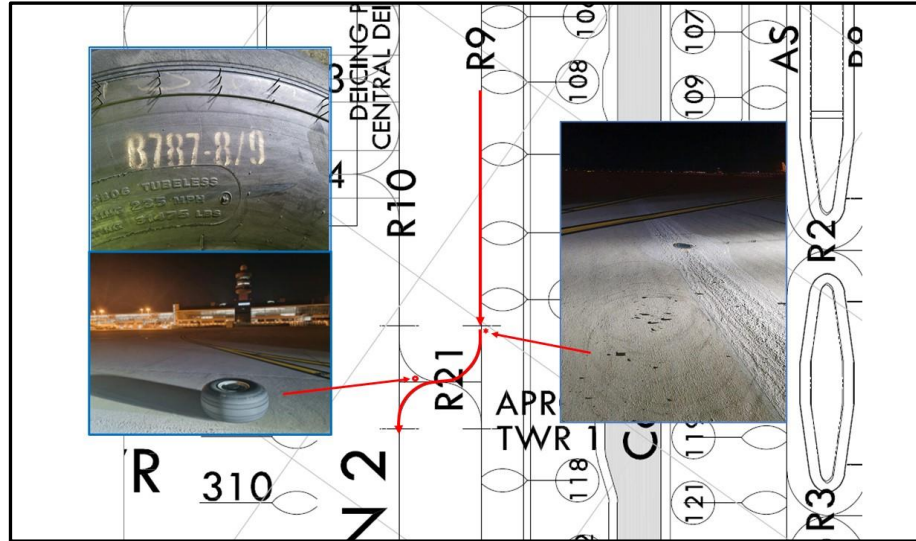
1.3.2.1 The LH nose wheel assembly together with the sheared outboard axle were found in ICN near the turn from Taxiway R21 to Taxiway R10. Debris pieces of the wheel's inboard bearing were also found strewn along Taxiway R9 before the turn to Taxiway R21 (see **Figure 3**). All parts of the inboard bearing were found and recovered except for the retaining clip and some rollers.

Figure 3: LH nose wheel and tyre debris location

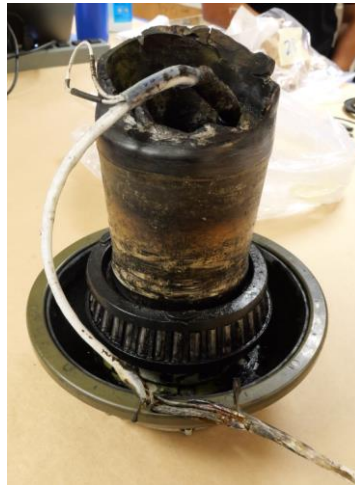
- 1.3.2.2 The outboard portion of the left axle was found together with the LH nose wheel. The bundle of wires for transmitting LH and right hand (RH) tyre pressure information to the EICAS was severed (see **Figure 4**).

Figure 4: Outboard portion of the sheared off left axle with severed wire bundle

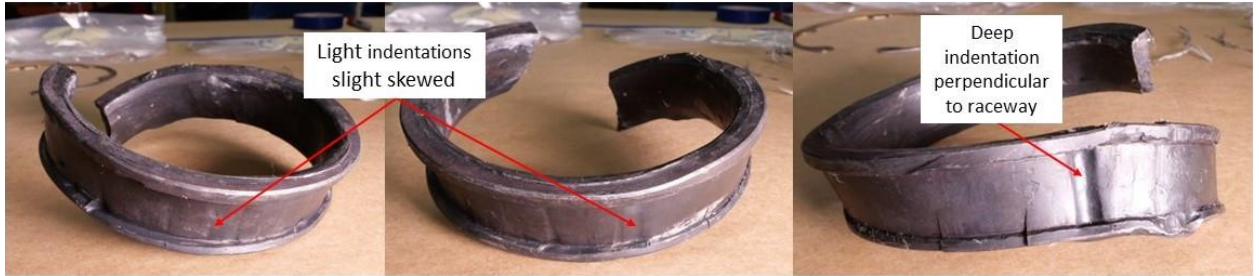
- (a) The damaged inboard bearing cone (inner race) had several light roller indentations which were at a slight angle (i.e. not fully perpendicular) to the inner race and also a deep roller indentation that was perpendicular to the inner race (see **Figure 6**). The wheel manufacturer opines that the light roller indentations were likely due to skewing of some rollers which were grinding against the inner race during operation, resulting in excessive heat being generated and causing the degradation of the inner race's hardness, and that the single deep indentation was likely due to a subsequent static load on the bearing. The rollers were found deformed and elongated. There was evidence of bearing seizure with signs of overheating on the inboard bearing cone, cup and remaining

Figure 6: Several light skewed indentations and a deep indentation on inboard bearing cone

- (a) On the one hand, as mentioned in paragraph 1.8.3(c), the aircraft manufacturer opined that the deep indentation that was perpendicular to the inner race was consistent with a high point load that exceeded design expectations. This deep indentation could have subsequently caused skewing of the rollers which resulted in the seizing of the inboard bearing¹¹.
- (b) On the other hand, as mentioned in paragraph 1.8.4(a), the wheel manufacturer observed that the damaged inboard bearing cone (inner race) had several light roller indentations which were at a slight angle (i.e. not fully perpendicular) to the inner race. The wheel manufacturer

concluded that some of the rollers were already skewed¹² at a slight angle before the occurrence. These skewed rollers had not been rotating squarely on the inner race, and had been grinding the inner race during taxiing, take-off and landing which generated excessive heat and softened the inner race material. The deep indentation that was perpendicular to the inner race was occasioned by a static load after the inner race material had been softened. This led to the seizure and eventual inboard bearing failure.

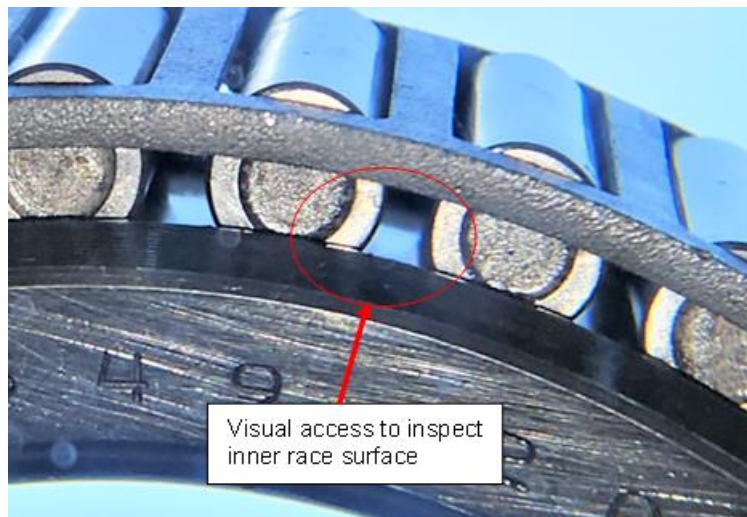
2.1.4 As regards the possibility of bearing defects not having been picked up by visual inspection of the bearing during wheel maintenance, the investigation team noted that the wheel manufacturer's inspection instructions in paragraph 1.6.3.1 are representative of the industry's standard practice in roller bearing inspection. The investigation team also noted that there are challenges in visual inspection in that, given the limited access of the inner race surfaces (see **Figure 7**), an inspector's ability in spotting defects may be subjected to human factors, which could give rise to inconsistent inspection outcome. The

investigation team believes that there is value in the development of a suitable non-destructive testing (NDT) method to enhance the robustness of the inspection of bearings in addition to visual inspection. There may also be value in imposing a life limit on the bearing assembly to enhance bearing reliability. However, according to the wheel manufacturer, such an NDT method is difficult to be developed.

Figure 7: Inspection of inner race surfaces

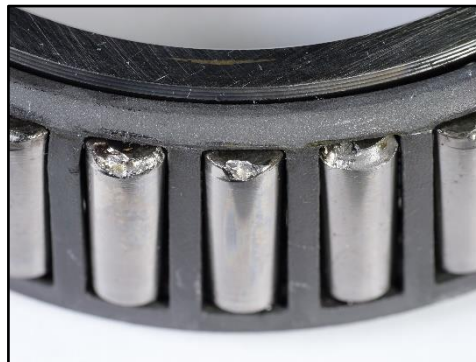
Figure B2: Damage on outboard bearing rollers

- (c) There were damages found on the outboard bearing indicating that it has been exposed to some areas of stress concentration and there was excessive end play.

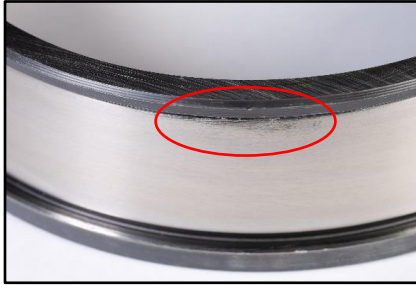
Figure B3: Markings on the cone (inner race)

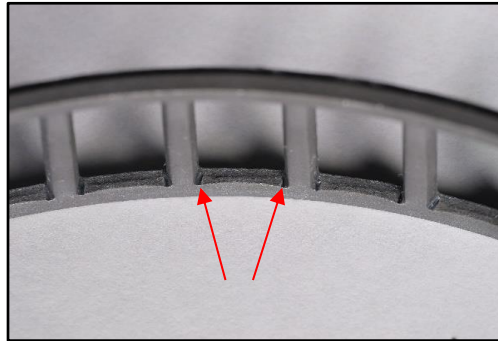
Figure B4: Cage pocket with markings

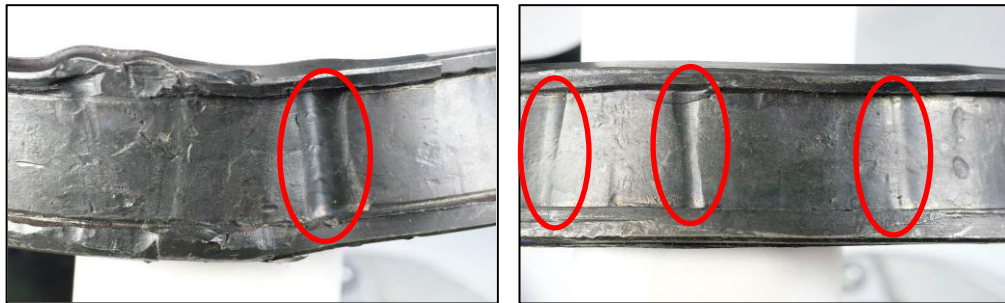
- (4) The axle was cut off from the inner cylinder assembly to facilitate examination of the separated LH axle.
- (5) Observation from the visual inspection of the separated LH axle
 - (a) Axle fracture location was at the inboard journal.
 - (b) Inboard bearing cone (inner race), cage and rollers sustained significant deformation. The cone (inner race) was found with an indentation of a roller bearing. This damage is known as brinelling. (See **Figure B5**) Manufacturer's bearing expert opined that the brinelling marks are consistent with the bearing having experienced high point loading with forces that exceeded design expectations.

Figure B5: Brinelling marks on inboard bearing cone (inner race)

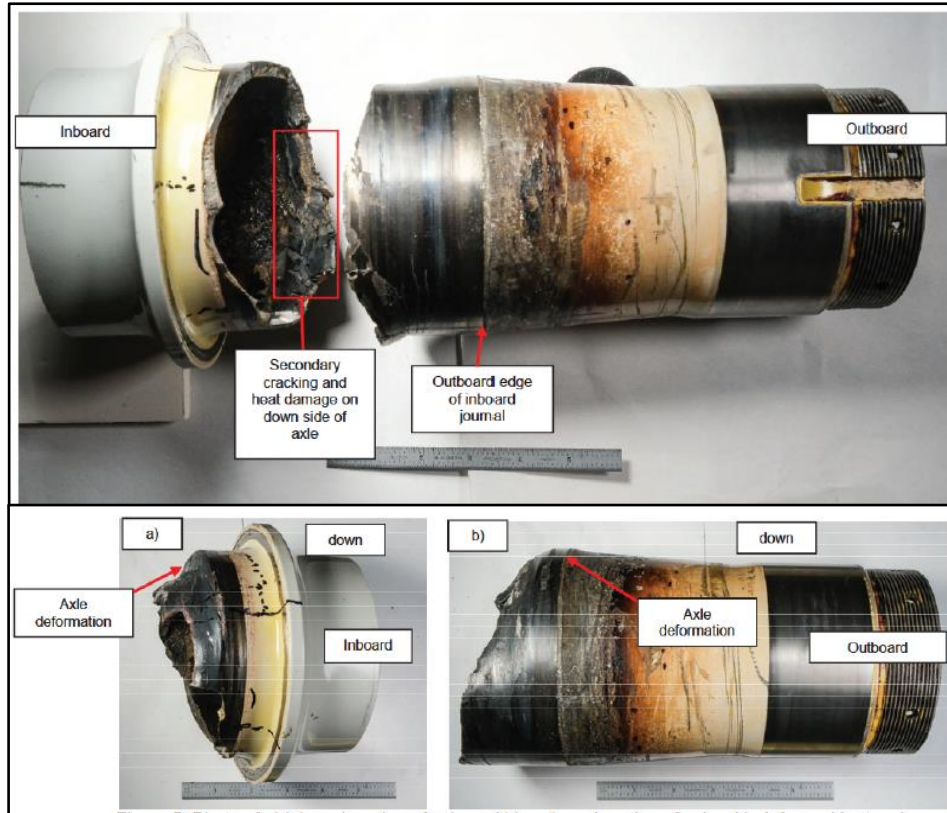
Figure B6: Fracture NLG axle

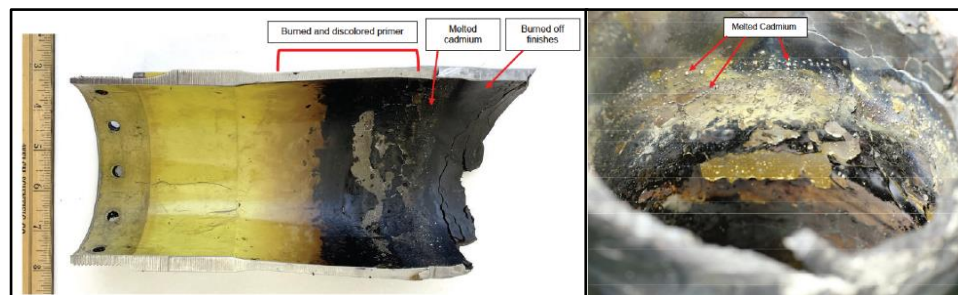
- (f) The cadmium plating on the inner diameter of the sheared LH axle was found to have melted and re-solidified close to the location of the fractured face with burnt primer.

- (c) Heat damage was observed on the outer diameter of the axle extending outboard from the inboard journal with burned off and heat tinted enamel on outboard area of the inboard journal.
- (d) Secondary cracks were found along the entire circumference of the axle on the both the inner and outer diameter of axle with most severe cracking found at the bottom of the axle. The axle was deformed with the inboard journal surface bending upwards. (See **Figure B6**)
- (e) The primer paint in the inner diameter of the axle was discoloured due to exposure to heat. The cadmium plating on the inner diameter were found to have melted and re-solidified closed to the location of the fractured face with burnt primer. (See **Figure B7**)

Figure B7: Discoloured and burnt primer with traces of melted cadmium

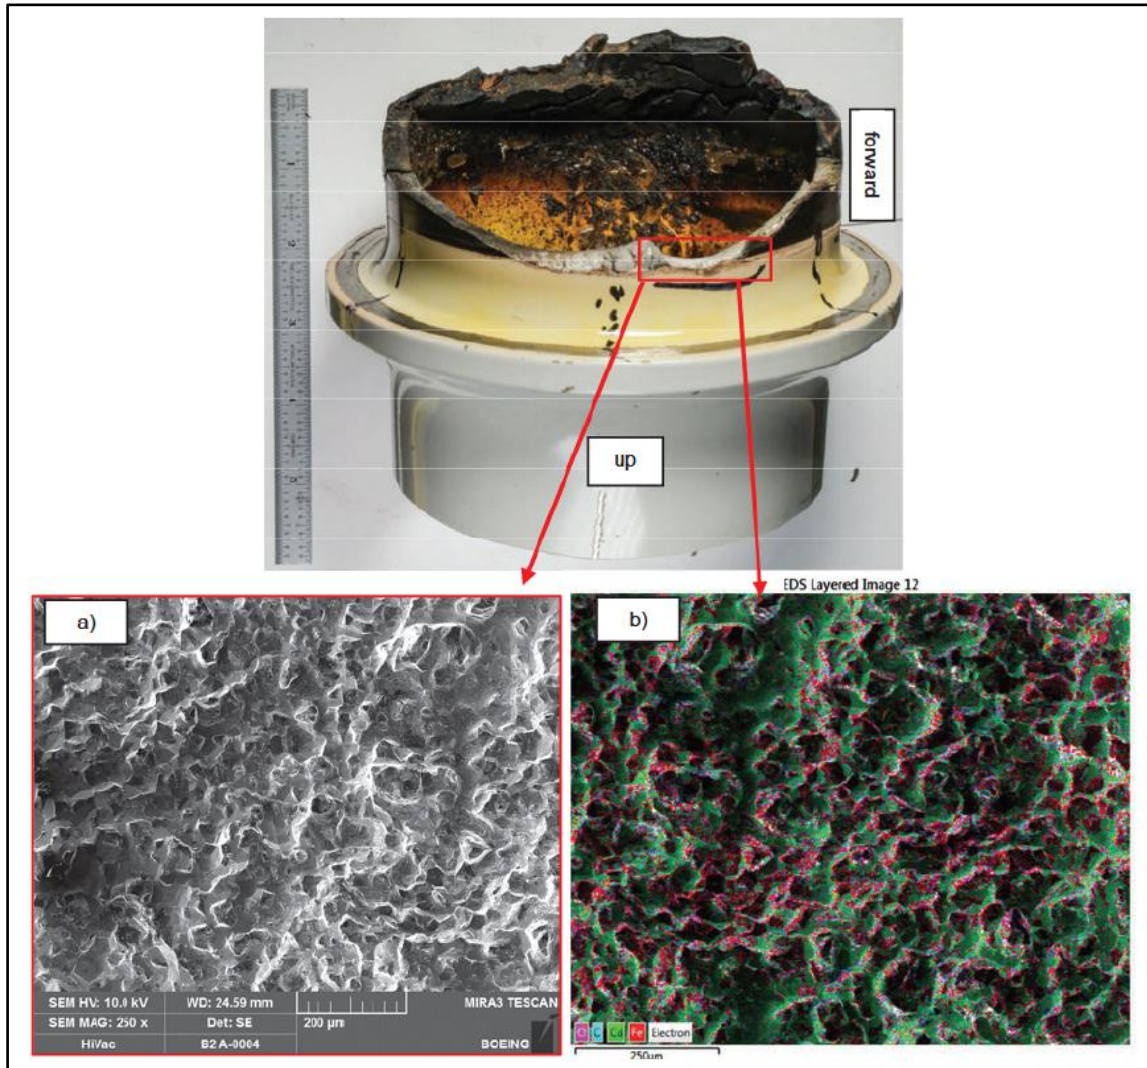
- (g) The fractured surfaces were examined using Scanning Electron Microscope (SEM) and Energy Dispersive X-ray Spectroscopy (EDS). The SEM confirmed the presence of cadmium on the fracture faces and that the failure of the axle was due to intergranular fracture. Cadmium was also found present within the intergranular cracks. This confirmed that the intergranular fracture was a result of cadmium embrittlement.

Figure B8: SEM image of fractured surface (near to top of separated axle) with cadmium covering the surface

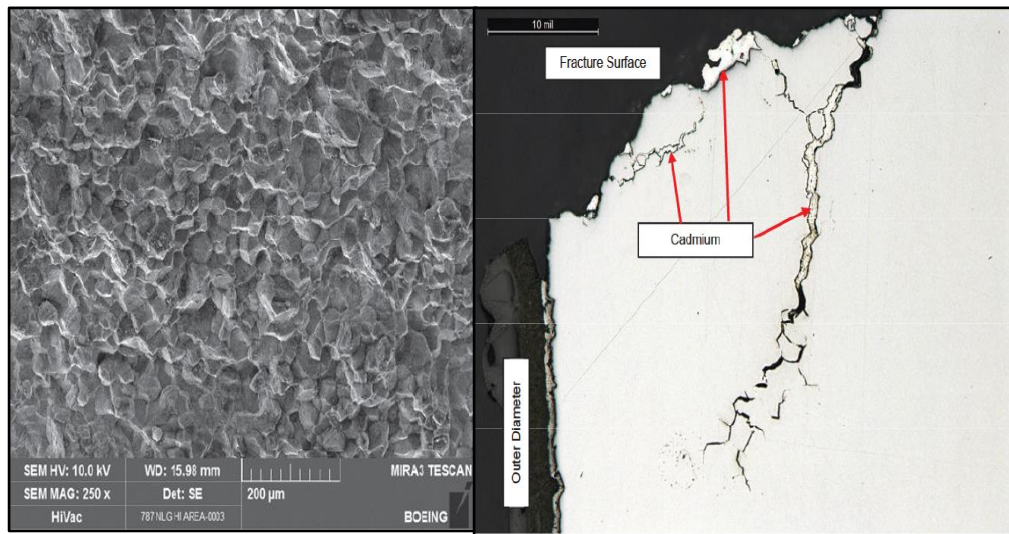
- (8) The inboard portion of the separated LH axle was sectioned, and the fracture surfaces examined by using Scanning Electron Microscope (SEM) and Energy dispersive x-ray spectroscopy (EDS). SEM and EDS examination of fracture surfaces from top, bottom, and forward sections of the axle confirmed the presence of cadmium on the fracture faces. The fractured faces were fully covered by cadmium. A section was taken from the forward part of the axle and cadmium was removed from the fracture face in order to reveal the underlying fracture microstructure. The SEM confirmed that the topography was consistent with intergranular fracture. The presence of cadmium on the fractured surface indicated that the intergranular fracture was a result of cadmium embrittlement. Cadmium was also found within the intergranular cracks in the base material which further confirmed that cadmium embrittlement contributed to the intergranular fracture.

Figure B9: Fracture surface showing intergranular cracks containing cadmium

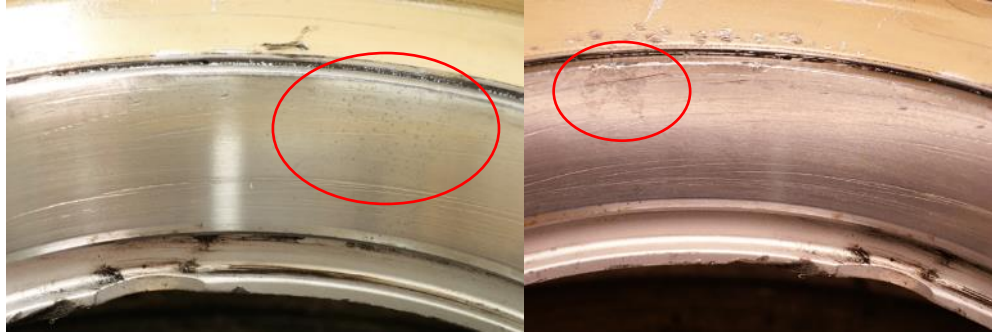
2.2.1 During the laboratory inspection, light traces of corrosion (pitting) were found on the outboard bearing cup (see **Figure B6** in **Appendix B**) after the layer of grease on the bearing cup was cleaned off. The investigation team noted the following possibilities but is unable to determine the cause of the corrosion:

However, the corrosion on the outboard bearing cup could not have caused the inboard bearing failure.

(b) Some light traces of corrosion (pitting) was observed on the outboard bearing cup (see **Figure B10**) after the layer of grease on the bearing cup was cleaned off. The wheel manufacturer believes that this corrosion could have occurred due to inappropriate storage condition during maintenance or storage before it was installed on the aircraft.

Figure B10: Outboard bearing cup surface with light traces of corrosion
