Final Report

A320NEO, B-305J

Smoke in Cabin, Engine fire, Evacuation

TIB/AAI/CAS.225

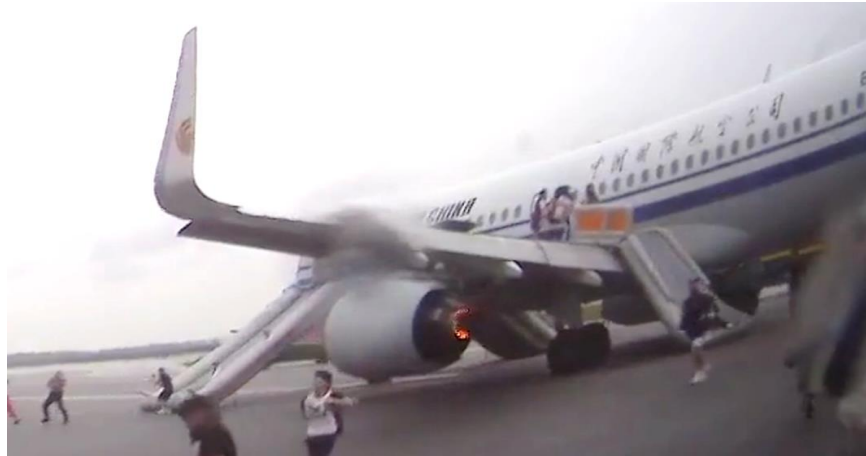
aircraft's left engine (see **Figure 1**). All the four ARFF vehicles eventually stopped in front of and facing the aircraft. Before this, T33 had travelled on the left side of the aircraft to enable the WO to have a better look at the fire at the rear of the left engine while the other ARFF vehicles travelled on the right side of the aircraft.

Figure 1: Fire at the tailpipe of left engine (Footage from T33's dashcam)

1.3.2 The left engine fire was a localised fire within the tailpipe of the engine. There was no sign of damage caused by the fire to any other parts of the aircraft.

- 2.1.4 The leaked oil also travelled through the bore of the HPC shaft and through the Low Pressure Turbine (LPT) shaft to the LPT area. The fire observed at the rear of the engine had likely resulted from the contact between the leaked oil and the high temperature LPT.

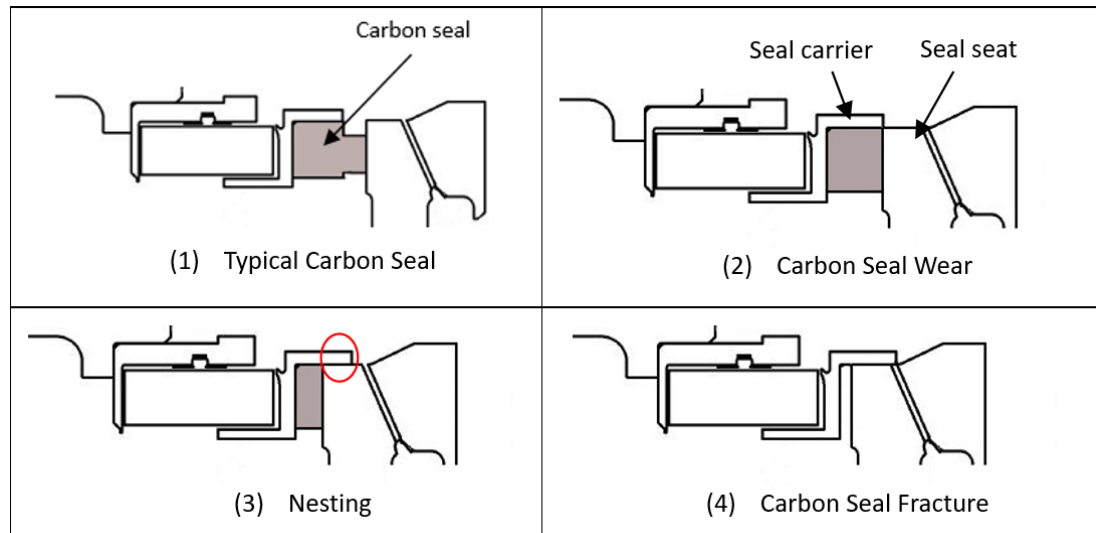
Figure 7: Carbon seal wear progression

¹⁷ “nesting” refers to an undesirable state of the carbon seal assembly where the seal seat is positioned inside the seal carrier as a result of the carbon seal wear (see Figure7(3)).

- 3.2 The engine manufacturer's engine health monitoring system had failed to detect the carbon seal "nesting" before it deteriorated to an undesirable "nesting" state and eventual carbon seal fracture.

- 4.1 The engine manufacturer has since November 2023 adjusted their database of patterns for the EHMS to better detect a deteriorated state of the No. 3 bearing carbon seal.

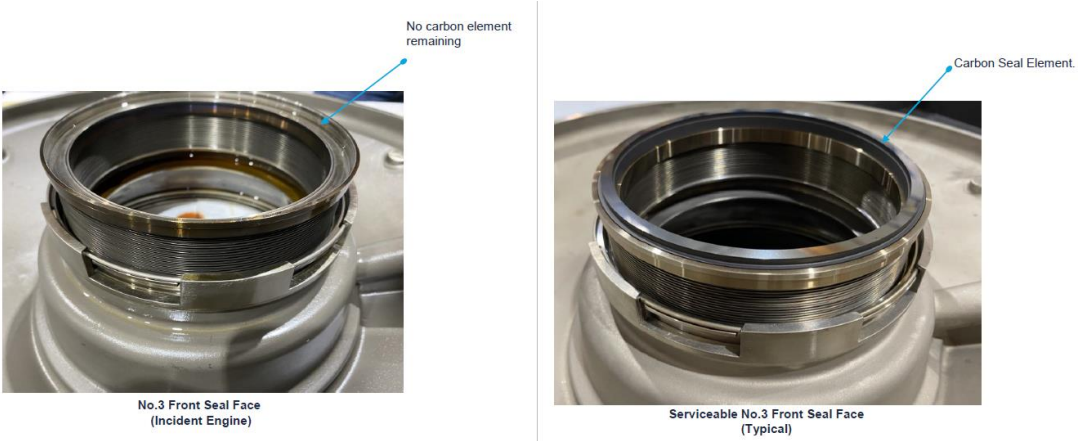
- 2.1.1 Post-incident examination of the left engine revealed that a carbon seal in the No. 3 bearing compartment had fractured and no remnants of the carbon element was found on the carbon seal carrier. This suggests that the undesirable state of No. 3 bearing front carbon seal fracture had occurred. However, the investigation team could not determine at which moment of the flight the fracture happened.

- 3.1 The smoke in cabin and the left engine fire was caused by the front carbon seal fracture of the No. 3 bearing. This resulted in oil leaking from the bearing compartment to the hot zones of the engine, which led to smoke/fumes being formed, with a twofold consequence: smoke/fumes travelling to the aircraft cabin and cargo compartment through the bleed system, and a localised fire at the engine tailpipe.

- (f) No remaining carbon element at the No. 3 bearing front seal (see **Figure A1**)
 - (g) Wear resulting in a trench at the No. 3 bearing front seal seat

Figure A1: Seal face on event engine with missing carbon seal (left) compared to typical seal face with intact carbon seal (right)

- 4.2 The engine manufacturer has also indicated to the investigation team that it planned to improve the design of the No. 3 bearing carbon seals to prevent “nesting” from deteriorating into the undesirable seal fracture state.
