Final Report

MAN OVERBOARD RESULTING IN DEATH INVOLVING SRS PROTEUS HARVONNE AT SOUTH KOREA ANCHORAGE ON 24 MAY 2024

TIB/MAI/CAS.168

Transport Safety Investigation Bureau of Singapore
Ministry of Transport
Singapore

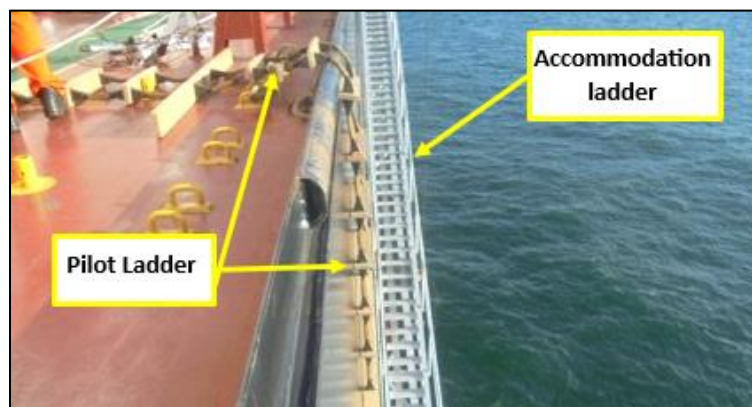
1.1.2 At about 2248H, the bunker barge came alongside and made fast on the starboard side. In anticipation of the ship's engineer and bunker surveyor embarking PH for the bunkering operation from the bunker barge, the Chief Mate (CM) had instructed the Bosun (BSN) and deck crew to prepare a combination ladder⁴ on the starboard side as the ship's freeboard was about 14.85m (See **figures 1**).

Figure 1 – Illustrating the combination ladder arrangement. *Source:* The Company. Annotation by TSIB.

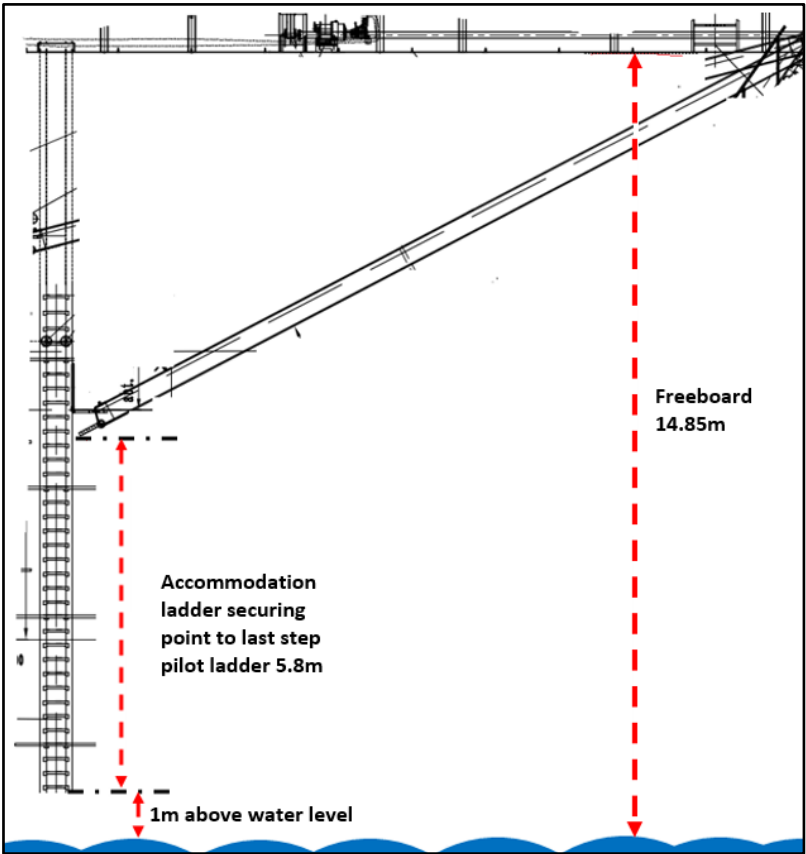
1.1.3 After the bunkering operation was completed on the next morning at about 0236H, the starboard combination ladder was left in rigged position in preparation for the upcoming change of Master. (See **figure 2.**)

Figure 2 – Illustrating the combination ladder shown on the starboard side
Source: The Company. Annotation by TSIB

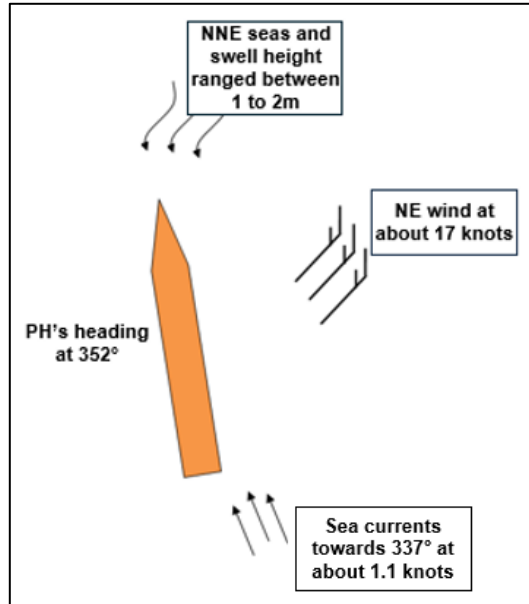
1.1.4 On 24 May 2024, at about 0800H, PH was heading at 352°, the Third Mate (3M) serving as the Officer of the Watch (OOW) recorded the weather conditions as cloudy and visibility ranging from 5km to 10km. The wind was from northeast at about 17 knots, with seas and swell from north-northeast ranged between 1m to 2m⁵. The sea current was setting towards 337° at about 1.1 knots. (See **figure 3**). During this time, a service boat ferrying the new Master arrived.

⁵ The crest of the swell occasionally struck the lower steps of the pilot ladder, causing it to sway and making it difficult for individuals to maintain a stable footing and a secure grip.

Figure 3 – Illustration of the weather and sea conditions relative to PH at 0800H. *Source:* The Company. Annotation by TSIB

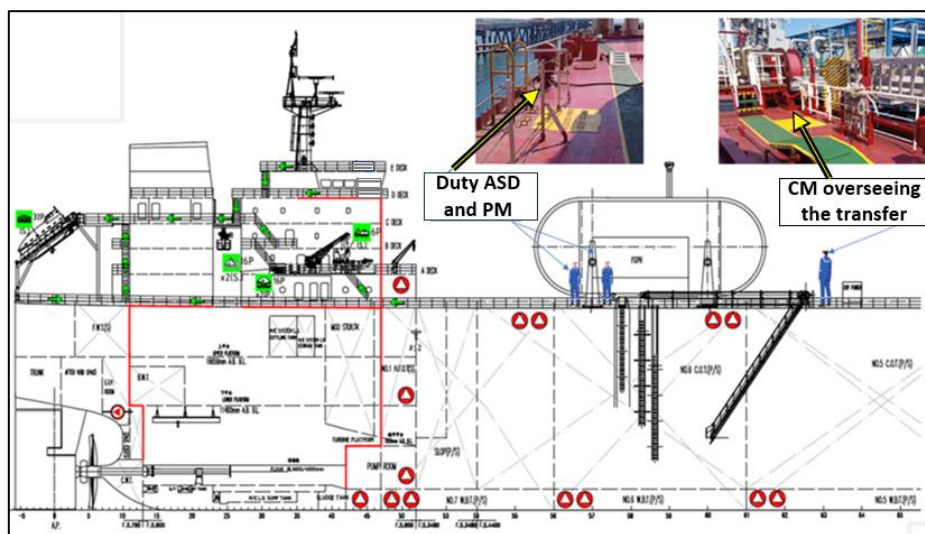
1.1.8 The transfer team, consisted of the CM and the ASD who were standing near the top platform of the accommodation ladder and the pilot ladder on deck respectively, was observing the descent of the OSM. The Pumpman (PM), who came to bid farewell to the OSM, stood near to the ASD. See **figure 4** - illustration indicating positions of the crew at the time of the occurrence.

Figure 4 - Indicating positions of the crew at the time of the occurrence.

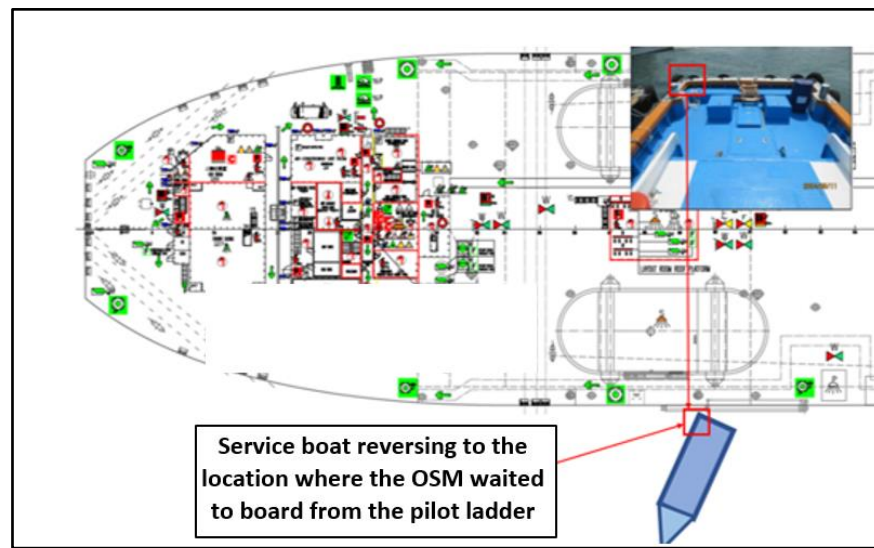
himself with the service boat deck for the transfer. During the first attempt to approach PH, due to heavy swell, the service boat failed to get close to the pilot ladder and was pushed forward. See **figure 5** – indicating the service boat angle of approach towards the pilot ladder.

Figure 5 – Indicating the service boat angle of approach. *Source:* The Company. Annotation by TSIB. (Not to scale)

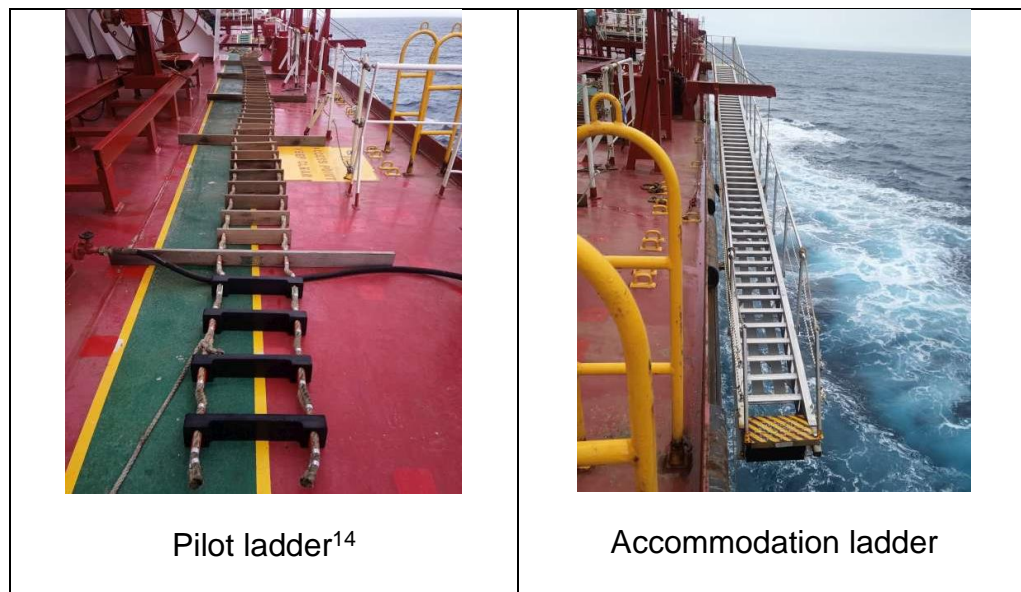
1.6.3 Transfer arrangements of vessels where the height from sea level to the point of access or egress exceeds 9m must use an accommodation ladder in conjunction with a pilot ladder, in compliance with Resolution MSC.308(88), adopted by SOLAS 74, as amended. PH was provided with the required equipment to facilitate safe transfers. See **figure 6** - Photographic evidence provided by PH indicating the condition of the equipment.

Figure 6 - Photographic evidence provided by the ship indicating that the ladders were in good working condition. *Source:* The Company.

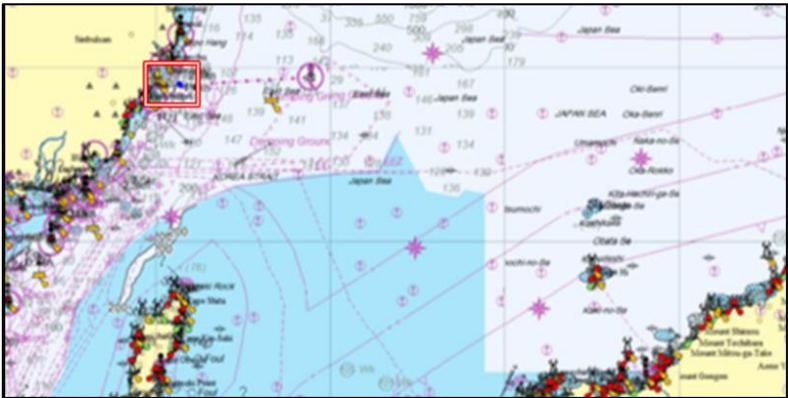
- 1.10 Location of anchorage
- 1.10.1 The B3-2 anchorage area was located approximately 4.5 nautical miles from the Korean coast. This location was characterised by its openness, making it vulnerable to various environmental factors such as weather, wind, sea currents, and tidal changes.
- 1.10.2 The exposure of the anchorage to these elements, along with the effects of high-speed passing vessels, significantly influences sea conditions. These conditions could affect the safety and stability of anchored vessels, particularly during personnel transfers. To ensure the safety of crew members and the stability of the vessel, careful monitoring and management of these factors were essential. (See **figures 7 and 8**).

Figure 7 - Chart illustrating the south-east coast of Korea. *Source:* The Company.

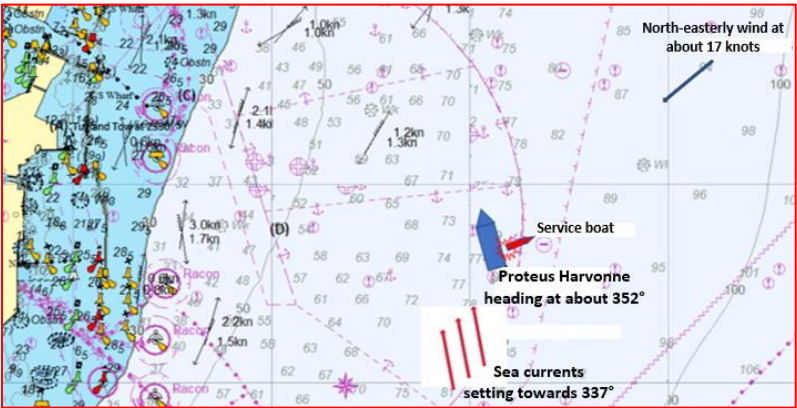
Figure 8 - Enlarged section of the chart illustrating the service boat approaching the ship at anchor and indicating the wind and sea currents at the time of the occurrence. *Source:* The Company. Annotation by TSIB.

2.2.4.4 The investigation team identified that the exposed location of the anchorage and the prevailing weather and sea swells were factors that were not adequately assessed during the planning and execution of the personnel transfer. The occurrence has demonstrated the need for more cautious risk assessment and consideration of alternate safer methods for personnel transfers in challenging sea conditions. Examples included creating a temporary lee for relatively calm seas during the transfer operation, waiting for the sea swells to subside, arranging for crew changes to be done at berth, in a sheltered location, or at the next convenient port.
