Final Report

DEATH OF A CREW DUE TO FIRE ONBOARD CD MANZANILLO AT PACIFIC OCEAN ON 10 OCTOBER 2023

TIB/MAI/CAS.150

Transport Safety Investigation Bureau
Ministry of Transport
Singapore

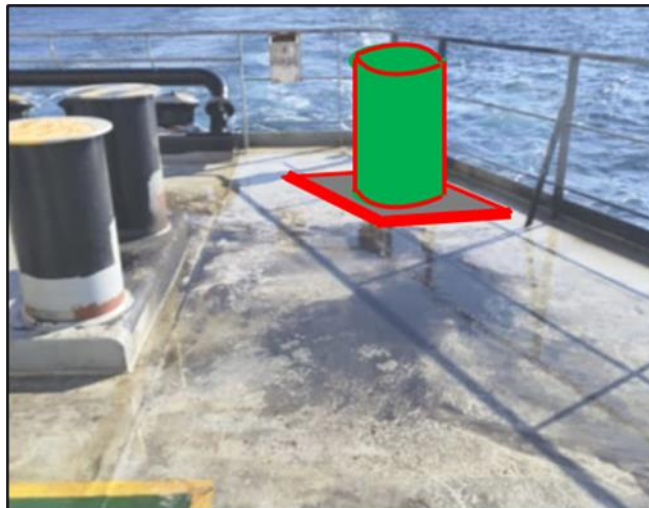
- 1.1.7 At around 1030 hours, following the coffee break, the three ASDs resumed painting the upper deck alleyway while the BSN began painting the interior of the changing room and gymnasium. The OS proceeded alone to burn the three trash bags of plastic wastes in the empty oil drum located at the poop deck. (See **figure 2**)

Figure 2 - Image depicting the empty oil drum used for burning the plastic wastes at the poop deck. Source: The Company. Sketch illustration by TSIB.

- 5.1 Remind its fleet not to burn garbage on the open deck and to advise ships' crew to check onboard and remove any drums previously used for burning garbage. **[TSIB Recommendation RM-2024-016]**
- 5.2 Encourage its crew to exercise Stop Work Authority when unsafe act is being performed. **[TSIB Recommendation RM-2024-017]**

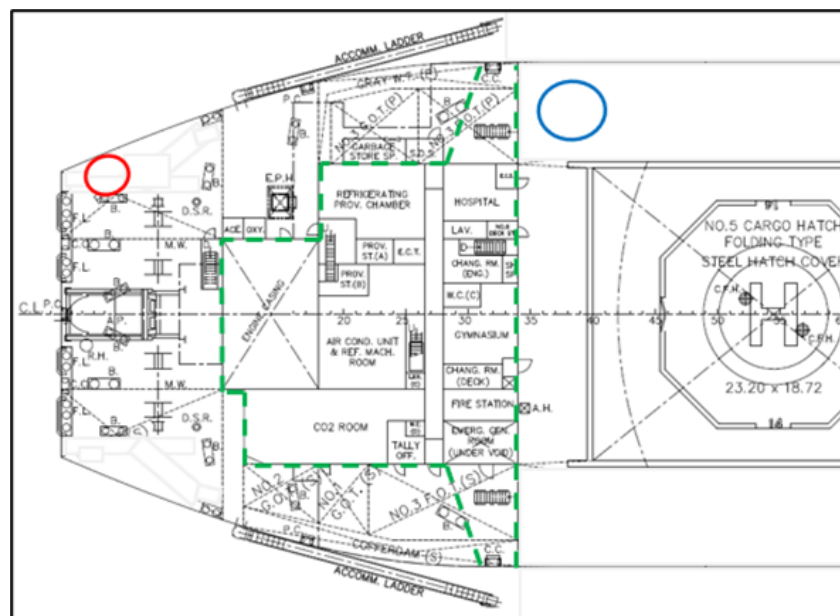
- 1.1.9 At about 1420 hours, an explosion was heard on the ship, followed by the activation of the fire alarm on the bridge's display panel, indicating a fire on the poop deck. The 2M promptly sounded the general alarm and broadcasted a public announcement, alerting the crew to the fire on the poop deck.
- 1.1.10 Concurrently, the three ASD and the BSN heard the explosion and cries for assistance coming from the poop deck, followed by the general alarm and announcement. Upon hearing this, the Master rushed to the port bridge wing, where he saw the OS, whose coverall was engulfed in flames near cargo hold #5¹⁰. The Master also witnessed that the BSN successfully extinguishing the fire on the OS' coverall using water from a garden hose within a few moments. (See figures 3.)

Figure 3 - The red circle on the poop deck marks the spot where plastic wastes was burned. The blue circle on the upper deck indicates where the OS had moved after catching fire and the BSN sprayed freshwater on the OS. The green dashed line outlines the approximate boundary of the accommodation block – Illustration not to scale. *Source:* The Company. Annotation by TSIB.

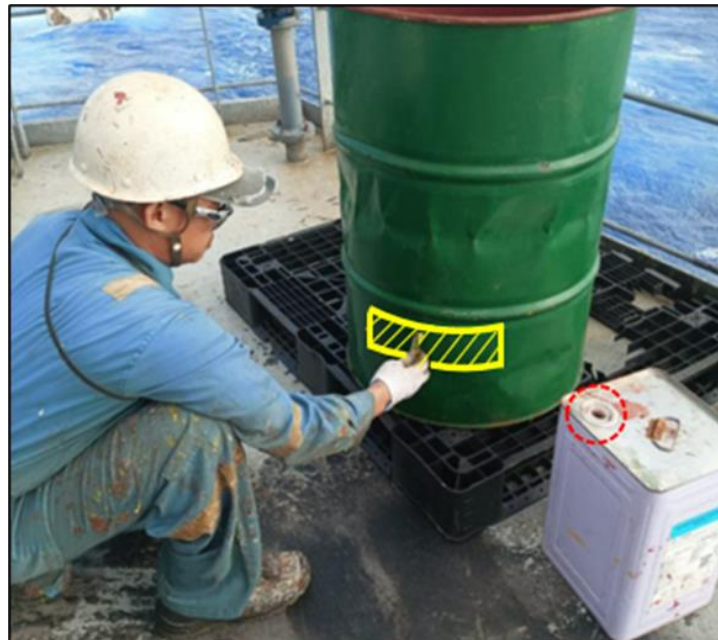
Figure 4 - Illustrates a crew member trying to ignite the garbage in the drum through the opening at the bottom of the drum. The opening of the drum is represented by yellow stripes, and the opening of the uncapped paint thinner is marked by the red dashed line. *Source:* The Company. Annotation by TSIB.

2.1.1 The OS had chosen to use thinner, instead of paper as an accelerant to start the fire in the empty oil drum for the burning of plastic waste. The uncapped thinner tin was placed near to the drum bottom opening had exacerbated the situation, increasing the risk of explosion and fire.

2.1.3 Hence, it is possible that the explosion was caused by the uncapped thinner tin being closed to the source of heat, either when the OS was lighting the plastic waste or when the plastic waste was burning in the oil drum. This explosion had resulted in OS being burnt by the fire from the explosion and subsequently succumb to the burn injuries.

- 3.1 The explosion and subsequent fire had likely originated from the uncapped thinner tin which was placed near to the bottom opening of the empty oil drum used for burning the plastic waste.

- (a) Thoroughly monitoring of ship garbage record book by sending to the Company on weekly basis.
- (b) Company reviewed its SMS procedure and added following details:
 - i. Burning of garbage using improvised equipment on an exposed deck is strictly prohibited.
 - ii. Garbage incineration request form (COMI-SM-5-61) to be sent to Company for approval at least one (1) day before or earlier prior operation.
- (c) Company conducted familiarisation and briefing session to all crew prior joining ship. This session included sharing of investigation findings from previous incidents, highlight the importance of compliance to SMS, and the significance of communication among the crew.
