Final Report

DEATH OF SEAFARER AFTER FALLING FROM HEIGHT ONBOARD XING XI HAI IN SOUTH ATLANTIC OCEAN ON 13 FEBRUARY 2024

TIB/MAI/CAS.157

Transport Safety Investigation Bureau
Ministry of Transport
Singapore

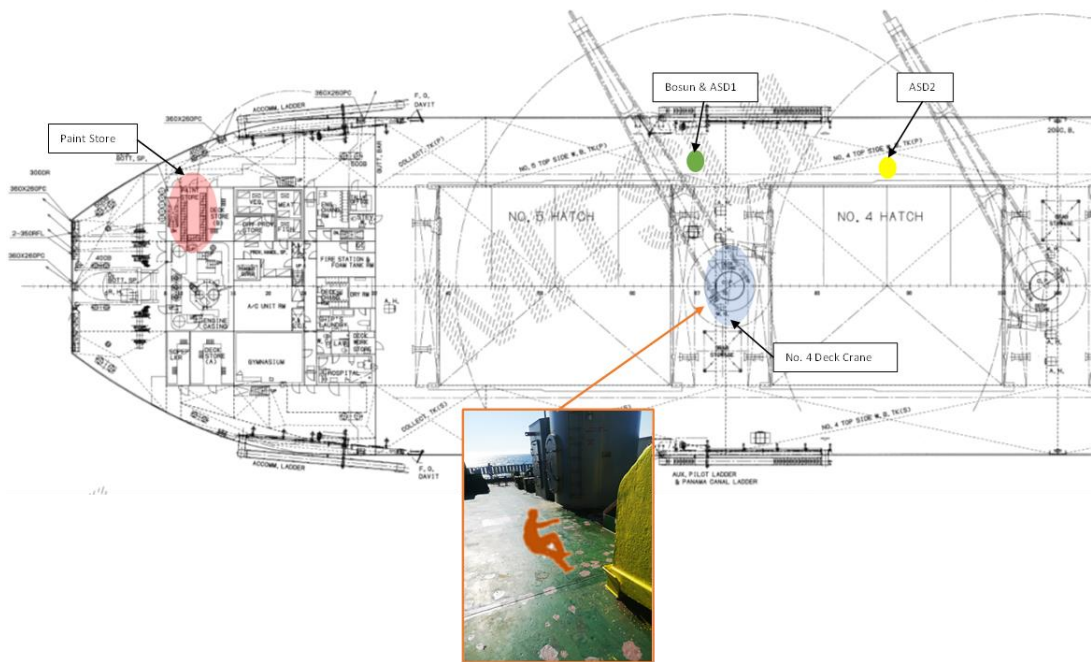
Figure 4 – The General Arrangement Plan showing the locations of the ASD4, paint store, no.4 deck crane, ASD2 and the location of the Bosun and ASD1 when the thumping sound was heard. (Source: the Company, colour shaded by the TSIB)

sound. While ASD2 was on his way back to the Bosun’s store to stop the hydraulic pump after opening the no. 4 hatch cover, ASD2 saw the Bosun and ASD1 running towards the no.4 deck crane. ASD2 then headed in the same direction behind the Bosun and ASD1. Upon arriving at the no. 4 deck crane, the Bosun and ASD1 saw the ASD4 lying on deck next to no. 4 deck crane (see figure 4).

- 2.1.1 The ASD4 was found lying next to the no. 4 deck crane with a fractured right ankle and was bleeding from his injured head as observed by the CO. While the exact cause of death of the ASD4 could not be determined as an autopsy examination report was not available, it is likely that the ASD4 had succumbed to the injuries from the fall from a height of about 8m.

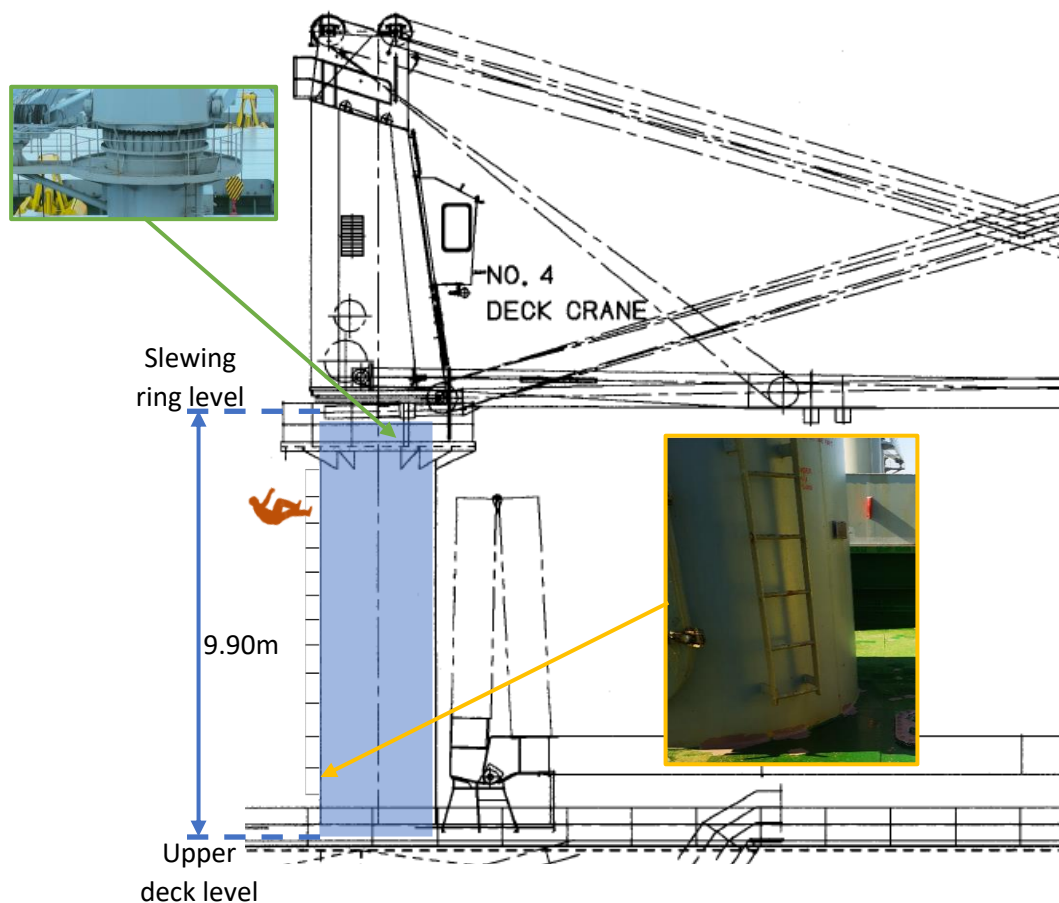
Figure 5 – Drawing of the no. 4 deck crane with the crane post shaded in blue⁸ (Source: the Company and annotated by the TSIB)

1.1.5 Separately, at about the same time (0802H), the Master, who was on the bridge saw⁷ a person fall off from the no. 4 deck crane’s post (see figure 5). The Officer of the Watch a third officer immediately made an announcement through the ship’s PA system requesting the CO to check on the fallen person after instructed by the Master. The CO, who was at the ship’s mess room quickly made his way to the location of the no. 4 deck crane after hearing the announcement.

⁷ The Master at the time could not ascertain who the person was and from which point on the no. 4 deck crane’s steel rung ladder the person had fallen. The Master could only estimate that the person had fallen from about three quarter’s height of the steel rung ladder.

⁸ Indicating a height of 9.90m from the upper deck to the slewing ring level of the no. 4 deck crane's post (shaded blue). A steel rung ladder (inset photo in yellow box) is affixed to the no. 4 deck crane's post, the steel rung ladder goes vertically upwards from the upper deck to the no. 4 deck crane's landing platform (inset photo in green box).

- 1.6 Additional information
- 1.6.1 According to the CO and Bosun, there were no tasks planned for the no. 4 deck crane on the occurrence day and there were no tasks carried out on the crane in the past few days. They were not able to ascertain why the ASD4 had climbed up the emergency access ladder of no. 4 deck crane's post.
- 1.6.2 According to the Bosun and ASD1 who first arrived at the scene, the ASD4 was not wearing a safety belt or harness, other than the safety helmet, gloves and safety shoes.
- 1.6.3 The vertical height from the upper deck to the slewing ring level of the no. 4 deck crane's post was 9.90m. According to the Master, the moment he saw the ASD4 fell off from the emergency access ladder, the ASD4 was at about 8m

above the upper deck (refer to **figure 5**).

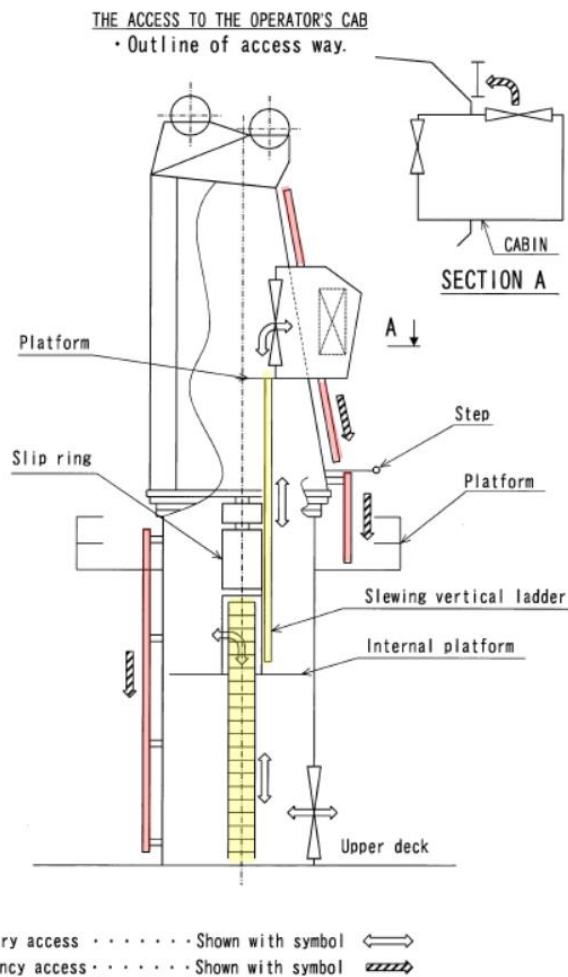
Figure 7 – Drawing of the no.4 deck crane showing the ordinary access (yellow) and emergency access (red). (Source: the Company)

1.5.2 The controls of the crane were in the deck crane cabin²¹ and was accessible through internal vertical ladder (ordinary access) located inside the deck crane's post. In an event of an emergency, where internal ladder could not be used, the crane operator could evacuate from the deck crane cabin to the upper deck, via series of external vertical steel rung ladder (emergency access) fitted (see **figure 7**). The crew onboard XXH were aware that the external vertical ladder was only for emergency use.

- 4.1 A safety meeting was held onboard XXH by the Master together with the Company's Designated Person Ashore²⁸ to discuss the incident with all crew. The crew were reminded to take care of their personal safety as well as the other colleagues. It was reiterated that unsafe acts were to be avoided by adhering to basic safety rules and common sense. Also, all crew shall not ignore hazard identification and risk assessment for safety at work and to call upon a Senior Officer on site for supervision if necessary.

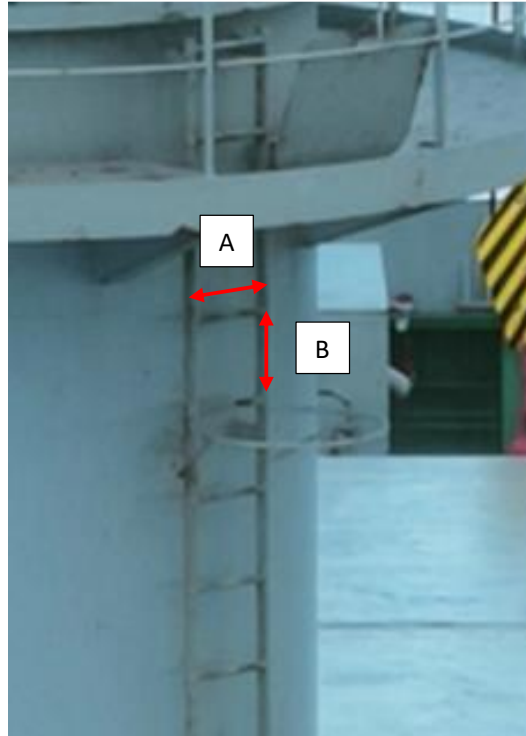
Figure 8 – External vertical steel rung ladder, with A at 37cm and B at 34cm.
(Source: the Company)

- 1.5.3 The emergency access vertical ladder affixed externally to the no. 4 deck crane's post was 925cm long with the steel rungs (steps) spaced 34cm apart and the longitudinal side handholds spaced at 37cm apart (see **figure 8**).
