Final Report

FATAL INJURY OF ENGINE CADET DUE TO COLLAPSED STEEL PLATES ONBOARD CHINA ACE AT SOUTH ATLANTIC OCEAN ON 13 JUNE 2024

TIB/MAI/CAS.171

Transport Safety Investigation Bureau
Ministry of Transport
Singapore

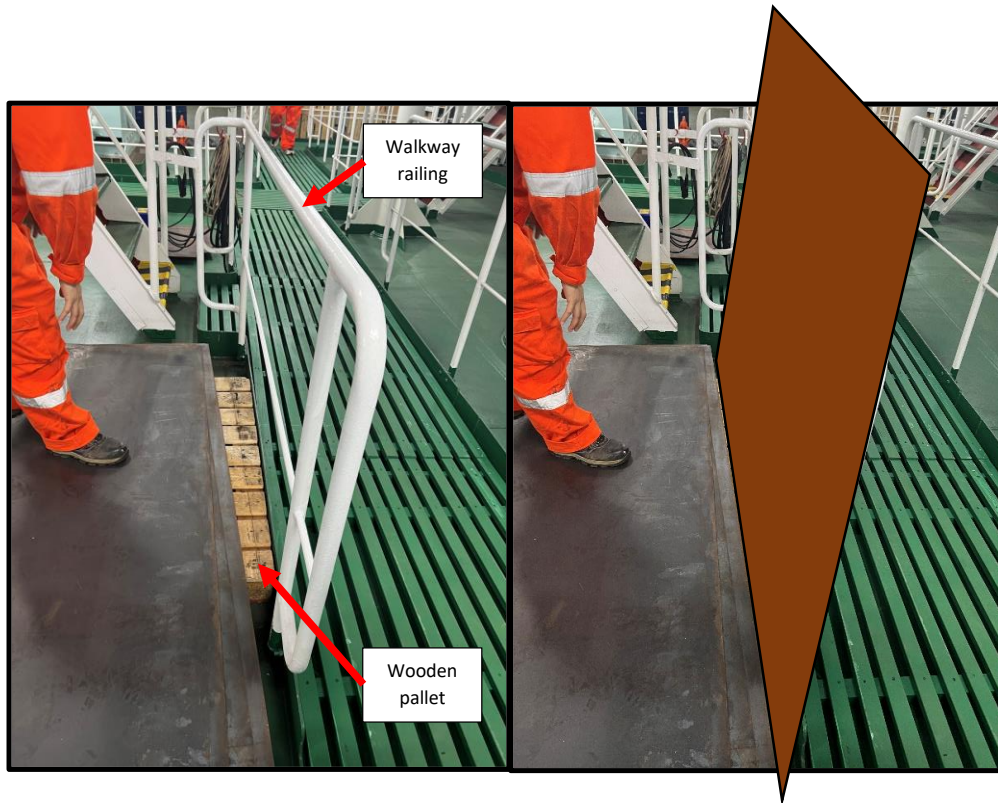
1.1.3 Since April 2024, these steel plates were delivered at shipyard and were stored onboard CA. The steel plates were vertically stacked on a wooden pallet (100 x 120 cm) and secured to a walkway railing by a rope (see **Figure 2**) in the steering gear room. The trio removed the rope and brought down sheet B steel plates, laying them flat onto the wooden pallet on the floor. Thereafter they brought down sheet A steel plate in the same manner and laid it on top of sheet B plates. The other steel plates remained leaning against the walkway railing. The trio did not re-secure the steel plates to the walkway railing with the rope.

Figure 2 – Illustration of the steel plates leaning vertically against the walkway railing in athwartship (*Source: the Company, illustration by the TSIB*)

- 3.2 The remaining steel plates leaning vertically against the walkway railing were not secured after the selected steel plates were laid on the floor. The fall of the remaining steel plates was likely due to the ship's pitching and rolling movements caused by the rough sea.

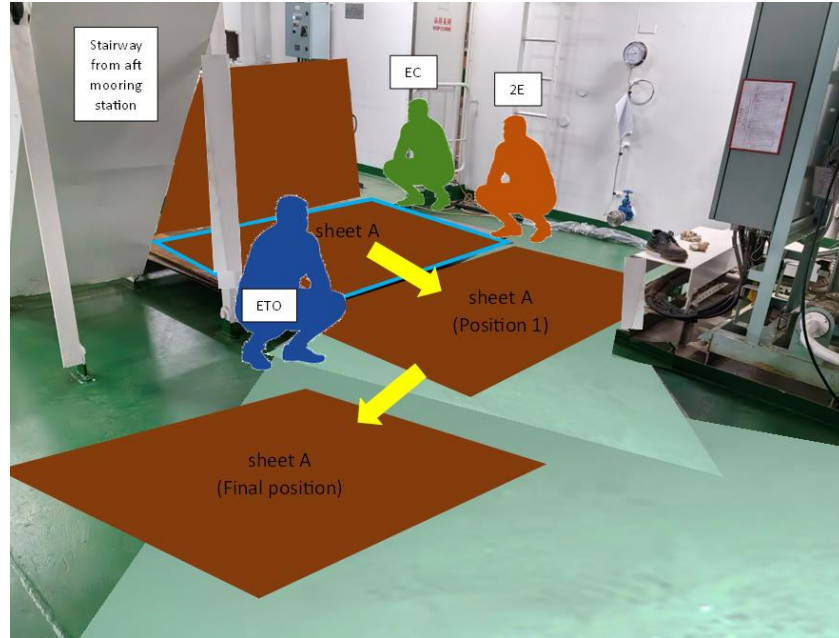
- 1.1.4 The trio positioned themselves at three corners¹² of sheet A and began to lift and shift the sheet A steel plate to a nearby location, about 3m away, where cutting was planned (see **Figure 3**). The trio managed to shift the sheet A steel plate slightly forward by about 0.5m.

¹² The corner directly opposite of the EC was obstructed by a stairway, thus the trio occupied the other three unobstructed corners of the sheet A steel plate (see **Figure 3**).

Figure 3 – The positions of the trio, prior to lifting and shifting sheet A steel plate to position 1 and thereafter to the final position (*Source: the Company, with annotation and illustration by the TSIB*)

⁴⁹ This is verbatim from the RA, the investigation team found out that it meant prohibiting any persons putting their hands / legs below the lifted steel plate (see **Figure 3** - blue box area).

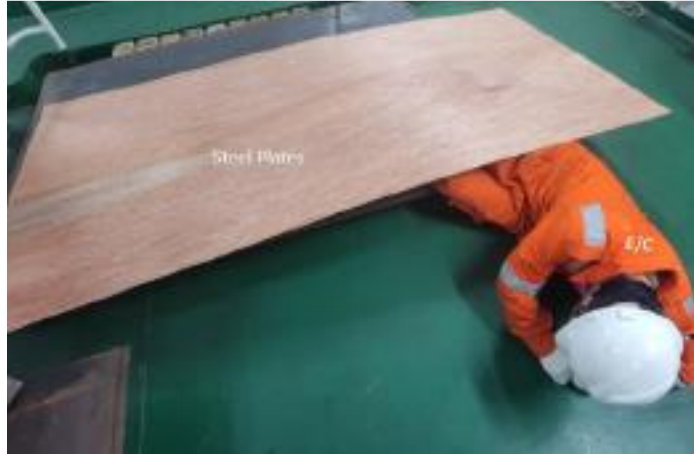
- 1.1.5 While shifting the sheet A steel plate further forward, the remaining steel plates which were leaning vertically against the walkway railing suddenly fell from their vertical position. The 2E and ETO recalled noticing the EC moving to support the falling steel plates. Both the 2E and ETO opined that the EC could have noticed the stack of steel plates falling and had instinctively reacted to stop the steel plates from falling. The sheer weight¹³ of the steel plates were on the EC's back, pinning him down onto the floor (see **Figure 4**).

¹³ The total weight of the steel plates was estimated to be 1346kg.

Figure 4 – Re-enactment of the EC's position when pinned down on the floor by the fallen steel plates (*Source: the Company*)

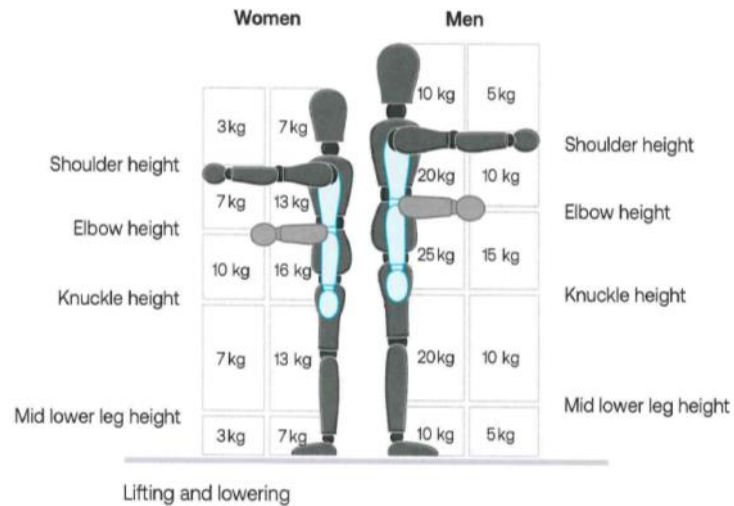
same chapter and referencing the guidelines for safe weights for manual handling, the maximum safe weight for manual lifting was 25kg for a person (see **Figure 7**). In this case, the weight of sheet A steel plate was about 142kg, which was about twice the combined weight of 75kg which the 2E, ETO and EC allowed to lift manually.

Figure 7 – Guideline for safe weights for manual handling⁴² (Source: the COSWP)

2.1.5 In addition, the RA did not adequately consider the heavy weight of the steel plates and associated hazards posed by this weight. The weight of the steel plate to be shifted was beyond the allowed weight of 25kg/person. The use of lifting equipment or trolley should have been considered to avoid injuries relating to strained back and the risk of dropping during shifting.
