Final Report

FATALITY OF CREW AFTER FALLING OVERBOARD FROM INCE NORTHWIND AT ISTANBUL ANCHORAGE ON 3 DECEMBER 2023

TIB/MAI/CAS.154

Transport Safety Investigation Bureau
Ministry of Transport
Singapore

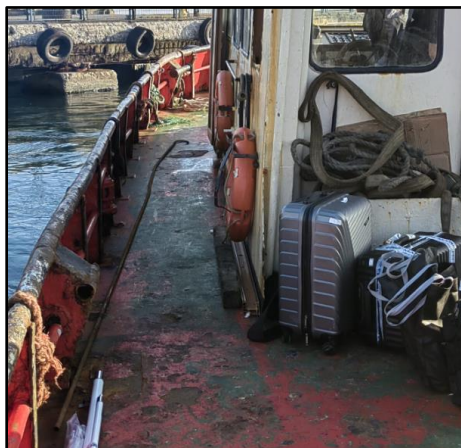
- 1.2.3 At the time of the occurrence, the launch was alongside and parallel with INW where the pilot ladder was in line with the launch cabin. The width of the walkway (see **Figure 2**) on both sides of the launch cabin was about 1m, and the height of the bulwark was about half a meter. There were rubber tyres (about 25cm width) secured around the hull of the launch as fenders. The provision store was loaded on deck at the aft part of the launch and was planned to be offloaded to INW after all on-signers boarded INW.

Figure 2 - View of the port side walkway of the launch
(Source: the Company)

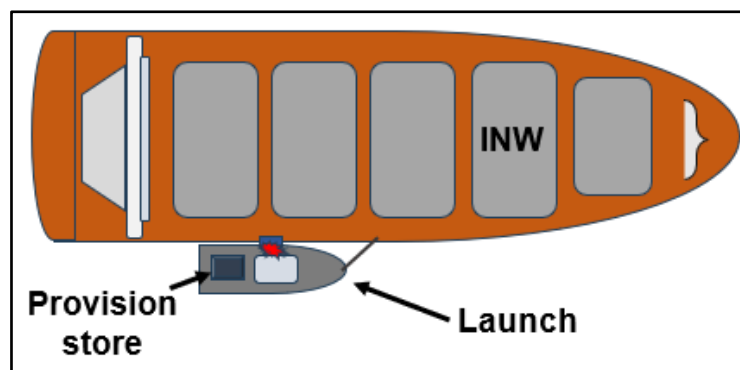
1.4.1 According to the launch master, the launch approached to INW's starboard side and went alongside (see **Figure 3**) with both bows facing at the same direction. Due to the sea swell (1-1.5m), the launch started rolling moderately and drifting away from INW, the launch master throttled the engine and used helm to keep the launch staying alongside to INW while the MA secured the launch to INW with a mooring rope.

Figure 3 - The launch went alongside INW's starboard side

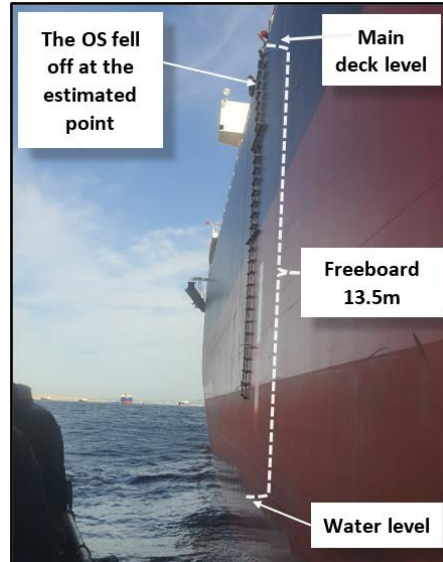
1.4.2 The pilot ladder had been prepared on the starboard side of INW (see **Figure 4**) when the launch arrived, the handrails at the access onboard the deck of INW were also rigged and ready for use. The height from the main deck of INW to the launch deck was about 12m. The height where the OS fell off from the pilot ladder onto the launch deck was about 9-10m. The height from lower platform of the accommodation ladder after rigged to the launch deck was about 5m.

Figure 4 – Pilot ladder rigged at starboard side of INW and freeboard height
(Source: the Company)

5.1.2 To review the process of rigging the combination ladder, when the freeboard is more than 9m, to ensure safe embarkation of crew members. [**TSIB Recommendation RM-2024-019**]

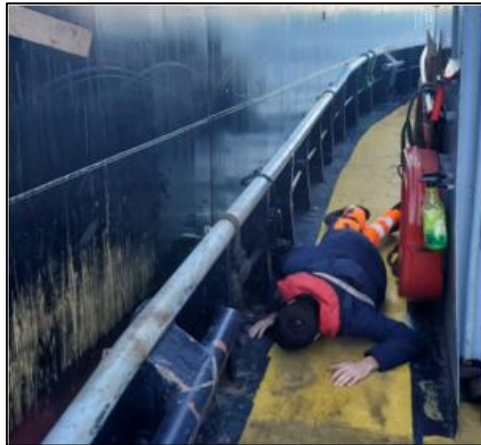
1.5.3 According to the CO of INW, the accommodation ladder was ready for use just before the OS was about to climb the pilot ladder. The OS gestured using hand signal to decline the use of accommodation ladder. The OS was seen slowing down when reaching about 4m to the deck which he had already passed the transfer point across to the accommodation ladder. The CO advised him not to rush and told him there were only few steps to reach the deck, the OS acknowledged "Okay, Brother". He then looked downwards and said, "tell the boat to move away", in about 3-4 seconds later, he fell off from the pilot ladder. The OS' waist and thigh were seen hitting the railing of the launch before

landing at the walkway area next to the cabin (see **Figure 5**). The CO recalled that the OS did not slip from the steps of the pilot ladder.

Figure 5 – Post accident enactment on how the OS landed on the launch
(Source: the UEIM¹⁰)
