# **Final Report**

## **Fatality of Deck Cadet onboard Strategic Harmony at sea on 1 May 2023**

TIB/MAI/CAS.142

Transport Safety Investigation Bureau  
Ministry of Transport  
Singapore

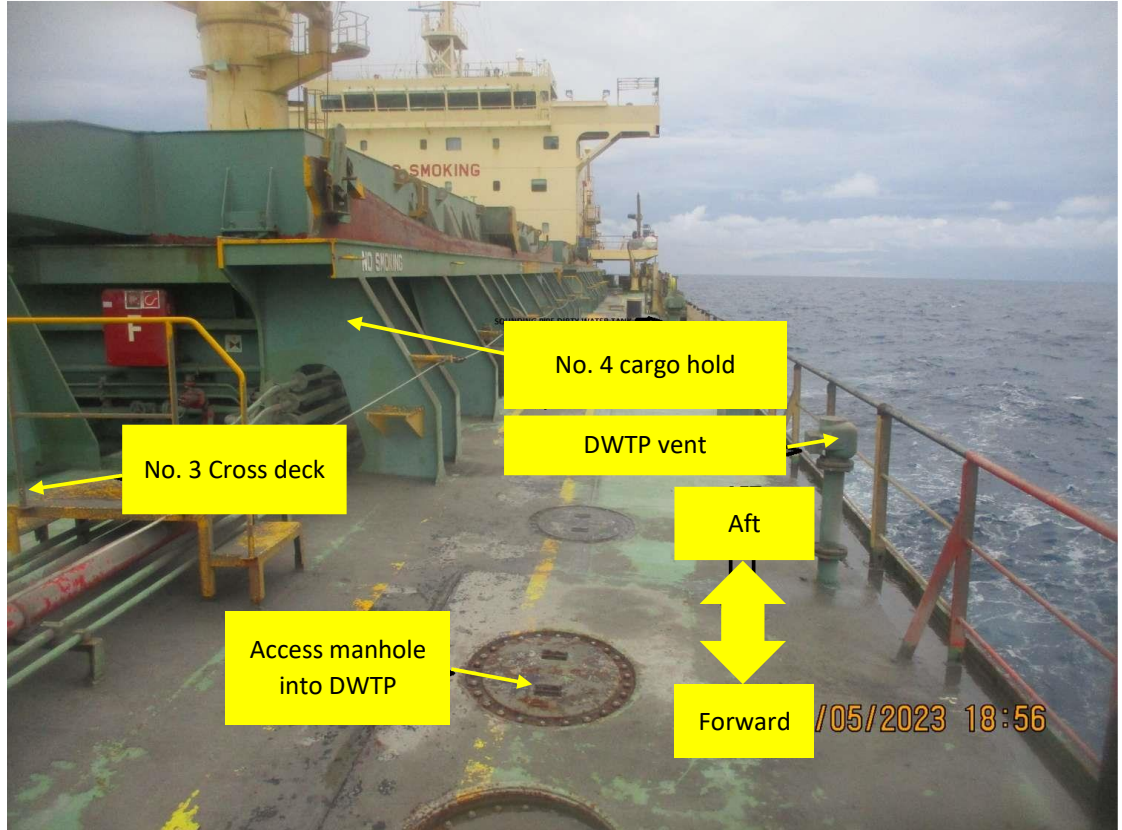
1.1.4 At about 1345H, the first rescue team consisting of the ASD1, ASD2, and ASD3 equipped with SCBA (see **figure 2**) entered the DWT Port (DWTP) through a manhole<sup>9</sup> (see **figure 3**) which was the only access into the tank. The DWTP was located adjacent to no. 4 cargo hold (see **figure 4**).

Figure 3 – DWTP access manhole (Source: the Company – annotation by TSIB)

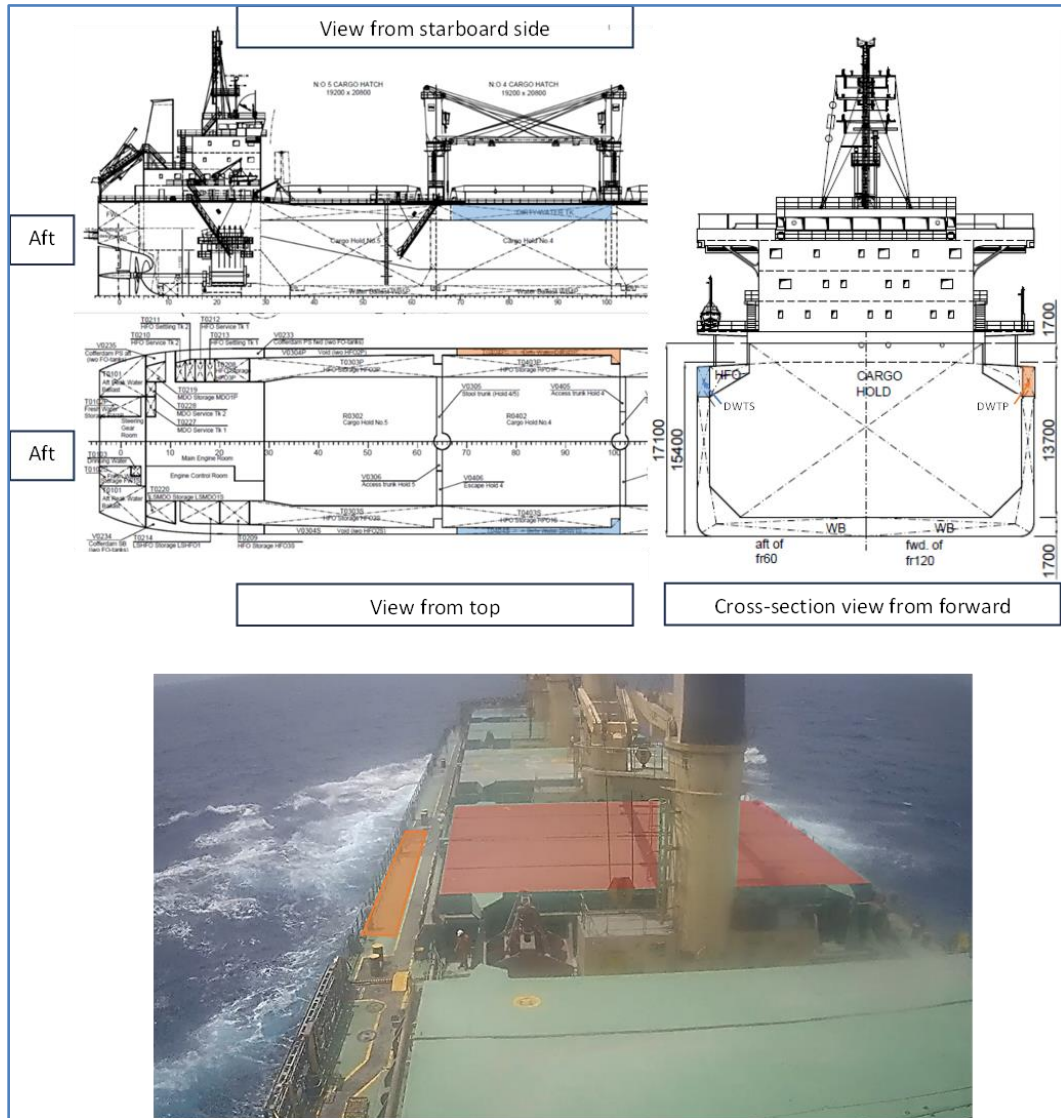
Figure 4 – DWTP - shaded orange in the drawings and photo, DWTS<sup>10</sup> - shaded blue in the drawings, and no. 4 cargo hold - shaded red in the photo. (Source: the Company – annotation by TSIB)

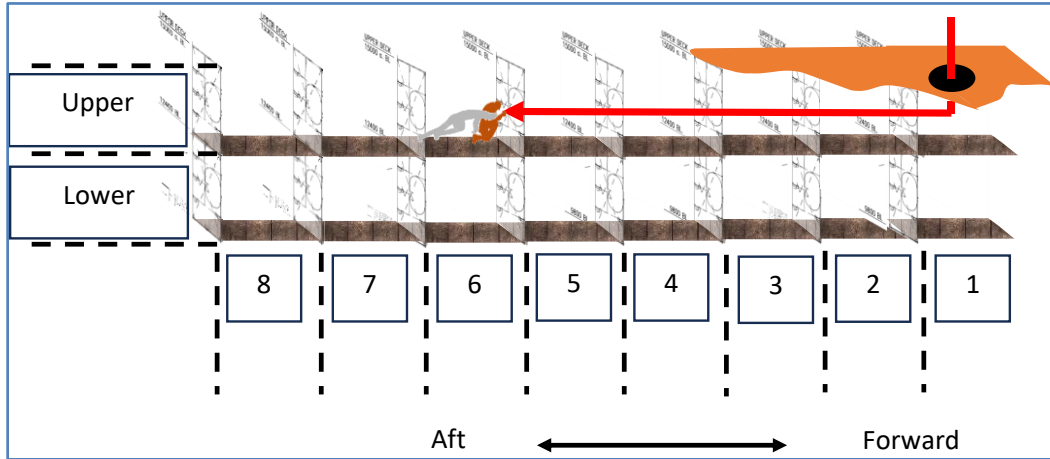
1.1.5 The ASD3 entered the DWTP first and located both the CM and DC inside the sixth upper compartment, about 14m aft from the manhole, (see **figure 5**). The ASD3 reported the location of the CM and DC to the Master after exiting the tank. At about same time, the ASD1 and ASD2 began evacuating the CM.

Figure 5 – Illustration of the location of the CM and DC - showing eight out of total eleven compartments (*Source: the Company – annotation by TSIB*)

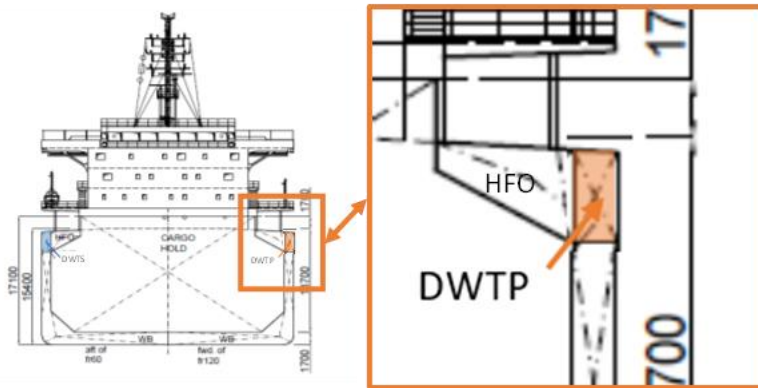
Figure 7 – Location of the HFO tank and DWTP (Source: the Company – annotation by TSIB)

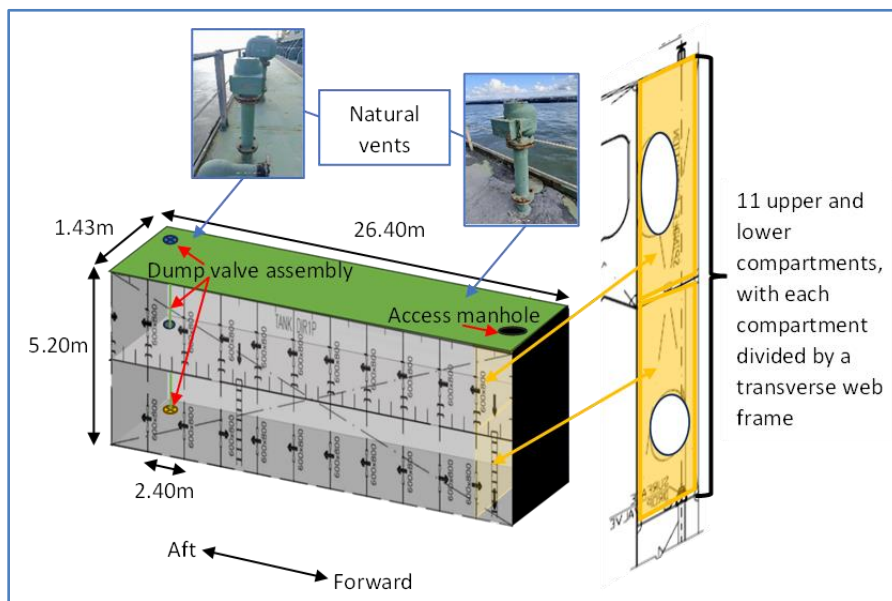
1.6.2 The DWTP was divided by 10 transverse frames and one intermediate deck floor, forming 11 compartments at the upper and lower floor respectively (see **figure 8**). The tank was about 1.43m wide and 5.2m deep. Two natural vents on main deck were connected to the tank at the two ends. One fire mains inlet line was connected to the tank for tank flushing and cleaning by sea water. The capacity of the DWTP was about 156.4 cubic meter.

Figure 8 – Overview of the DWTP for illustration purpose (Source: the Company – annotation by TSIB)

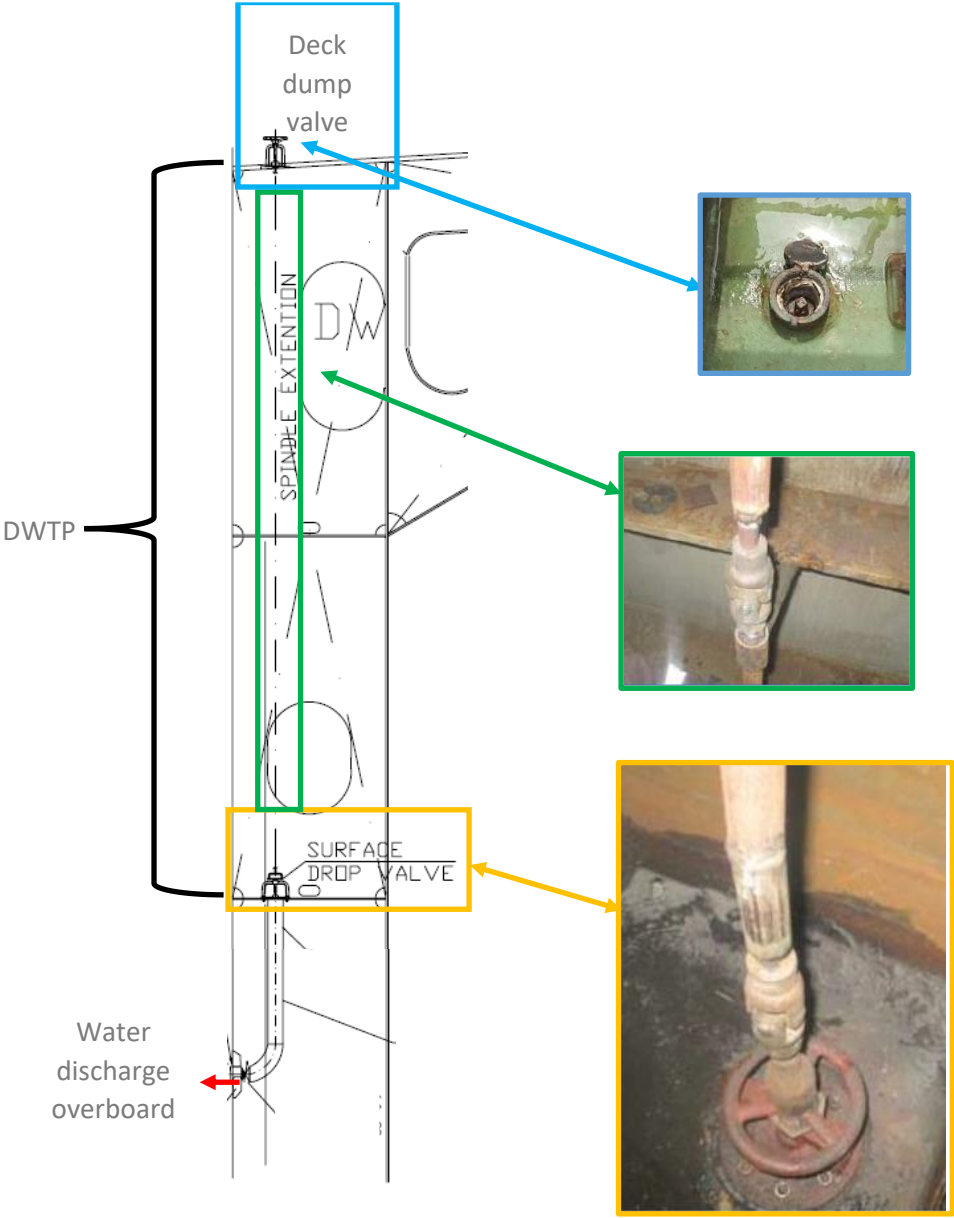
1.6.3 The dump valve assembly consisted of the deck dump valve, the spindle extension (including universal / union joint) and the surface drop valve which was connected. Waste water inside the DWTP could be discharged overboard by turning the deck dump valve on the main deck, which in turn opens the surface drop valve located inside the tank (see **figure 9**).

Figure 9 – Dump valve assembly in the DWTP, cross-section view from aft  
(Source: the Company – annotation by TSIB)

- 1.6.5 The dump valve assembly of the DWTP was reported defective on 11 April 2023 and remarked 'not working' in the vessel's Planned Maintenance System<sup>50</sup> (PMS). According to the 2E's statement the "spindle" of the dump valve assembly was broken<sup>51</sup> requiring hot work repair, which could only be performed after the cargo of coal was discharged.
