Final Report

UNMANNED AIRCRAFT, DrN-35LS LOSS OF AIRCRAFT AT SEA

19 FEBRUARY 2024

TIB/AAI/CAS.230

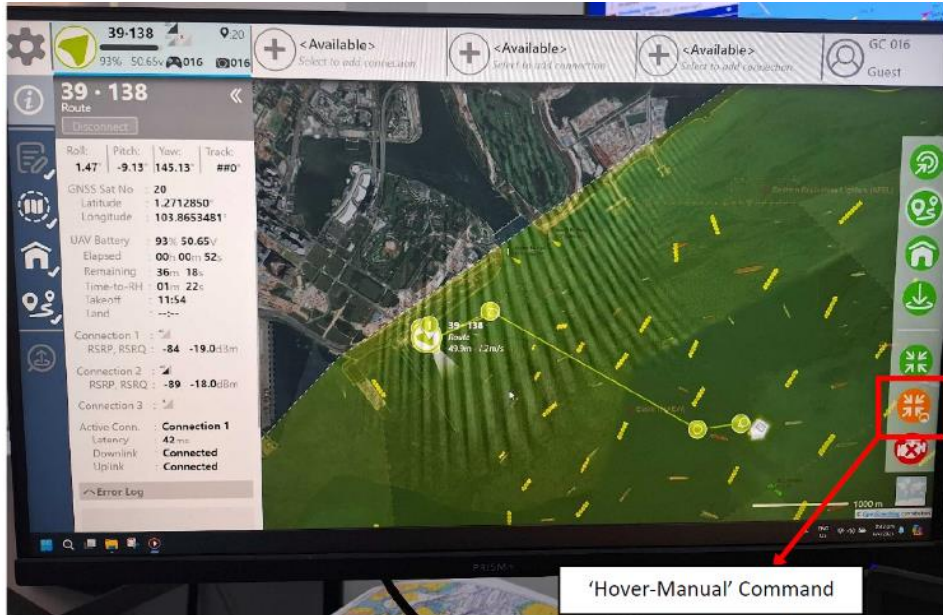
Figure 3: 'Hover – Manual' command button on the GCS screen

- 1.1.2 At 11:45:50 hrs, a 'POSITION X-CHECK FAIL' error message appeared on one of the screens of the GCS (see paragraph 1.5.4 for more details), accompanied by an aural alert. At the same time, the UA reverted, as per design, to hover mode, i.e. stopping any horizontal movement, but maintaining its altitude.
- 1.1.3 The UAP had a window of five seconds to prevent the UA from transitioning to a controlled descent in the 'Land – GPS Lost' mode, as per design, by assuming manual control of the UA by clicking the 'Hover-Manual' command button on the GCS screen (see **Figure 3**) (see paragraph 1.5.5 for more details). However, the UAP attempted instead to take over control of the UA by pressing the 'Hover' command button on the UA controller (see **Figure 4**). The UA did not respond to the UAP's input (see paragraph 1.5.3 for a description of the 'Hover' and 'Hover-Manual' modes).

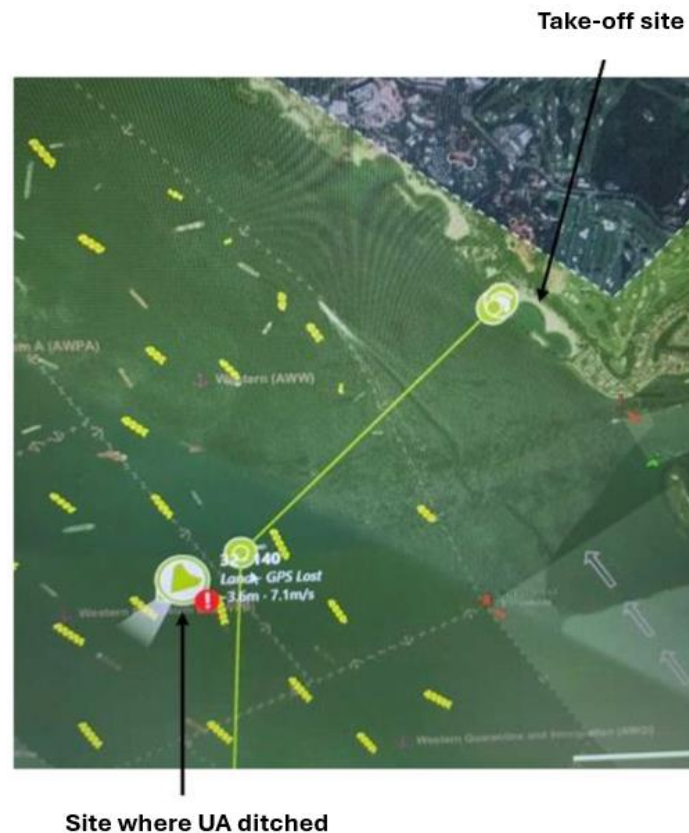
Figure 5: Trajectory of the incident flight

1.1.5 About 60 seconds after the 'POSITION X-CHECK FAIL' error message was generated, the UAP realised that the correct action was to select the 'Hover-Manual' command button on the GCS screen to resolve the error but by this time the UA had already ditched and was sinking into the sea. **Figure 5** shows the trajectory of the incident flight.

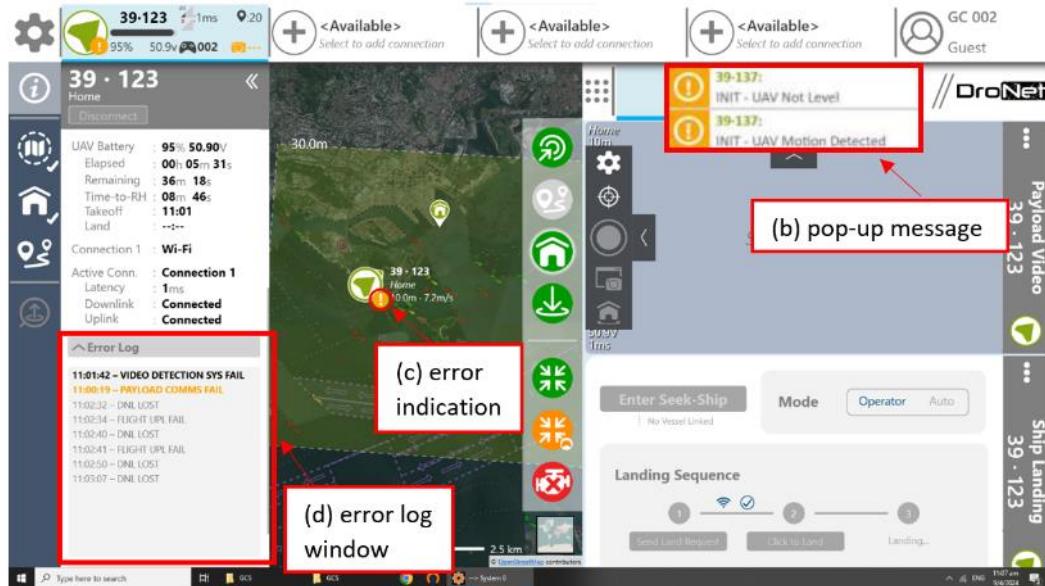
Figure 6: Error messages displayed on the GCS screen

- 1.10.4 Display of error messages on the GCS screen
- 1.10.4.1 When a UA encounters an error, the alerts and cues listed below will be displayed on one of the GCS screens. **Figure 6** is an illustration of the alerts displayed (not from the actual incident).

- (a) An aural alert;
 - (b) A pop-up message on the top right of the menu bar will be displayed for five seconds;
 - (c) An error indication attached to the UA icon; and

- (d) An error message in the error log window.
- 1.10.4.2 The 'Failure Management' section of the flight manual lists the considerations and the recommended actions to be taken by a UAP for each type of error that may be encountered. However, such considerations and recommended actions are not displayed on the GCS screen for a UAP's reference. According to the UA manufacturer, these considerations and recommended actions are not displayed because they can be lengthy and may clutter up the GCS screen.

5.2 It is recommended that the UA manufacturer consider developing a method to make readily available the recommended actions when an error is encountered. [TSIB Recommendation RA-2024-007]
