Final Report

RUNWAY INCURSION AT CHANGI AIRPORT

5 FEBRUARY 2024

TIB/AAI/CAS.228

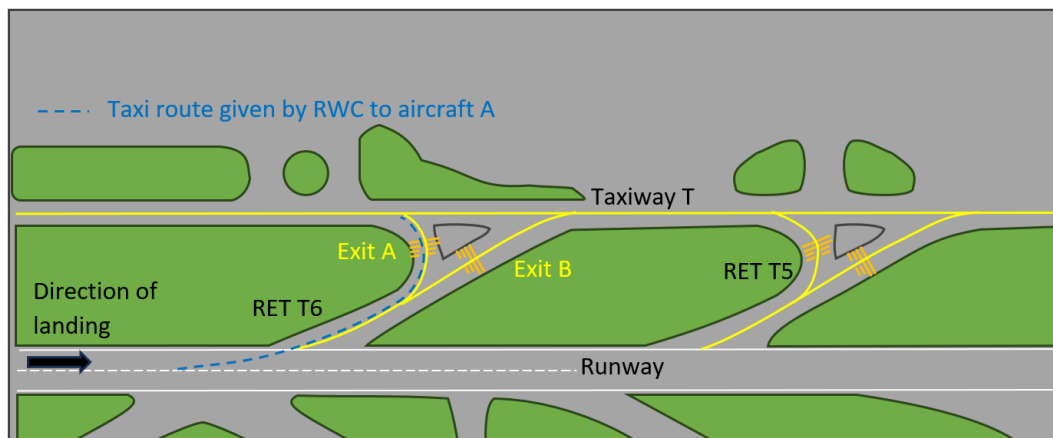
Figure 1: Taxi route given by the RWC to Aircraft A

1.1.2 Aircraft A was instructed by the Runway Controller (RWC) to vacate via Rapid Exit Taxiway (RET) T6 and to turn left onto Taxiway T (see **Figure 1**).

1.1.4 While Aircraft A was taxiing on RET T6 after exiting the runway, the PM established contact with the GMC. The GMC provided taxi instructions to parking bay G18, which the PM read back correctly. According to both the PF and PM, they understood the taxi instruction to mean that they would need to turn onto Taxiway T via Exit A, which was in line with one of the three possible

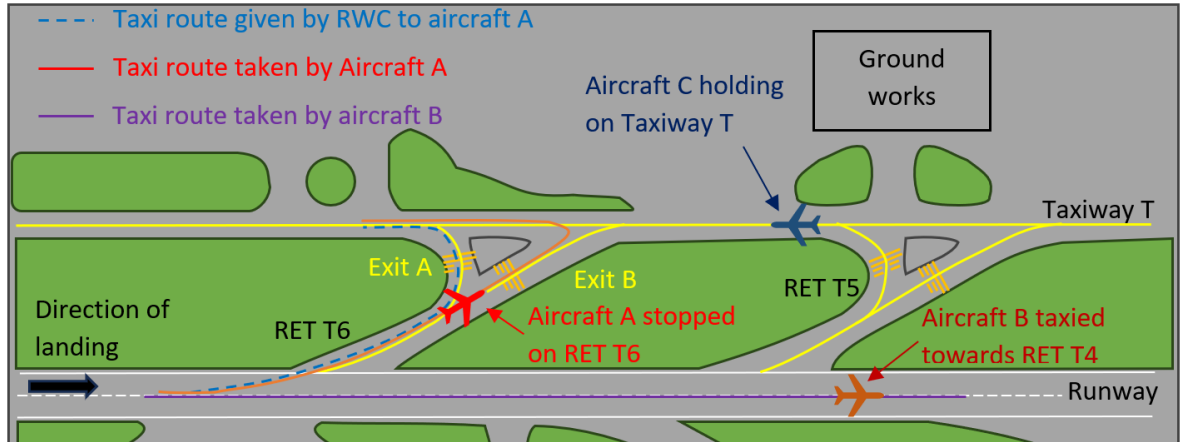
Figure 2: Movements of Aircraft A and Aircraft B

- 1.1.8 After Aircraft B had landed, the RWC instructed Aircraft B to vacate the runway via RET T4 (see **Figure 2**).

1.1.9 The GMC informed the flight crew of Aircraft A that there was another aircraft (Aircraft C) holding on Taxiway T near RET T5. The flight crew discussed and proposed to the GMC that Aircraft A taxi towards Exit B and vacate RET T6 by making a sharp left turn onto Taxiway T. The GMC assessed the overall traffic condition and acceded to the pilot's proposal. Aircraft A executed the sharp left turn onto Taxiway T and proceeded to parking bay G18.

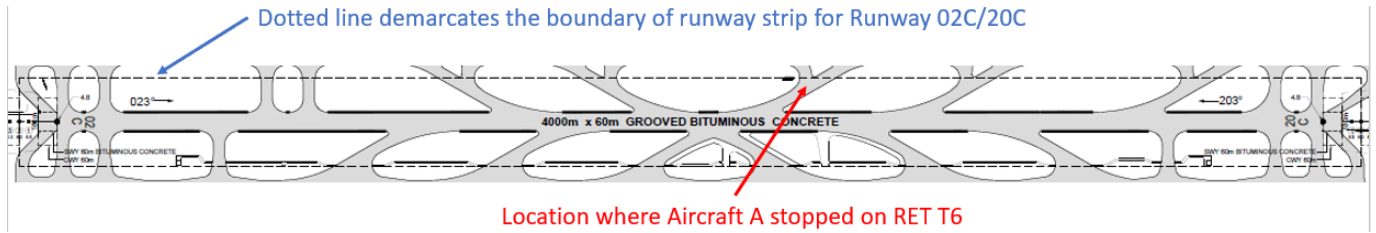
Figure 3: Runway strip area of Runway 02C/20C

1.6.2 For Runway 02C/20C, the defined area (see **Figure 3**) comprises²:

- (a) An area that extends 140m laterally from the centreline of the runway
- (b) An area that extends 60m from the ends of the two stopways
