Final Report

PASSENGER TRAPPED BETWEEN TRAIN AND STATION PLATFORM DOORS

11 MARCH 2024

TIB/RAI/CAS.012

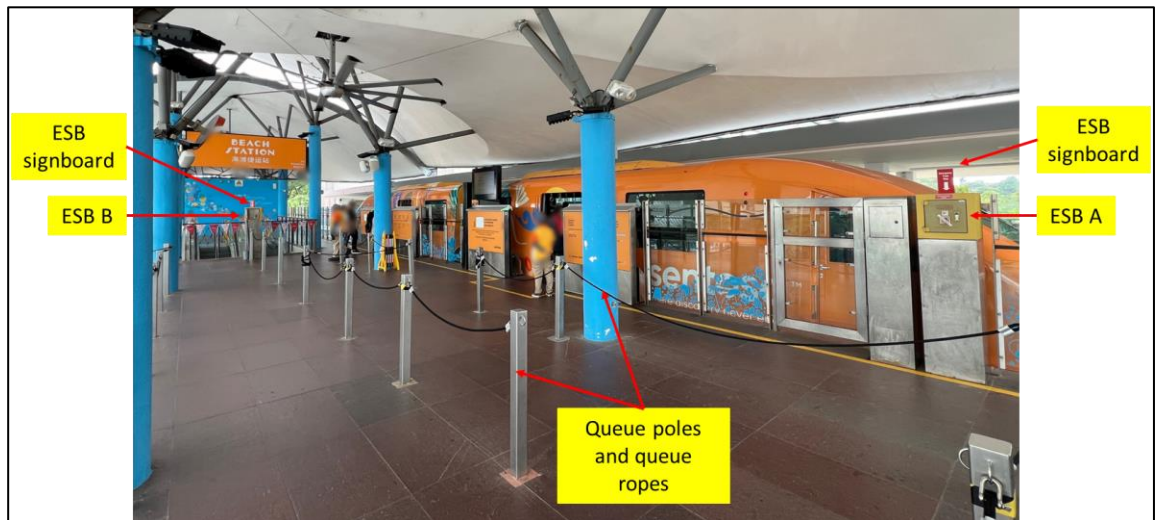
Figure 1: Layout of BEA boarding platform

1.7.2 At BEA, there were two ESBs at the boarding platform: ESB A and ESB B (see **Figure 1**). The ESB A was at the edge of the boarding platform near the PGDs on the right side whereas the ESB B was at the centre of the boarding platform. There were signboards above each ESB to facilitate them being identified. However, the ESB B was facing away from the platform waiting area (see **Figure 2**).

- 2.2.2 The ESB A was very much further away than the ESB B from the trapped passenger. It was not unexpected that SA1 and SA2 did not call to mind to press the ESB A.

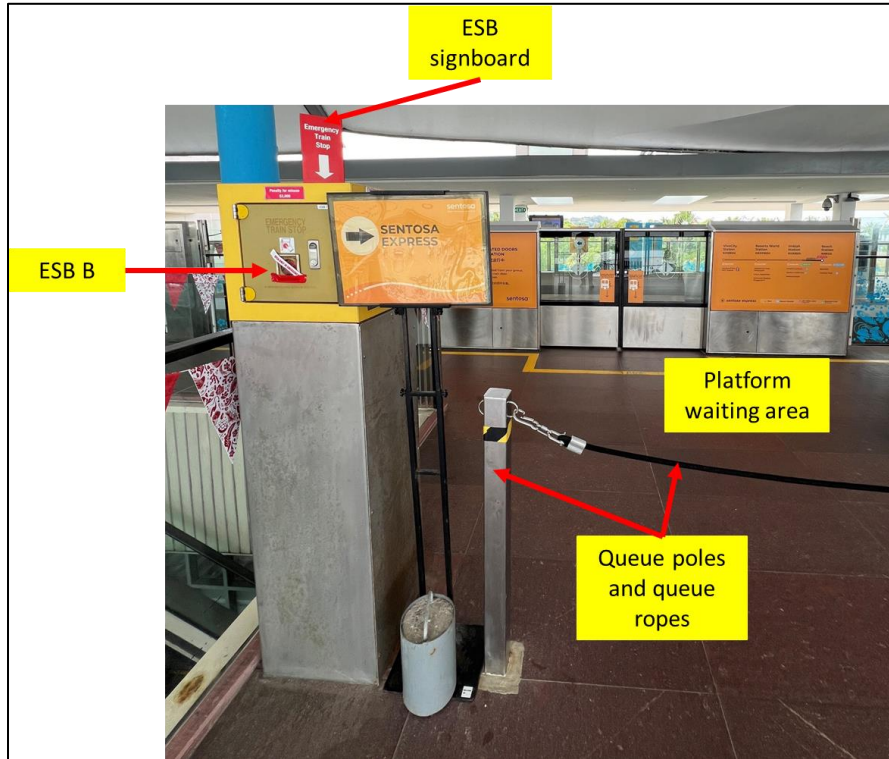
Figure 2: ESB B at BEA boarding platform facing away from platform waiting area

- 2.2.3 The ESB B was nearer SA1 and SA2 but was facing away from the platform waiting area and was thus not amenable to be noticed and used by the people (passengers as well as monorail operator's staff) congregated at the platform waiting area near the PGDs. The signboard for the ESB B was not conspicuous as the words on the signboard were of a relatively small font size. In addition, the queue poles and queue ropes around the ESB B would suggest instinctively to the people standing near the PGDs that the area around the ESB B was a cordoned-off area and they would unlikely call to mind that there was an ESB there.

- 2.2.4 The investigation team suspects that these could be the reasons that SA1 and SA2 did not call to mind to use the ESB B. The TSIB opines that emergency devices such as ESBs, being crucial for public safety, should be sited in such a way as to ensure accessibility and visibility of these devices, which would facilitate a quick response, thereby preventing unnecessary accidents or mitigating the severity of accidents.

- 3.2 The ESB B at BEA boarding platform, which was nearer the SAs than the ESB A, was facing away from the platform waiting area and was thus not amenable to be noticed and used by the people (passengers as well as monorail operator's staff) waiting there. In addition, the queue poles and queue ropes around the ESB B would suggest instinctively to the people standing near the PGDs that the area around the ESB B was a cordoned-off area and they would unlikely call to mind that there was an ESB there. The investigation team suspects that these could be the reasons the SAs did not call to mind to use the ESB B.

- 4.5 The monorail operator relocated the emergency stop button (i.e. ESB B) at the boarding platform of BEA so that it is more noticeable to and accessible for use by monorail staff as well as passengers during emergencies.

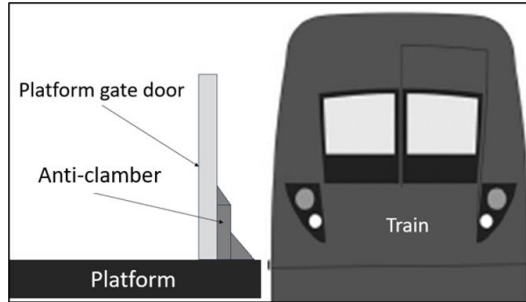
Figure 3: Anti-clamber

1.8.4 In this incident, the closing PGDs did not come into contact with the passenger as she had manoeuvred out of the way of the closing PGDs and managed to hold onto the top of the PGDs and stand on the lower part of the anti-clamber.

- 4.3 The monorail operator modified the anti-clamber to reduce the likelihood of passenger entrapment between the PGDs and train.
- 4.4 The monorail operator is installing infrared sensors on the existing PGDs to enhance the obstacle detection system.

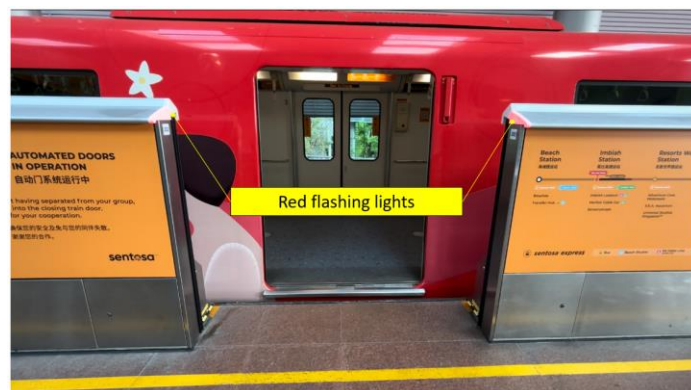
1.8.3 In 2022, the monorail operator further enhanced safety by upgrading the PGDs with door closing buzzers and indicator lamps (see **Figure 4**). The PGDs would sound a buzzer alarm and have its red indicator lights flashing when the PGDs were closing. Signs were also put up to remind passengers not to rush into closing train doors.

Figure 4: Red flashing lights on PGDs

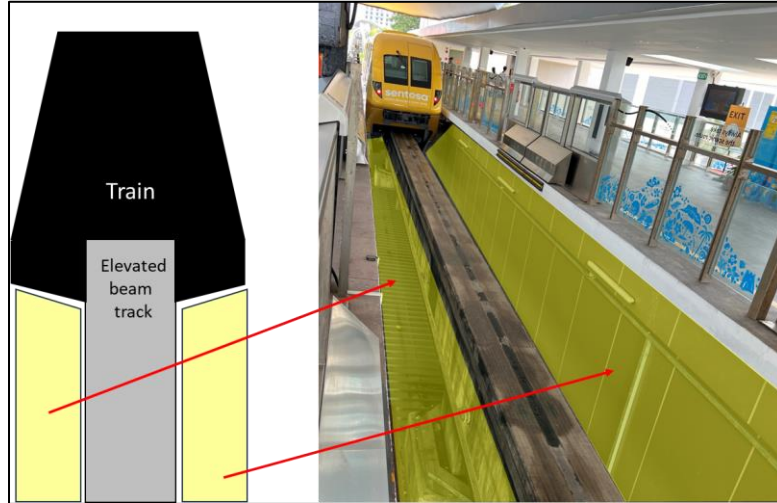
1.9.1 The monorail travelled on an elevated beam of track which was above ground. There were gaps of about 1m between the monorail track and the platforms on either side of the track (see **Figure 5**). The height between the platform and the ground was about 4m.

Figure 5: Gaps between monorail track and platforms as highlighted in yellow

2.4.1 There are gaps between the monorail track and the platform. A person who has fallen off the platform will likely fall through such a gap onto the ground below and will likely suffer serious injury. The investigation team believes it is desirable for the monorail operator to conduct a risk assessment on how such a consequence may be mitigated.

- 3.5 A person who is trapped between the track and platform and has failed to cling onto the PGDs will fall through the gap between the track and platform onto the ground below and will likely suffer serious injury.

- 4.7 The monorail operator has implemented three-monthly refresher training to all SAs to keep them current.
- 4.8 According to the monorail operator, it had conducted a risk assessment in response to the investigation team's view in paragraph 2.4.1 concerning the risk of a person falling off the platform through the gap between the monorail track and the platform after a train has left the station. The monorail operator is confident that its safety actions in paragraphs 4.1 – 4.5 above will mitigate against the risk of a train leaving a station when a person has been trapped between train doors and PGDs and also that the aforesaid safety actions will reduce to an acceptable level the risk of a person falling through the gap between the monorail track and the platform onto the ground.
