Final Report

Collision

**Between BW Seine and barge SOL 2315 towed
by tug SOL 1009**

TIB/MAI/CAS.138

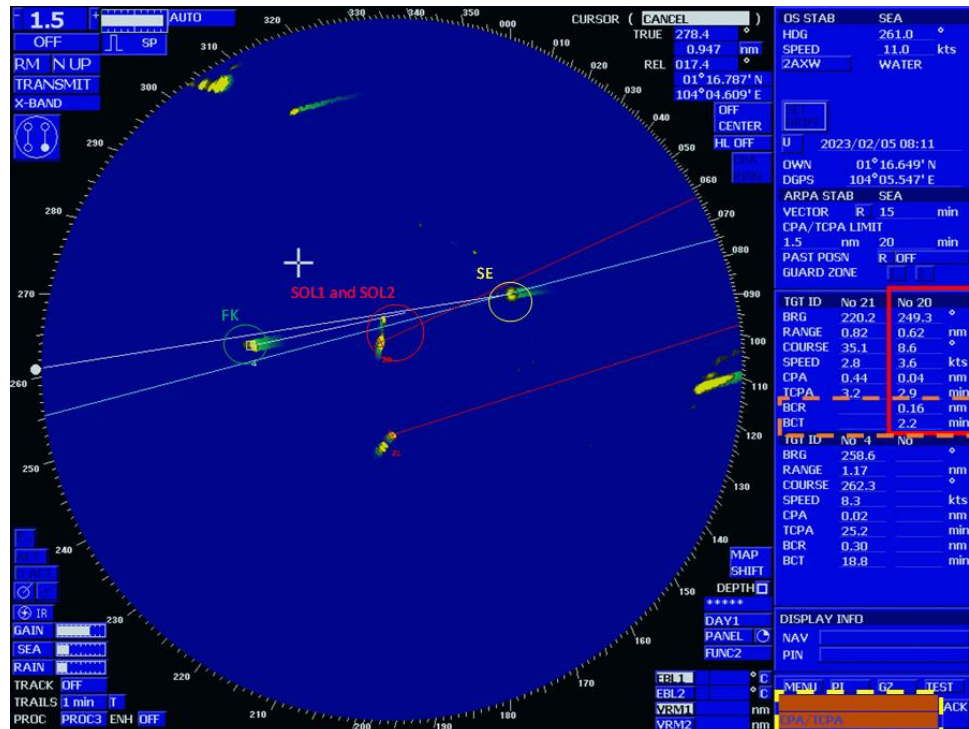
- 1.1.23 When SOL2 was at about 0.62nm and bearing 249.3° ahead of SE's port bow with CPA at 0.04nm (74.08m) in 2.9mins and BCR at 0.16nm (296.32m) in 2.2mins (see **figure 15**), the SE's Master began the adjustment on the ship's engine telegraph reduce engine rpm to 77⁵².

Figure 15 – SE's X-band ARPA radar screen at 1611H showing the position of vessels (two minutes before the collision) (Source: the Company – annotations by the TSIB)

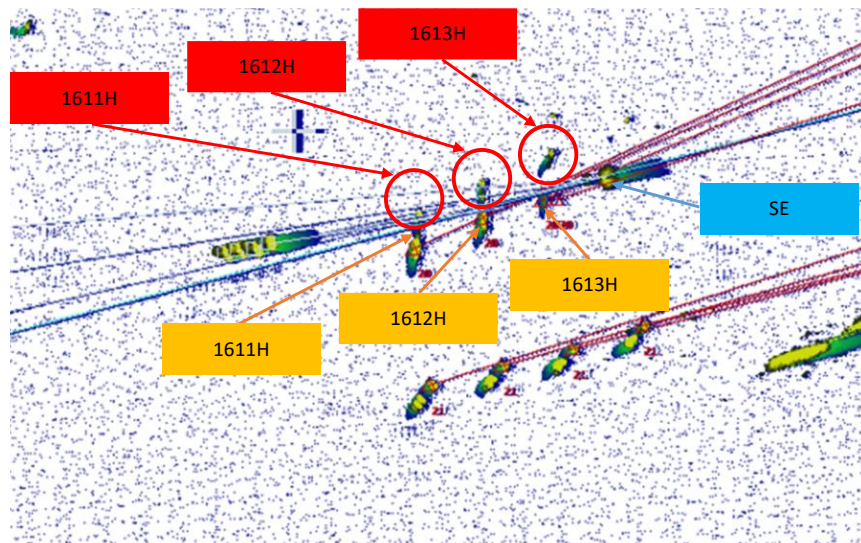
1.1.25 The Master of SOL1 confirmed that prior to the collision, he manoeuvred the tug more to starboard and increased the speed (see **figure 16**, in red circle). The Master further clarified that this action was taken for the safety of the tug and his crew, to avoid the tug being pull by the towing rope if SE were to be in between the tug and the barge, as such an event would lead to the tug to capsize due to girting⁵⁴.

Figure 16 – Overlay of the radar signature of the targets SOL1 (red label), SOL2 (orange label), and SE (blue label) as seen on SE’s X-band ARPA radar from 1611H to 1613H (*Source: the Company – annotations by TSIB*)

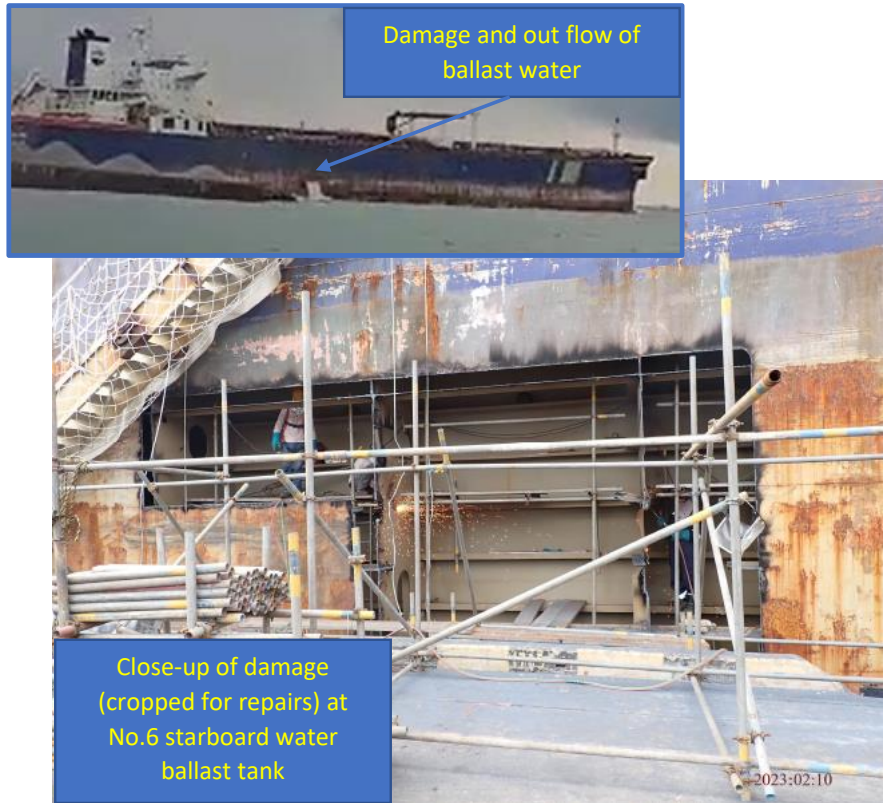
- 1.4 Damage and additional information on SE
- 1.4.1 SE’s no. 6 starboard water ballast tank was ruptured⁶⁸ (sheared and distorted) as indicated in **figure 18**, causing ballast water to flow out from the tank and into the sea. SE’s bow was also damaged as a result of the collision.

⁶⁸ A report from the Classification Society stated that the extent of damage extended to an area of approximately 5m x 2.5m.

Figure 18 – Hull damage on SE (*Source: the Company and SOL1 (inset) – annotation by TSIB*)

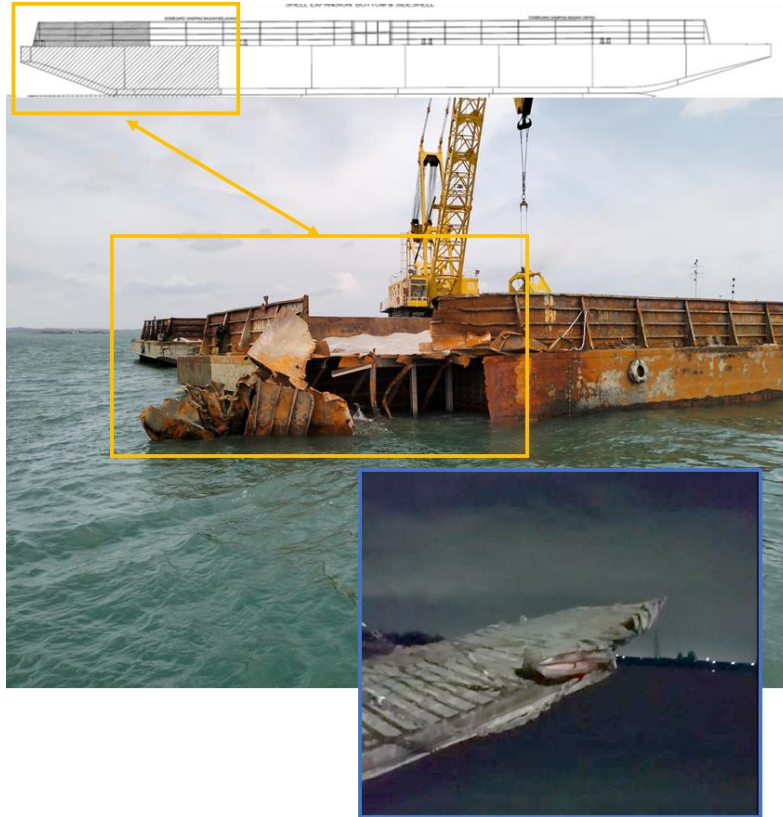
1.5.1 There was no damage to SOL1 as a result of the collision. SOL2's starboard quarter was damaged on the side wall and the hull in way of void tanks no. 7 and 8 starboards were ruptured and deformed with sea water ingress into the breached compartments. SOL2's bow ramp door also suffered damages, where the forward starboard end was sheared when it came into contact with SE's hull (see **figure 20**).

Figure 20 – Hull damage on the barge SOL2 and damage bow ramp door (inset) (Source: SOL1)

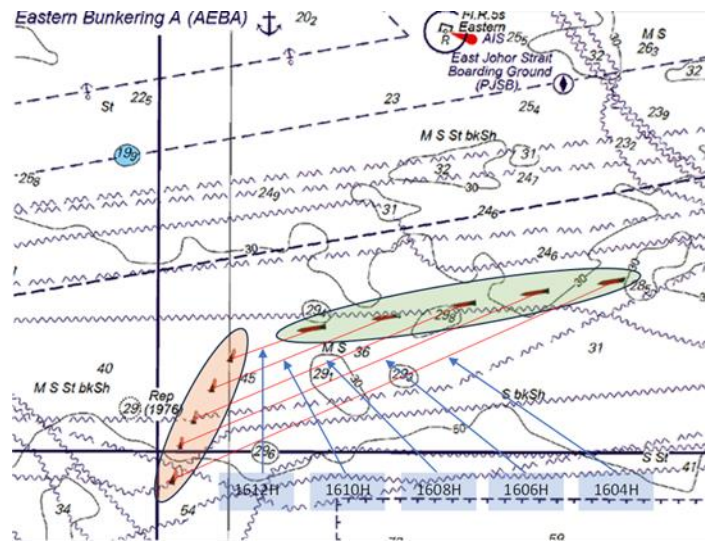
Figure 27 – Positions of SE shaded green and SOL2 shaded orange with bearing line in red which did not appreciably change, from 1604H to 1612H (Source: TSIB)

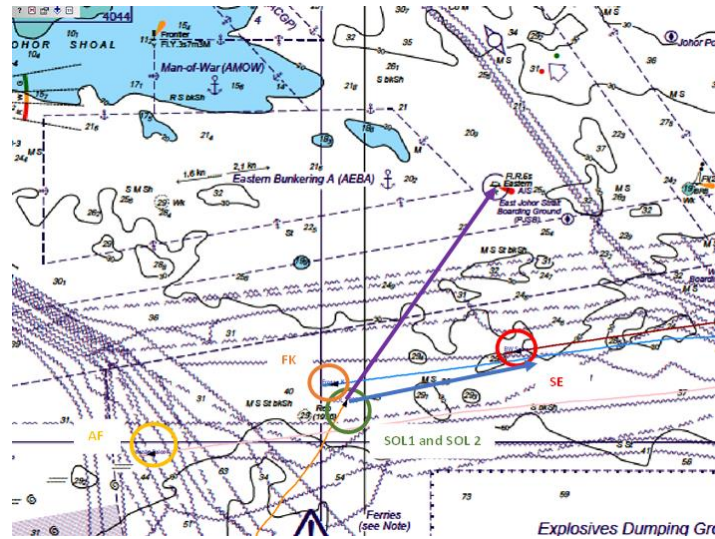
2.4.3 At about 1609H, from the AIS information, the CO observed that SE was about 1nm away and decided to continue heading towards Eastern Buoy, instead of passing the astern of SE (see **figure 32**).

Figure 32 – SOL1 and SOL2 circled green with heading in purple arrow line towards Eastern Buoy and with blue arrow line indicating the possible route to pass astern of SE circled red (*Source: TSIB*)

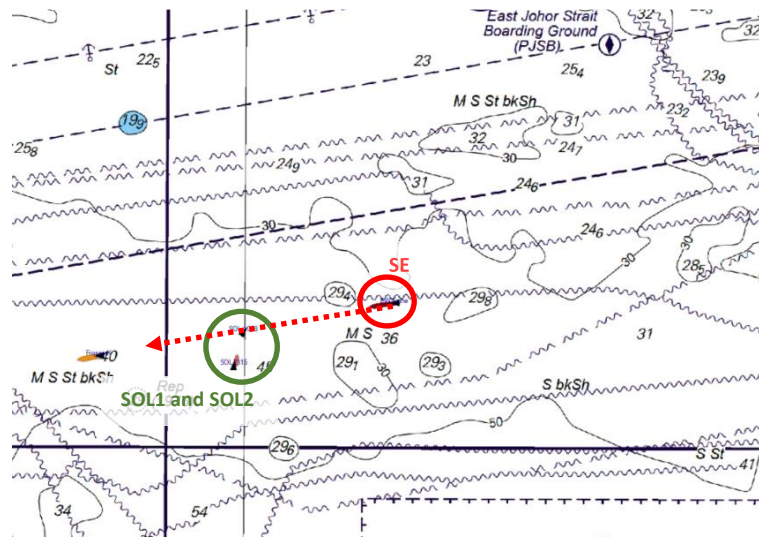
2.4.9 The Master of SOL1 continued to steer SOL1 and SOL2 towards Eastern Buoy and at 1611H observed the heading of SE unchanged (see **figure 33**) and from the perspective of the Master, SOL1 had just crossed SE's bow from port to starboard. The Master was aware that SOL2 was still on the port side of SE's bow, altered SOL1 course to starboard⁹⁷.

Figure 33 – SE's (circled red) heading at 261° in dashed red line with SOL1 and SOL2 (circled green) ahead of SE. (*Source: the Company and TSIB*)

2.4.10 The course changed by the Master had probably caused the pulling tension of the towline to decrease which resulted in the reduction of SOL2's ahead movement, albeit residual ahead momentum. The reduction of SOL2's ahead movement, coupled with the effect of the easterly tidal stream, had placed SOL2 in the path of SE and had consequently resulted in a collision.
