Final Report

FATALITY OF HARBOUR PILOT AFTER FALLING INTO WATER DURING TRANSFER IN SINGAPORE ON 11 FEBRUARY 2023

TIB/MAI/CAS.139

Transport Safety Investigation Bureau
Ministry of Transport
Singapore

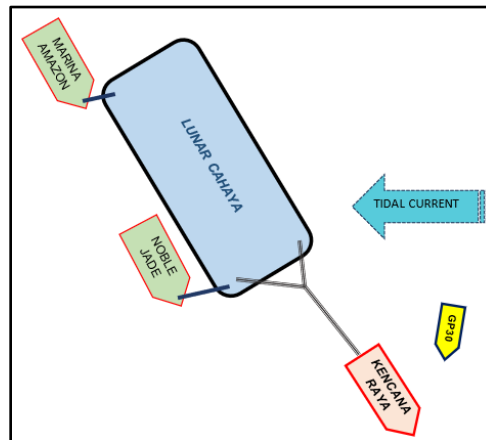
- 1.1.4 Between 0200H and 0220H, as the convoy transited south-easterly towards the pilot disembarkation ground at a speed of about 3.0kts. The pilot launch, GP 30, arrived near the port side (from the east) of KR in preparation for the Pilot's disembarkation. The tidal current was westerly and the lay of LC relative to KR's heading was to the starboard (see **figure 2**).

Figure 2: The lay of LC when GP 30 arrived near KR. – *Illustration not to scale.*

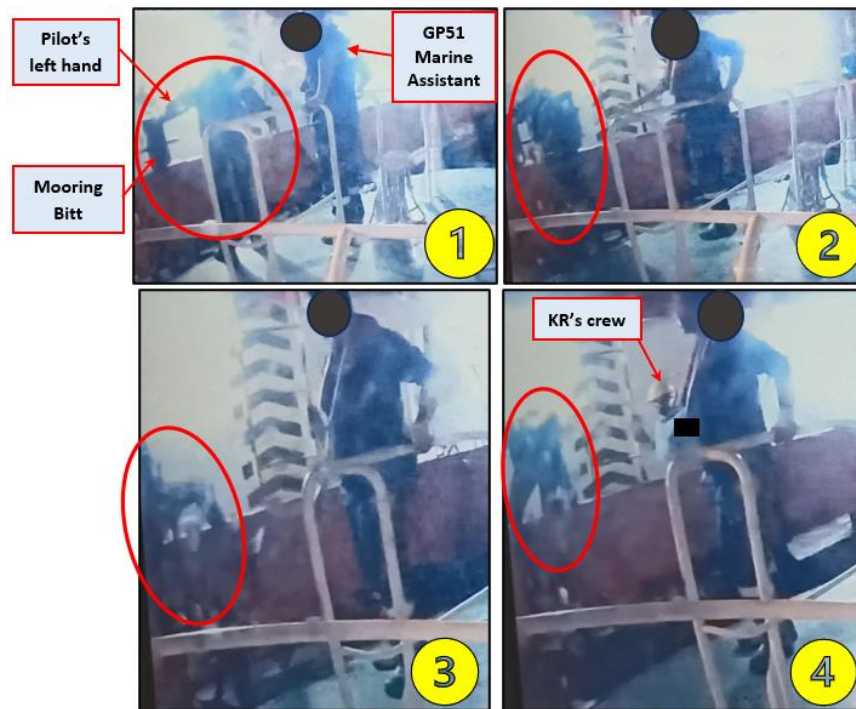
Figure 4: The CCTV camera footage regarding the transfer of the Pilot (circled in red) from GP 51 to KR.

- 1) The Pilot leaned towards KR's bulwark putting his left hand on the mooring bitt and the right hand on the bulwark, supporting his weight.
- 2) With the left foot stepping on KR's tyre fender, the Pilot pushed his body upwards and swung the right leg over the bulwark.
- 3) When the right thigh was seated on the bulwark, the Pilot swung his left leg over the fender and could be seen momentarily freeing the left hand from the mooring bitt.

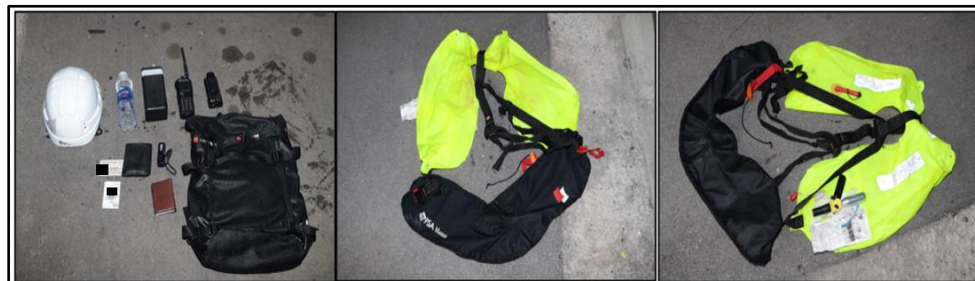
1.4.1 The backpack of the Pilot (see **figure 10**) was weighed by the PCG to be about 4.6kg containing essential items for pilot's work.

Figure 10: The backpack and lifejacket. (from left – the backpack and the items found inside. The front and back of the lifejacket – after being intentionally deflated)
(Source – PCG)

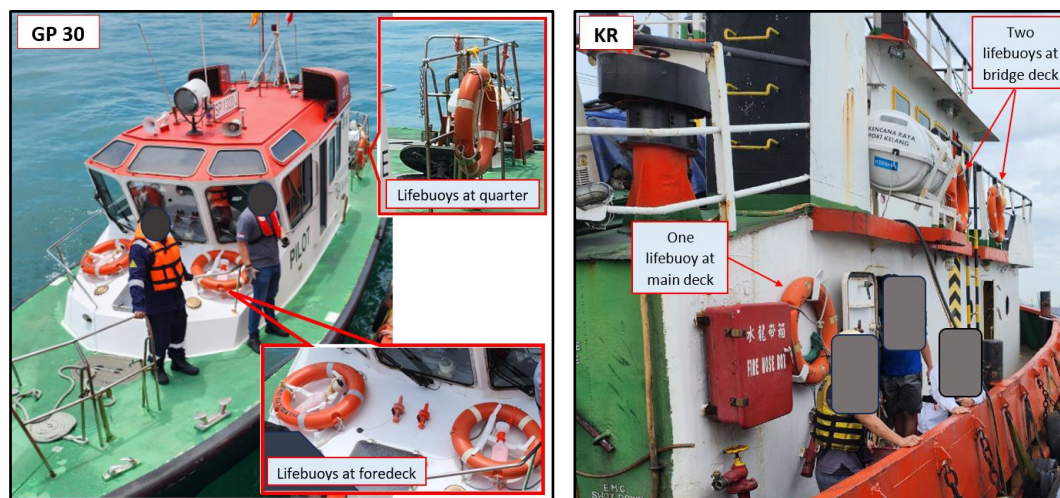
- 1.10.5 There were lifebuoys available⁴⁹ in the vicinity of the pilot transfer location onboard GP 30 and KR and could be released quickly (see **figure 12**). According to the MA of GP 30 and the AB of KR, they did not release the lifebuoy because the Pilot was already a distance away (more than 10m) from their vessels (which were making way at about 2.4kts) after he fell into water and the distance was increasing due to the forward movement of both vessels.

Figure 12: The location and placement of the lifebuoys on GP 30 and KR
