# **Final Report**

## **MAN OVERBOARD (LOSS OF LIFE) FROM THE BUNKER TANKER VENUS AT ANCHORAGE IN THE PORT OF SINGAPORE ON 16 FEBRUARY 2021**

TIB/MAI/CAS.103

Transport Safety Investigation Bureau  
Ministry of Transport  
Singapore

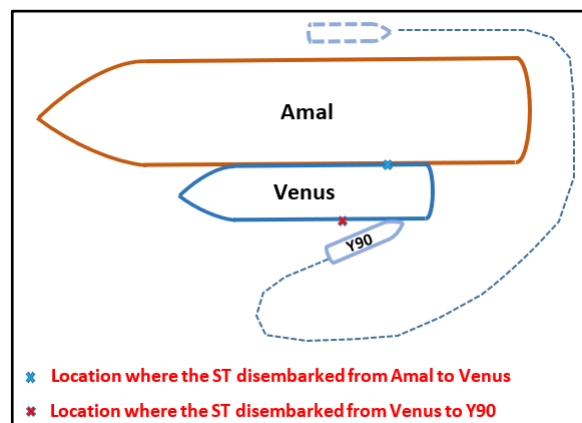
- 1.1.16 According to the ASD-V, the ST started to descend the pilot ladder while Y90 was approaching Venus. Soon, the bow of Y90 touched the hull of Venus lightly (see **figure 1**), but the stern was not parallel alongside yet, i.e. there was still a gap<sup>20</sup>.

Figure 1 – Illustration of Y90's approach to Venus (not to scale)

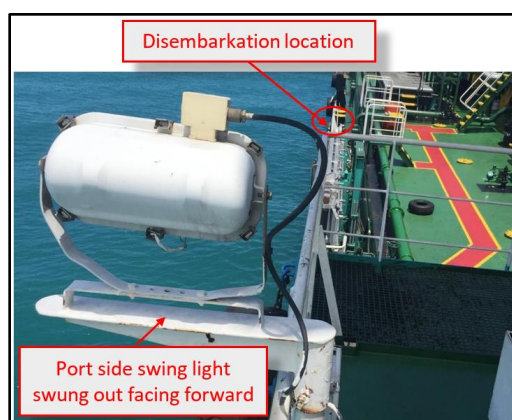
- 1.2.3 A swing light was installed at the port and starboard poop deck (about 15m away from the disembarkation location) for lighting over seaside of Venus. At the time of the ST’s disembarkation, the port side rotatable light was swung out (see **figure 2**). At the material time, the crew of Venus confirmed the deck was well lit.

Figure 2 – Swing light installed at port side poop deck on Venus – photograph taken during daylight hours after the occurrence

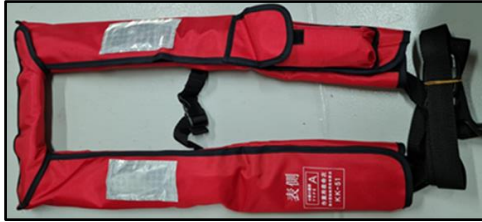
- 1.5.1 As a freelance marine service engineer, the ST procured his own personal protective equipment (PPE)<sup>36</sup>, which included the lifejacket. The NOK shared a picture of the lifejacket<sup>37</sup> with the PCG which was possibly the one worn by the ST on the day of the occurrence (see **figure 3**).

Figure 3 – Photo of the lifejacket provided by the NOK

- 3.2 The lifejacket worn by the ST was a PFD likely equivalent to the performance level 100 of the international standards (ISO 12402) which is suitable to be used in sheltered or calm waters. The lifejacket did not prevent the swells (less than 2m) flushing over the ST's face which resulted in sea water entering the ST's airway and causing him to drown.

- 3.8 There are PFDs of various performance levels meant for different environmental conditions. While the anchorages are considered as protected waters by the port authority, the sea conditions could be rough with higher swells. The minimum performance level of the PFDs to be used for transfers of personnel at anchorages should be reviewed.

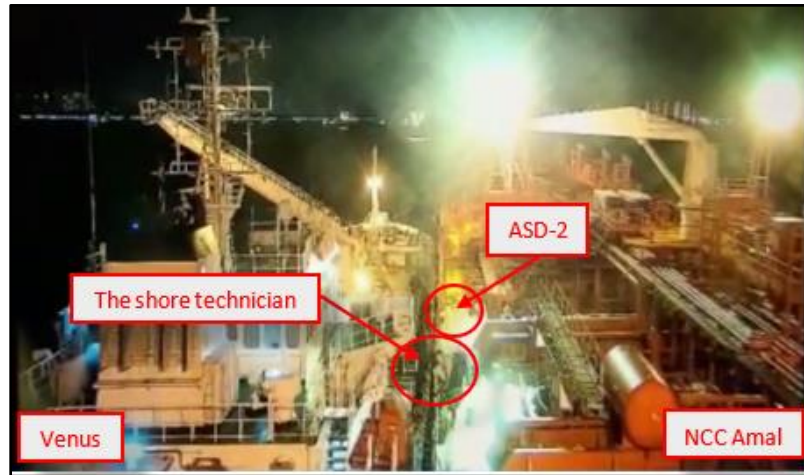
ladder rigged on top of the shipside safety railing<sup>43</sup> of Amal that was near the bridge wing of Venus. The footage also revealed that the ST wore a lifejacket, carried a backpack as he crossed over the Amal's safety railing (see **figure 4a**) onto the pilot ladder. Thereafter the ST was seen descending the steps of the pilot ladder before stepping on top of the safety railing of Venus, eventually landing on the poop deck of Venus (see **figure 4b**).

Figure 4a – CCTV footage indicating the ST was half-way crossing over the shipside safety railing of Amal with one leg  
(Source: Company-A)

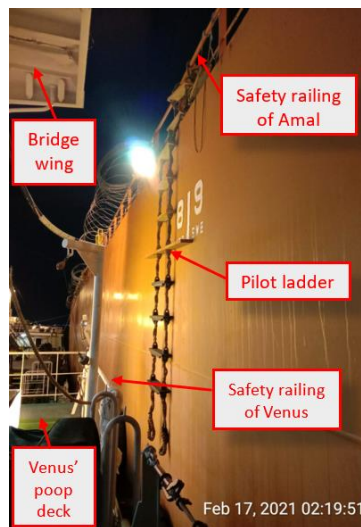
Figure 4b – Pilot ladder rigged at the time the ST disembarked from Amal  
(Source: Company-V)

<sup>43</sup> Company-A informed the investigation team that the pilot ladder was rigged at a non-designated location and rigging the pilot ladder on top of the safety railing was not permitted.

1.7.4 The SMS does not permit pilot ladder to be rigged at any non-designated embarkation/disembarkation points. On the day of the occurrence, the location where the pilot ladder that had been rigged by Amal's crew was at a non-designated location. The investigation team noted that Amal's crew rigged the pilot ladder on the safety railing at the CO-V's suggestion, to facilitate the ST's disembarkation from Amal onto Venus.

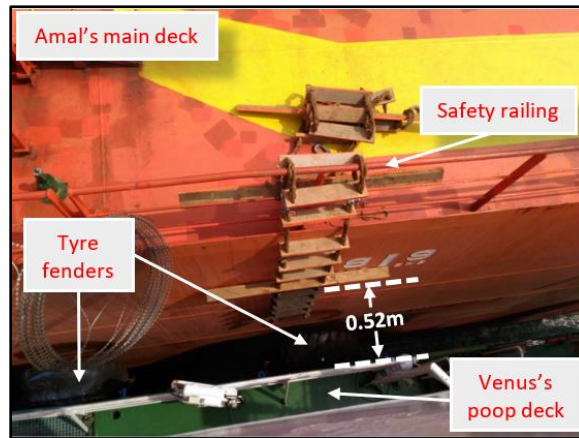
1.6.2 At this location, the spacing between the hull of both ships was estimated by the investigation team to be about 0.5m based on the width of the tyre fenders fixed on Venus. **Figure 5** shows the re-enactment of how the Amal's pilot ladder was rigged for the ST to disembark.

Figure 5 – View of Amal's pilot ladder from Venus – rigged for re-enactment –  
(Source and annotations - TSIB)

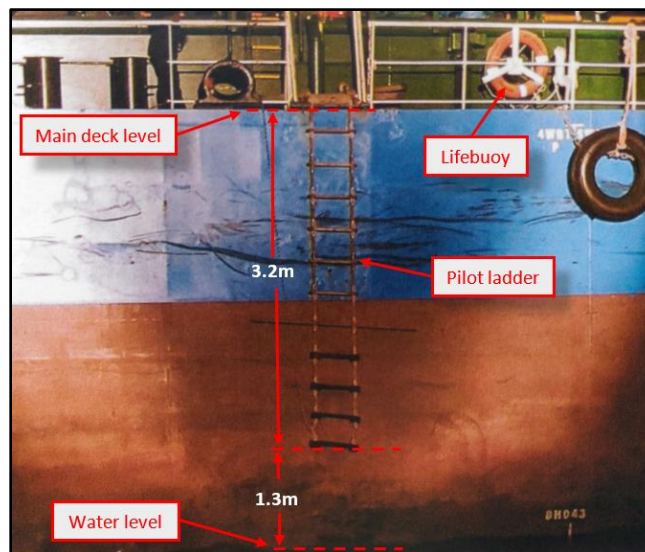
1.6.3 There was no CCTV camera installed onboard Venus. According to the ASD-V, he did not witness the ST's fall into the water. Prior to the fall, the ST was last seen standing on the pilot ladder (see **figure 6**) with his head below the main deck level.

Figure 6 – View of port side pilot ladder rigged for disembarkation  
- annotated by TSIB  
(Source: PCG)

- 3.1 The fall of the ST from the pilot ladder into water could be due to losing balance or dizziness during the descent. With his underlying medical conditions, the probability of him feeling dizzy after assisting with the rigging of the pilot ladder onboard Venus to facilitate his disembarkation could not be ruled out.

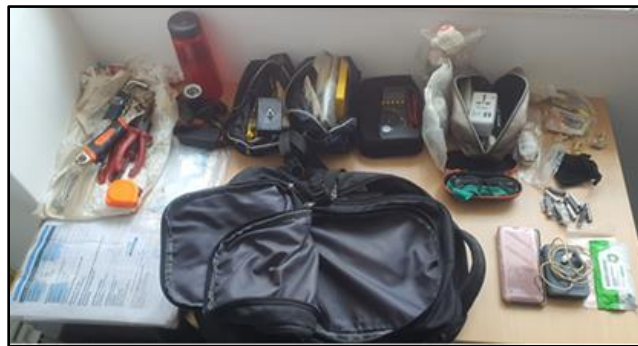
- 1.6.6 The backpack carried by the ST was retrieved by the PCG from Y90. The contents were working tools and personal belongings (see **figure 7**). The bag and its contents together weighed<sup>44</sup> about 8kg.

Figure 7 - The tools and personal belongings inside the backpack  
(Source: PCG)
