Final Report

FIRE

ONBOARD X-PRESS PEARL

TIB/MAI/CAS.110

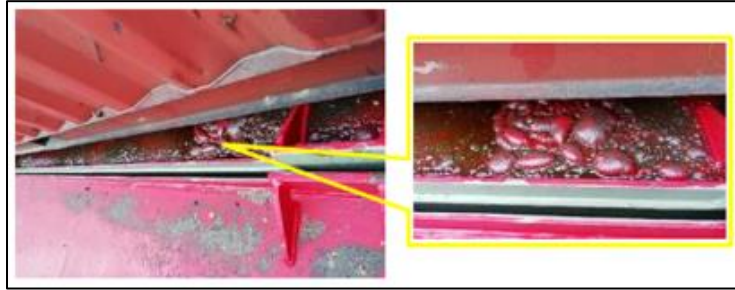
- 1.1.5.4 Bubbling of the paint on the hatch cover was noted and documented, see **figures 2 and 3** below showing the extent of leak. The rate of leak was assessed to be about 0.5 - 1 litre/ hour. Container *FSCU7712264* had the placards showing IMDG Class 8 and Class 5.1.

Figure 2 - Bubbling of hatch cover paint underneath container *FSCU7712264*
 - Source: The Company (annotation in yellow by TSIB)

- 1.1.5.8 The Master followed up with the Operator and Shipper stating that the leaking container had heavily corroded the hatch cover, seeking guidance for it to be offloaded³⁶ or whether it was to be carried till Port Klang, Malaysia.

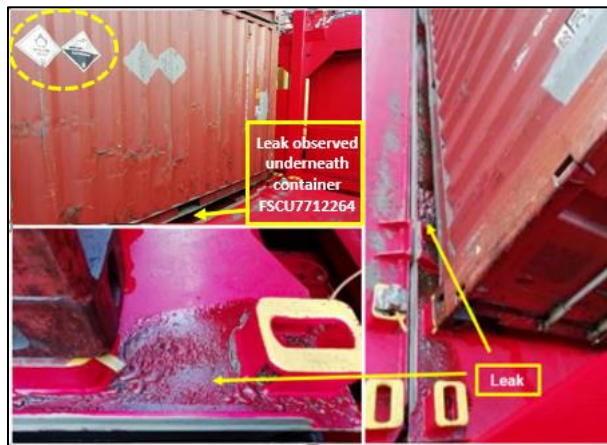
- 1.1.5.3 At about 0900H, while the cargo operation was underway, the duty officer on deck (3O) noted a green liquid around container *FSCU7712264* with no visible damage to the exterior of the container. There was a strong chemical smell in the area. The 3O took some photos of the container and showed it to the CO.

Figure 3 - Indicating leaked cargo observed underneath container and labelling of Primary (Corrosive) with Subsidiary risk (Oxidising agent) -
 Source: The Company (annotations by TSIB)

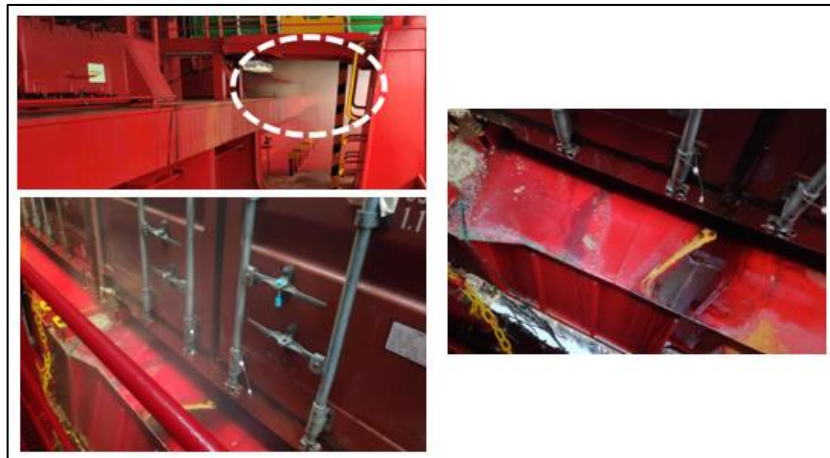
- 1.1.7.11 The investigation team further established from the Master's response to the Superintendent's email that container *FSCU7712264* had been producing orange smoke for some 10 days, reasons for which could not be established as the container was locked, and considering that there was a strong chemical smell, risk of fire could not be ruled out.

Figure 4 - Orange/ brown⁴⁵ smoke and acid leak as reported by the Master -
Source: The Company (*annotation by TSIB*)

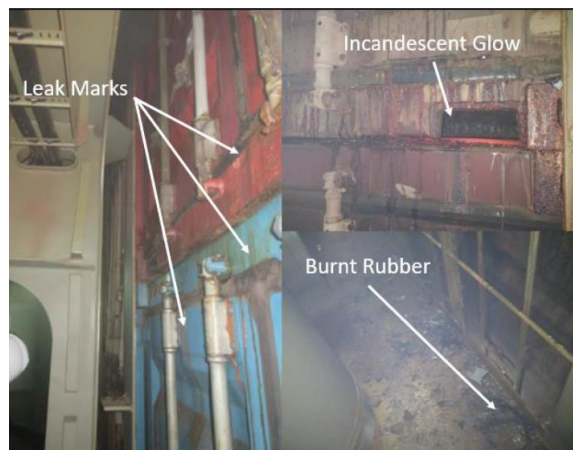
- 1.1.8.22 The CE and the A-2E entered the starboard side passageway and traced the smell to cargo hold #2. As both the CE and the A-2E entered cargo hold #2, they saw the space filled with smoke and several small fires at the top tiers between rows 05/07 and 06/08. One of these small fires was around the upper section door (along the rubber gasket) of one of the containers. In addition, the A-2E also recalled leak marks on some containers, as well as signs of melted metal (see **figure 5**).

Figure 5 - Leak marks on containers inside cargo hold #2 and burnt rubber as well as incandescent glow - Source: The Company (*annotation by the TSIB*)

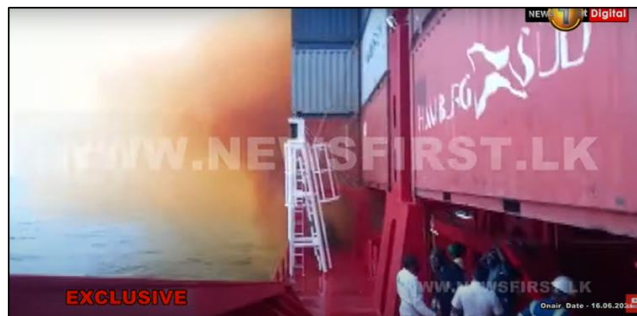
Figure 6 - Orange/ brown smoke - *Source:* Screenshot from Exclusive Video footage posted by newsfirst.lk

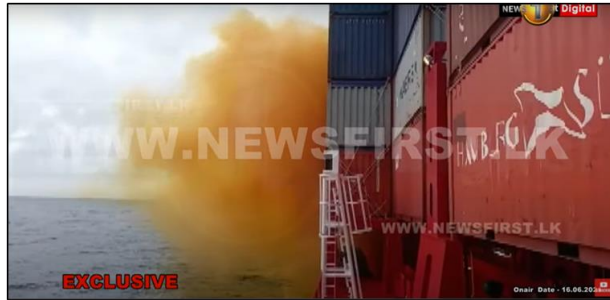
Figure 7 - Orange/ brown smoke increasing in intensity - *Source:* Screenshot from Exclusive Video footage posted by newsfirst.lk

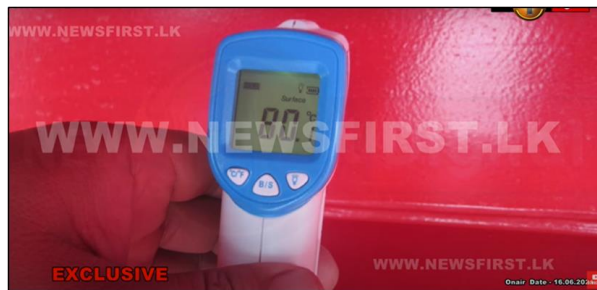
- 1.2.21.5 The firemen informed the A-2E that due to presence of chemical fumes and CO₂ in cargo hold #2, they would have to return to port and discuss further actions. All the four personnel disembarked XP at about 1830H. The investigation team noted from the video footage that the surface temperature of cargo hold #2 was about 80°C (see **figure 8**).

Figure 8 - Temperature of cargo hold # 2 - *Source:* Screenshot from Exclusive video footage posted by Newsfirst.lk

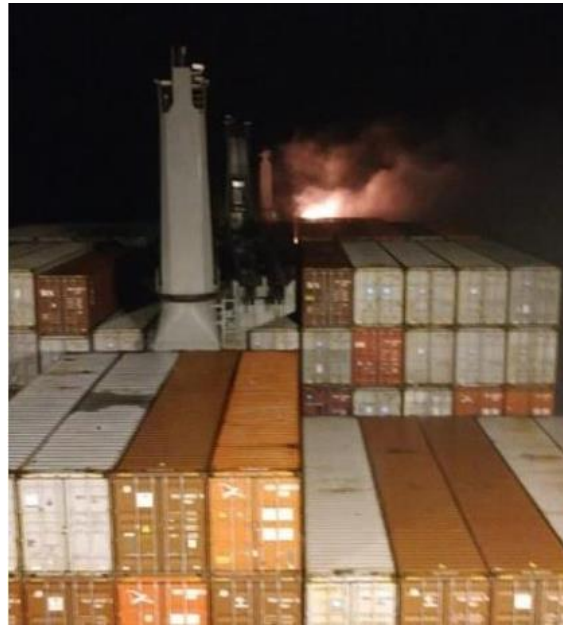
- 1.2.21.8 At around 2300H, the Master who was with the 3O on the Bridge recalled seeing a flame along with thick smoke that was higher than the stack of containers in the region of position 110582 (see **figure 9**).

Figure 9 - Photo taken at about two hours after fire was sighted - *Source: The Company*

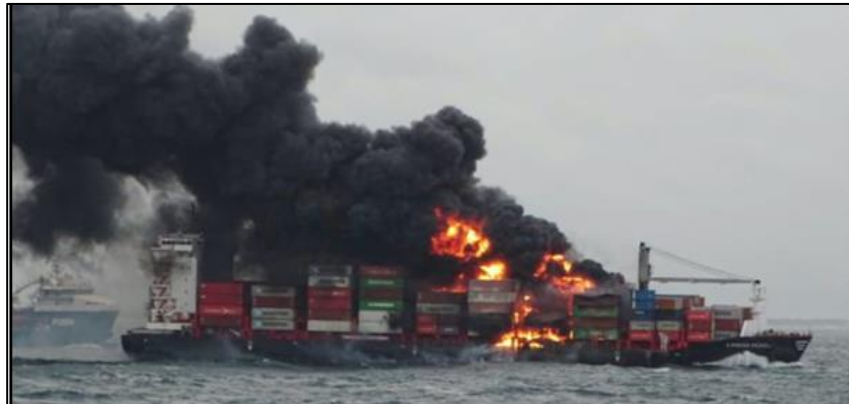
Figure 15 - XP after being abandoned - *Source: SLPA*

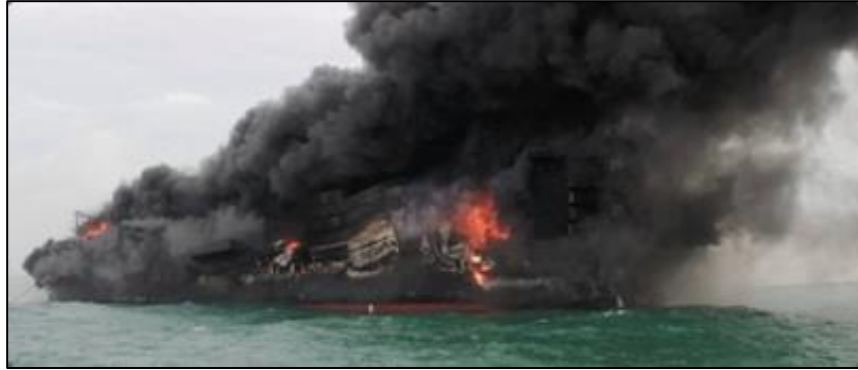
Figure 16 - Fire spread to other parts - *Source: SLPA and Indian Coast Guard (ICG) respectively*

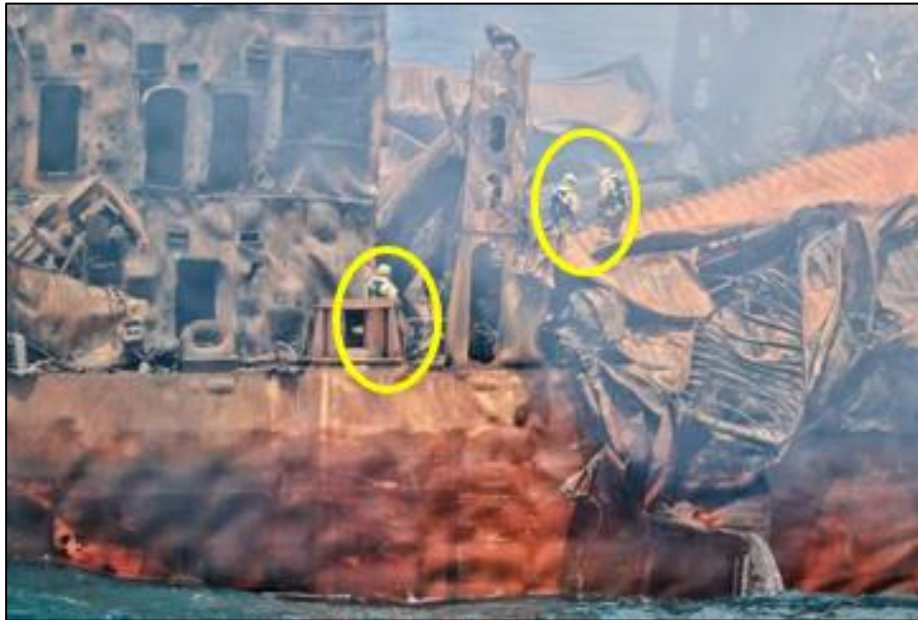
Figure 17 - Salvors onboard XP to inspect the extent of damage - *Source: SLPA (annotation by TSIB)*

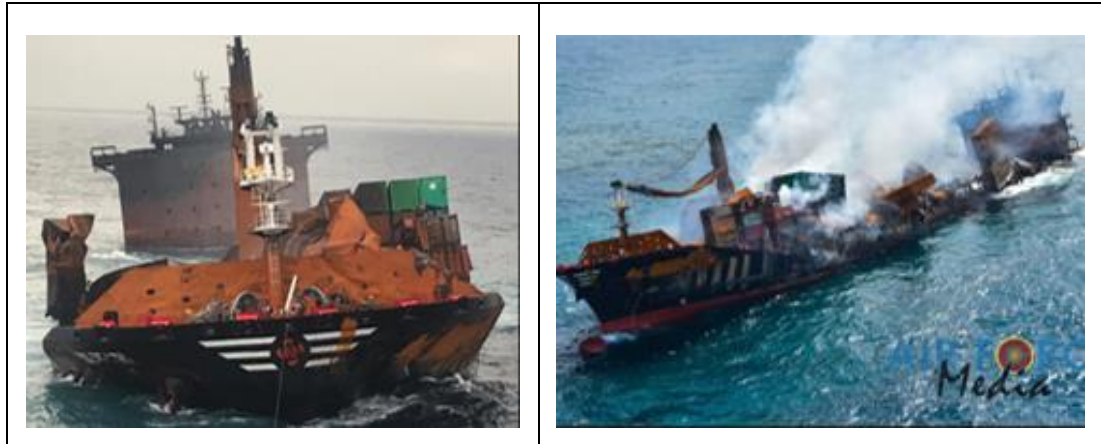
Figure 18 - XP sitting on the shallow seabed - *Source: The Company and Sri Lankan Air Force*

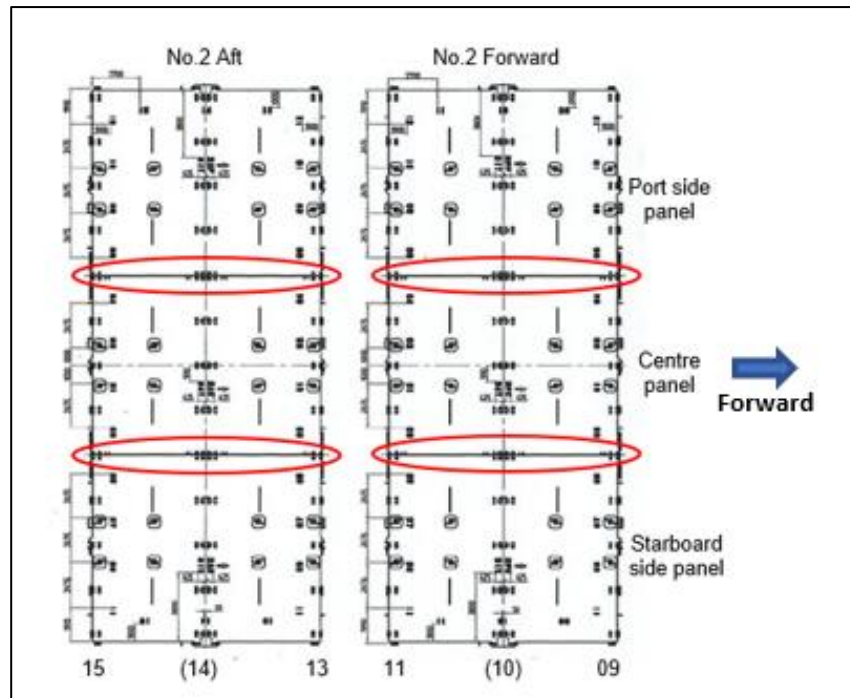
1.4.4.1 The cargo holds were fitted with non-weather tight hatch cover¹⁰³ panels, typical for a ship of this design (see **figure 22**).

Figure 22 - Hatch cover panels of cargo hold #2 (forward and aft) showing the gaps between the fore-aft gutter plates (circled in red) - Source: The Company (annotations by TSIB)

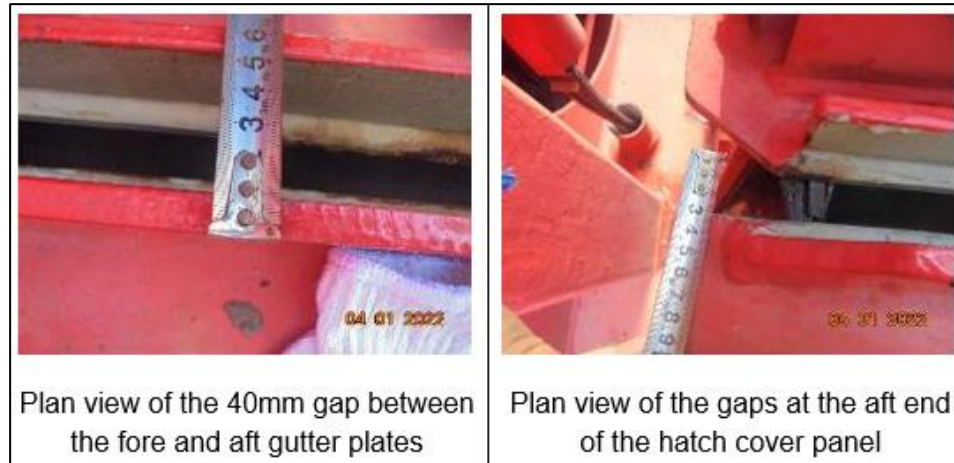
Figure 23 - Gaps between the hatch cover panels - *Source:* The Company

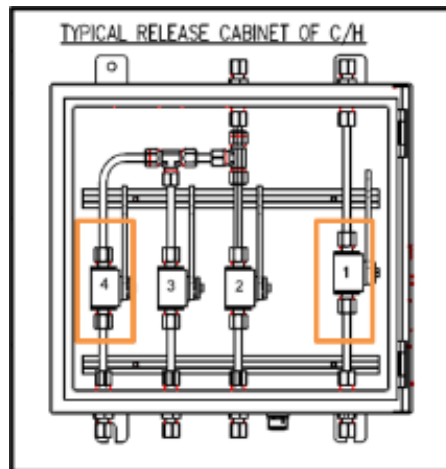
- 1.5.8 A total of 174 bottles were released into cargo hold #2, of which 170 bottles were by activating valve no.2 (see **figure 32**) and four more bottles (meant for cargo hold #3) were released manually. The investigation team could not establish the rationale for valve no.2 to be activated by XP's crew, instead of valve no.4.

Figure 32 - Discharge valves arrangement for release of CO₂ into cargo hold #2 - Source: The Company (annotations by TSIB)

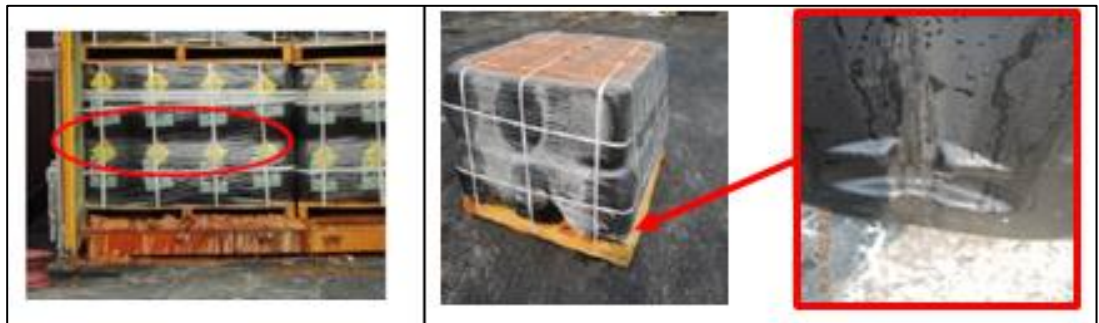
Figure 40 - Case 2, lower tier jerrican crushed and damaged (hairline crack at the bottom of the jerrican) - *Source: Regulator of the Port of Singapore*

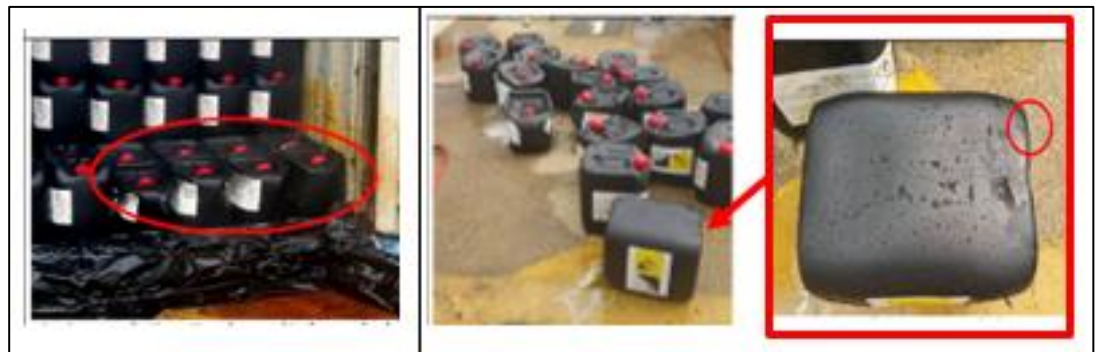
Figure 41 - Case 3, lower tier jerrican crushed and damaged (1 cm crack at the bottom of the jerrican) - *Source: Regulator of the Port of Singapore*
