Final Report

B787-9, 9V-OJF

**Nose Wheel Detached During taxi
Incheon Airport, Korea**

TIB/AAI/CAS.222

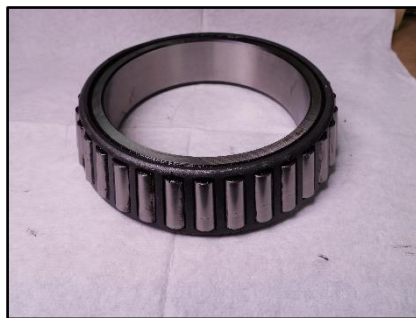
Figure B1: Outboard Bearing Cone

- (1) The NLG inner cylinder sheared axle and parts of the inboard bearing were sent to the aircraft manufacturer's test facility for metallurgical examination.
- (2) The outboard bearing cone (see Figure B1) that was recovered together with the detached LH nose wheel was disassembled and visually inspected. Signs of damage were found on a number of roller bearings (see Figure B2). Damaged marks were found on the cone (inner race) (see Figure B3). Roller cage pockets were found with wear marking caused by roller movements (see Figure B4).
