Final Report

A320NEO, B-305J

Smoke in Cabin, Engine fire, Evacuation

TIB/AAI/CAS.225

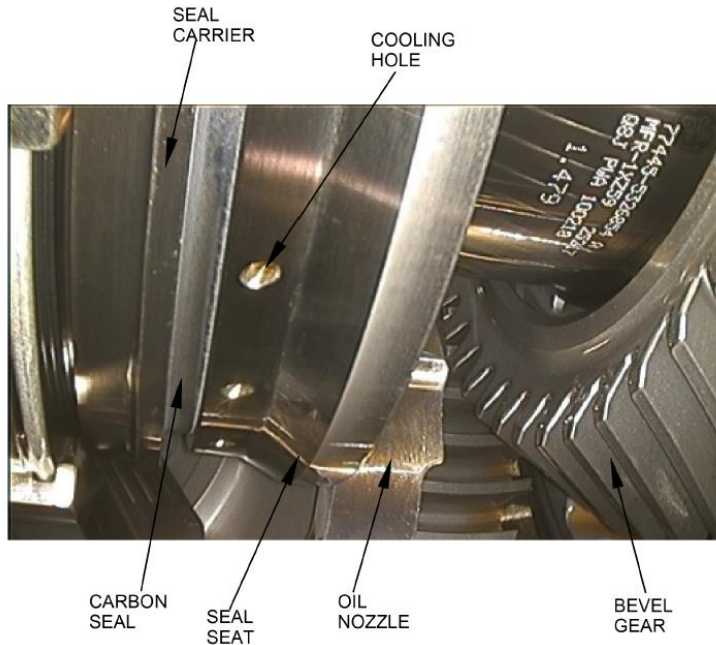
Figure 4: No. 3 Bearing Front Carbon Seal

- 1.11.7.3 The seal assembly consists of two components – a seal carrier, and a carbon seal that seats at the rim of the seal carrier (see **Figure 4** and **Figure 5**).

- 2.1.1 Post-incident examination of the left engine revealed that a carbon seal in the No. 3 bearing compartment had fractured and no remnants of the carbon element was found on the carbon seal carrier. This suggests that the undesirable state of No. 3 bearing front carbon seal fracture had occurred. However, the investigation team could not determine at which moment of the flight the fracture happened.

- 2.1.2 The No. 3 bearing front seal fracture resulted in oil leaking from the front of the No. 3 bearing compartment towards to the rear of the LPC, the HPC, and the turbine exhaust case. These areas were characterised by high temperatures, which caused the leaked oil to vaporise and generate oil fumes/smoke.

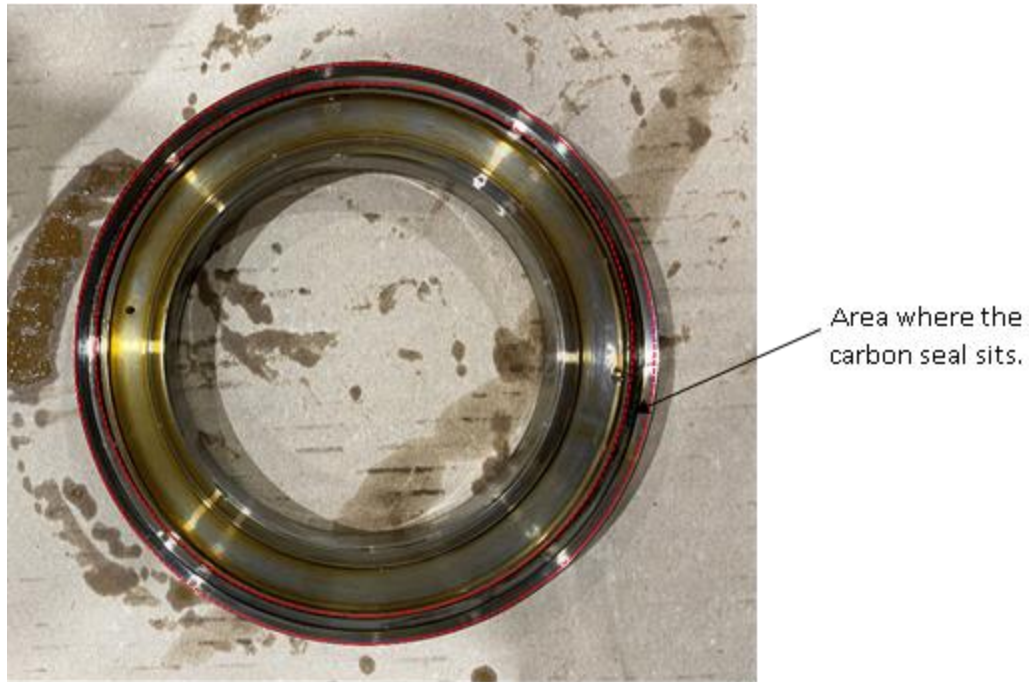
Figure 6: Seal seat

1.11.7.4 The seal assembly is a stationary component. The carbon seal sits on a seal seat (see **Figure 6**) which rotates with the shaft of the HPC. The face of the carbon seal and the face of the seal seat rub against each other when engine is in operation, creating friction and wear.
