Final Report

FATAL INJURY OF ENGINE CADET DUE TO COLLAPSED STEEL PLATES ONBOARD CHINA ACE AT SOUTH ATLANTIC OCEAN ON 13 JUNE 2024

TIB/MAI/CAS.171

Transport Safety Investigation Bureau
Ministry of Transport
Singapore

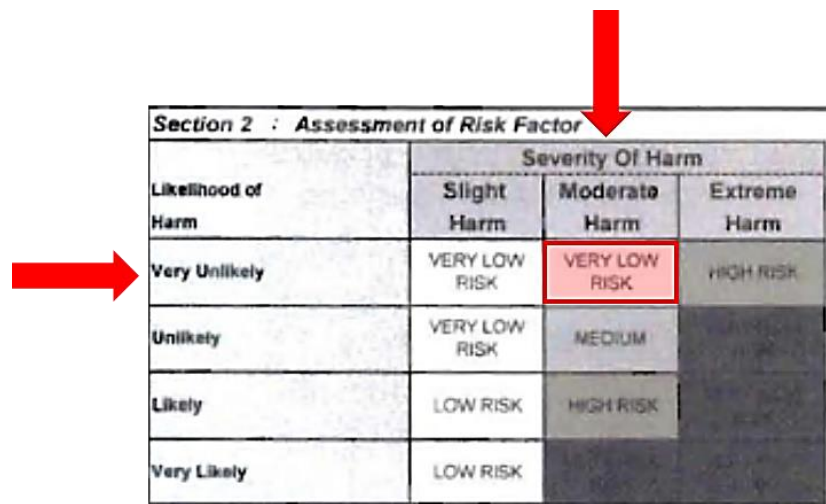
1.9.5 The CE had identified hazards and control measures (see **Table 4**) for the manual lifting of steel plates, which were recorded as very unlikely to cause harm⁴³ with a moderate severity of harm⁴⁴. It was also concluded that the manual lifting of steel plates was of very low risk⁴⁵ (see **Figure 9**) after assessing risk factors. The CE and 2E both signed off the RA⁴⁶ for the manual lifting of steel plates⁴⁷.

1.9.7 The CE added that when drafting the RA for the relocation of steel plates, the falling hazard of the remaining steel plates leaning against the walkway railing

was not anticipated. The RA also did not consider that the sea condition would cause the stack of steel plates to fall.
