Final Report

FATALITY OF CREW AFTER FALLING OVERBOARD FROM INCE NORTHWIND AT ISTANBUL ANCHORAGE ON 3 DECEMBER 2023

TIB/MAI/CAS.154

Transport Safety Investigation Bureau
Ministry of Transport
Singapore

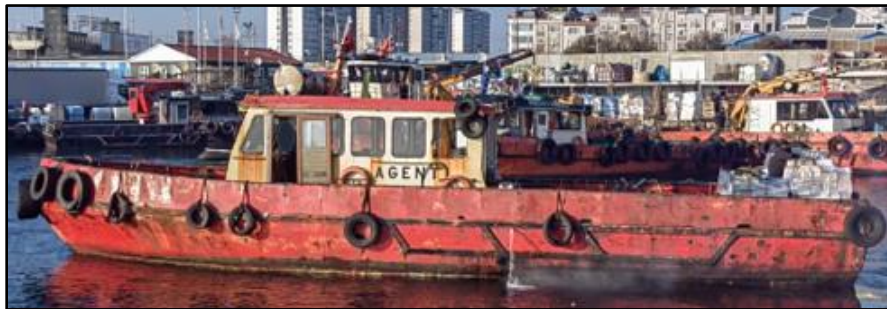
1.1.2 On the afternoon of 3 December 2023, an Istanbul registered agency service boat, “Yildiray-I” (a launch) (see **Figure 1**), was proceeding to INW with the ship’s provision and nine joining crewmembers.

Figure 1 - The agency service boat, Yildiray-I
(Source: the Company)
