# **Final Report**

## **Fatality of Deck Cadet onboard Strategic Harmony at sea on 1 May 2023**

TIB/MAI/CAS.142

Transport Safety Investigation Bureau  
Ministry of Transport  
Singapore

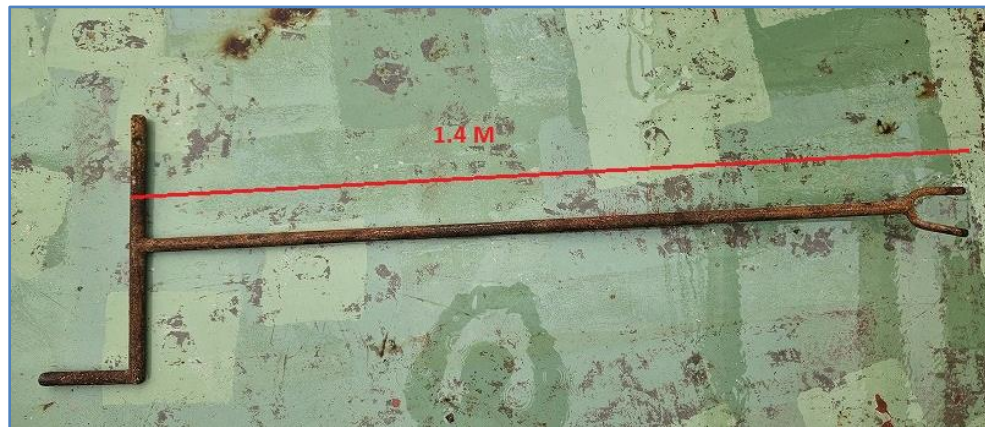
Figure 6 – 1.4m long T-spanner (Source: the Company)

- 1.2.7 The investigation team gathered from the CM that he had changed his plan of using the electric sump pump to discharge the waste water, after considering the DC's suggestion and planned to enter the DWTP to open the surface drop valve. At about 1330H, the CM carried, a portable VHF radio and torches<sup>29</sup>, entered the DWTP and made his way to the sixth upper compartment. The CM added that upon entering the DWTP there was a scent of rotten soya bean meal. The DC carrying a portable VHF radio and a T-spanner<sup>30</sup> (see **figure 6**) entered the DWTP about two minutes after the CM.
