Final Report

UNMANNED AIRCRAFT, DrN-35LS LOSS OF AIRCRAFT AT SEA

19 FEBRUARY 2024

TIB/AAI/CAS.230

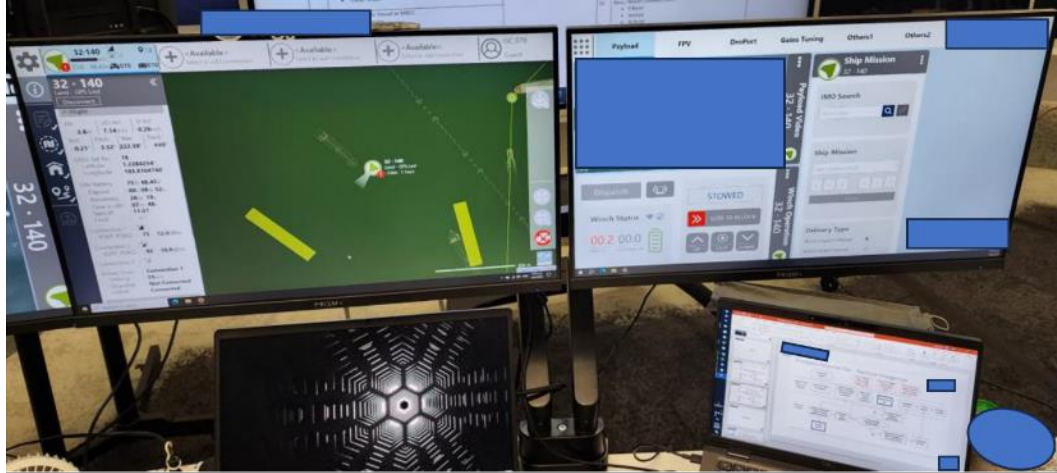
Figure 1: DrN-35LS involved in the incident

1.1.1 On 19 February 2024, a model DrN-35LS unmanned aircraft (UA) (see **Figure 1**) was to operate a demonstration flight from Tanjong Beach, Sentosa island, Singapore to the Western Anchorage located south of the island. The UA was programmed to fly in beyond visual line-of-sight (BVLOS) mode to the planned waypoints autonomously. The UA took off at 11:37:58 hrs and flew along a predetermined route about 164 feet (50m) above the sea. The UA pilot (UAP) in charge of the demonstration flight manned the Ground Control Station (GCS) (see **Figure 2**) at a remote site. The UAP had the option of taking over control of the UA via the GCS (see paragraph 1.5.3 on the GCS set-up) when needed.

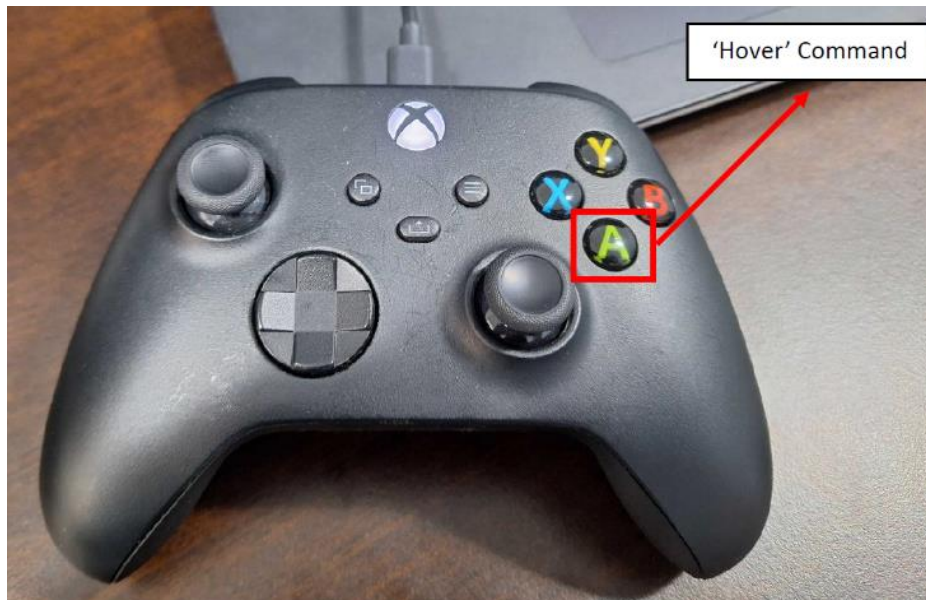
Figure 3: 'Hover – Manual' command button on the GCS screen

- 1.5.4.2 The UA is designed to hover, i.e. stopping any horizontal movement but maintaining its altitude for five seconds¹, when the 'POSITION X-CHECK FAIL' error arises. If the UAP does not assume manual control by clicking the 'Hover-Manual' command button on the GCS screen (see **Figure 3**) within this period, the UA will transition to the 'Land – GPS Lost' mode and land at its current location. During the landing phase, the UAP may still assume manual control of the UA by clicking the 'Hover-Manual' command button. The time available for the UAP to assume manual control once the UA transitions to the 'Land-GPS Lost' mode is dependent on the UA's altitude.
