Final Report

Collision

**Between BW Seine and barge SOL 2315 towed
by tug SOL 1009**

TIB/MAI/CAS.138

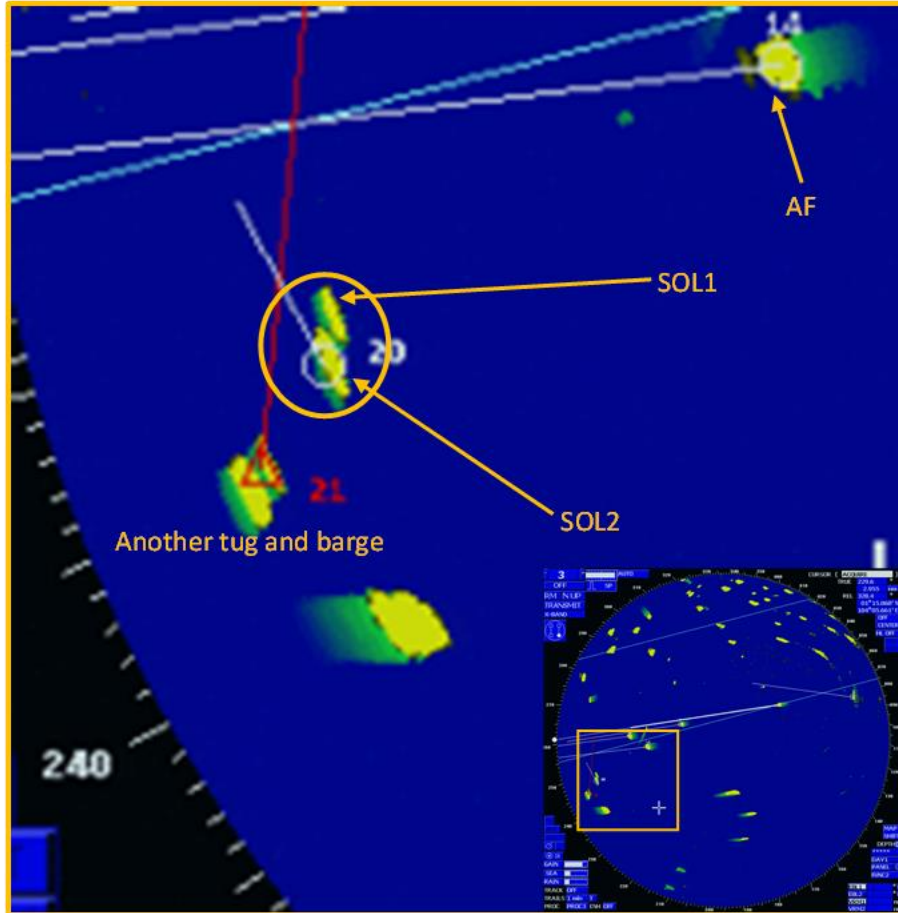
Figure 9 – SOL2’s target signature (no. 20) acquired (Source: VDR of SE – annotation by TSIB)

1.1.6 At about 1556H the CO of SOL1 was manoeuvring to pass clear of AF which was on SOL1’s starboard side. Meanwhile, onboard SE, the Master acquired the target signature of SOL2 on the X-band ARPA³¹. SOL1 and SOL2 were seen as two separate targets in close proximity (see **figure 9**).

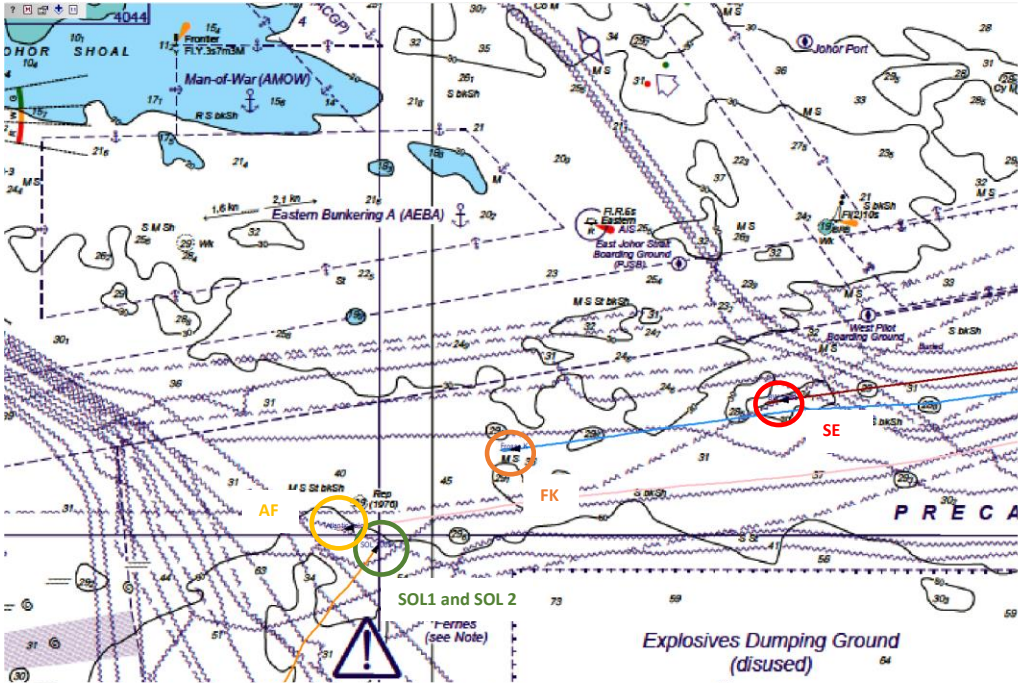
Figure 10 – Positions of SOL1 towing SOL2 (green circle), AF (yellow circle), FK (orange circle), and SE (red circle) on the chart (Source: TSIB) – Not to scale

1.1.10 At about 1603H³², SOL1's CO called VTIS East to inform their intention to pass astern of FK³³ which was about 0.7nm on SOL1's starboard side and about 1.46nm ahead of SE (see **figure 10**). SOL1 was towing SOL2 at an approximate speed SOG 3.5 knots on COG 024.5°.

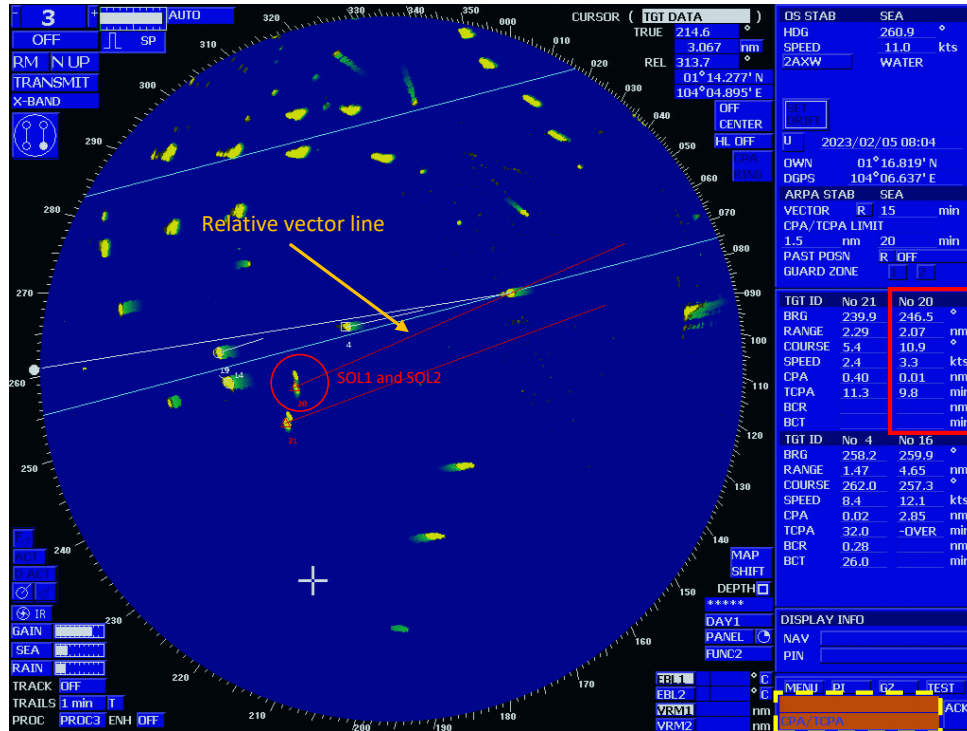
Figure 11 – SE’s X-band ARPA radar screen⁴⁰ at 1604H showing target information of SOL2 (in red box on the right column) (Source: the Company – annotation by TSIB)

1.1.11 At this time³⁴, SE was proceeding on COG 261.9° with SOG 9.5 knots (heading was 261° with STW at 11.0 knots). SE's X-band ARPA radar indicated SOL2 was at about 2.49nm and bearing 246.6° ahead of SE's port bow with a CPA of 0.04nm (74.08m) in about 12mins.

³⁸ SOL2 was at a distance of 2.07nm, bearing 246.5° ahead of SE's port bow with a CPA of 0.01nm (18.52m) in 9.8mins.

³⁹ ARPA information indicated SOL2's BCR of 0.14nm to 0.23nm between 1605H and 1611H, but the BCR was reduced from 0.13nm at 1612H to 0.03nm at 1613H when SOL1 began turning to starboard (See **table 2**).

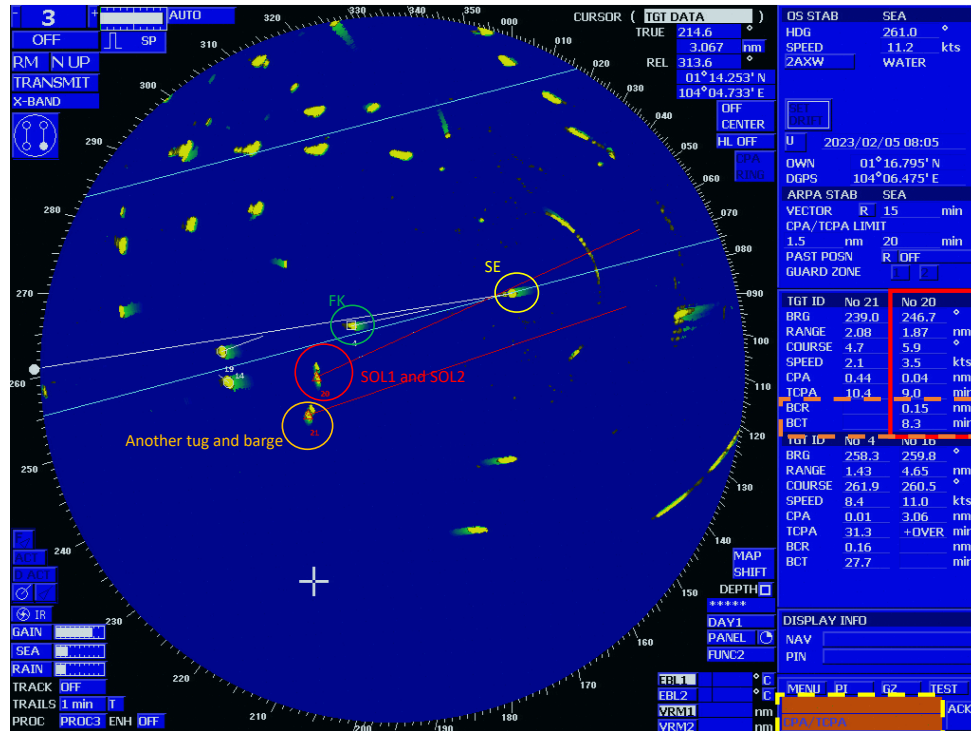
Figure 12 – SE's X-band ARPA radar screen at 1605H showing target information of SOL2 (in red box on the right column) with its BCR (*Source: the Company – annotation by TSIB*)

- 1.1.15 At about 1605H, the Master of SE, noting two sets of tug and tow visually on SE’s port bow, asked the 2O which of the two would be crossing SE’s bow. Soon after, the Master realised that the first set (SOL1 and SOL2) was the tug and tow that would cross SE’s bow (referring to the BCR) while the other set would pass on SE’s port side. SE’s X-band ARPA radar indicated SOL2 to be at about 1.87nm and bearing 246.7° ahead of SE’s port bow with a CPA of 0.04nm (74.08m) in 9mins and a BCR of 0.15nm (277.8m) in about 8.3mins (see **figure 12**).

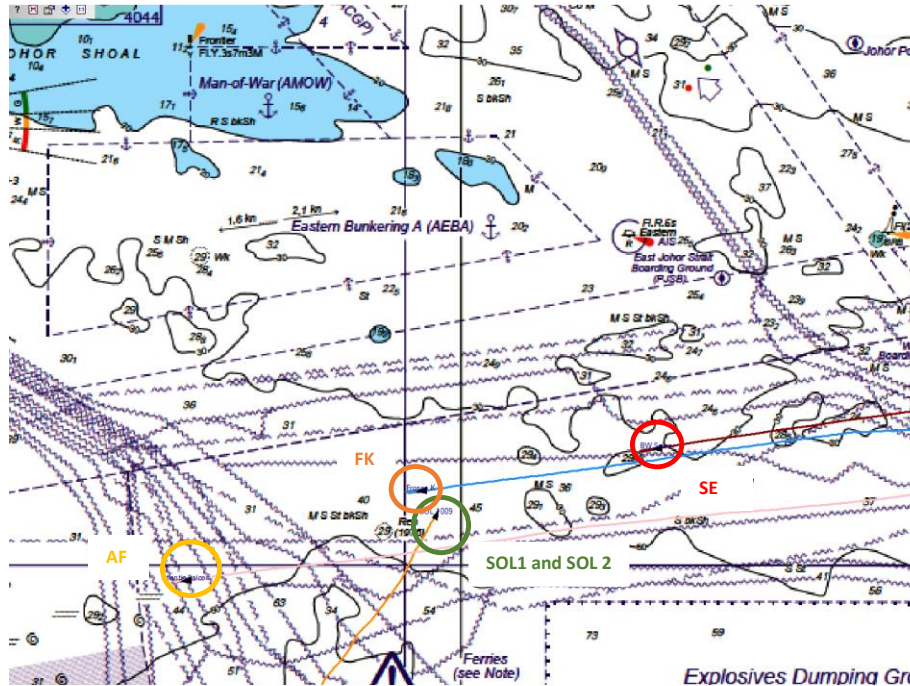
Figure 13 – Positions of SOL1 towing SOL2 (green circle), AF (yellow circle), FK (orange circle), and SE (red circle) on the chart (Source: TSIB) – Not to scale

- 1.1.16 At about 1606H SE was on COG 261.2° with SOG 9.4 knots (heading was 260.7° with STW at 11.2 knots). The Master of SE informed the 2O of his intention to go in between the two sets of tug and tow, i.e., ahead of the tug and tow that was behind SOL1 and SOL2. In his interaction with the investigation team, the Master of SE clarified that at this stage, he intended⁴¹ to maintain SE's course and speed.
- 1.1.17 By about 1608H SOL1 had cleared FK (the latter was on the port side of SOL1 at a distance of about 0.1nm) and SOL1⁴² continued its northerly passage towards Eastern Buoy (see **figure 13**).

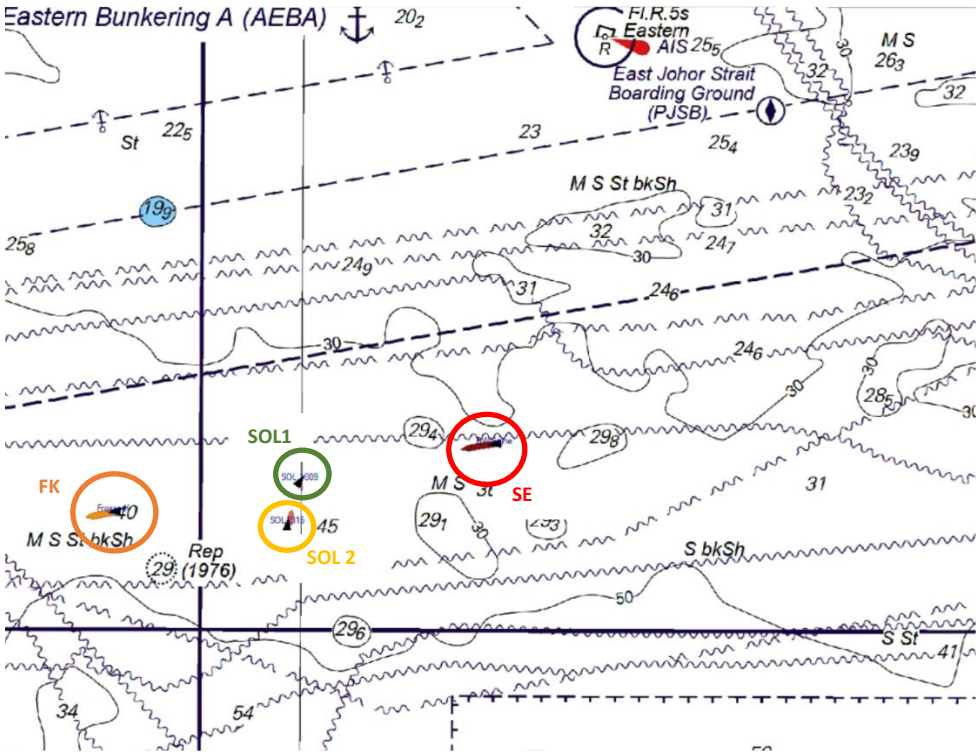
Figure 14 – Positions of SOL1 (green circle) towing SOL2 (yellow circle), FK (orange circle), and SE (red circle) on the chart (Source: TSIB) – Not to scale

- 1.1.20 The investigation team noted that between 1608H and 1610H VTIS East channel was busy with attending to calls from a regional ferry which was attempting to make a routine report of crossing the TSS and the VTIS East operator was trying to call a merchant ship⁴⁹ to provide navigational information.
- 1.1.21 At about 1611H the Master of SE informed the 2O that after the tug and tow (SOL1 and SOL2) had passed, the ship's engine should be brought down to 77 rpm from the current 81 rpm and, thereafter the 2O was to bring the ship's engine speed up to 80 rpm. At this time SOL1 was about 0.44nm and bearing 262.6° ahead, fine on the starboard bow of SE⁵⁰ (see **figure 14**).

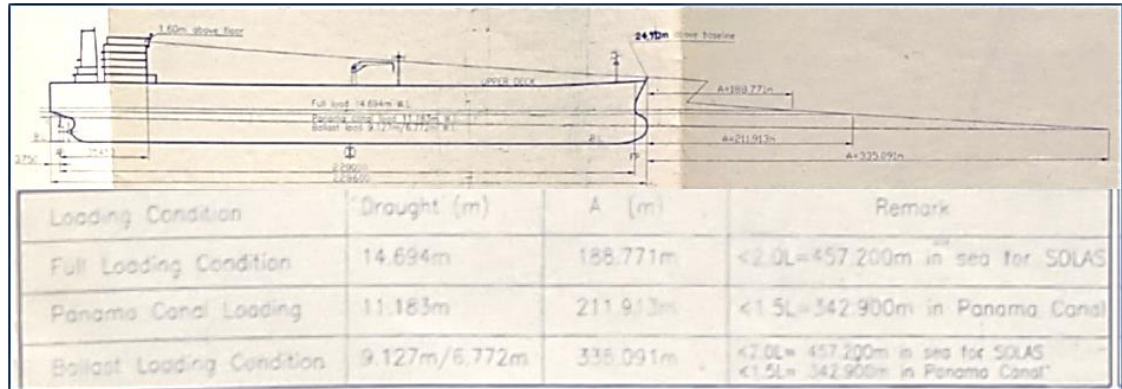
Figure 19 – SE's visibility plan table (Source: the Company)

- 1.4.2 SE has a valid Safety Management Certificate (SMC) with an approved safety management system⁶⁹ (SMS) onboard. All other statutory certificates of SE were valid at the time of the incident.
- 1.4.3 At the time of the collision, SE was on her ballast passage to Singapore, with draughts 6.3m (forward) and 8.3m (aft) with a 2m trim by the stern, for taking bunkers and change of crew. SE's visibility plan indicated, from the conning position (bridge) the minimum visibility⁷⁰ range as 188.771m in full loaded condition and 335.091m in ballast condition (see **figure 19**).

⁷⁰ SOLAS V/22 - Navigational bridge visibility - Ships of not less than 55m in length, shall meet the following requirements: 1) The view of the sea surface from the conning position shall not be obscured by more than two ship lengths, or 500m, whichever is the less, forward of the bow to 10° on either side under all conditions of draught, trim and deck cargo.

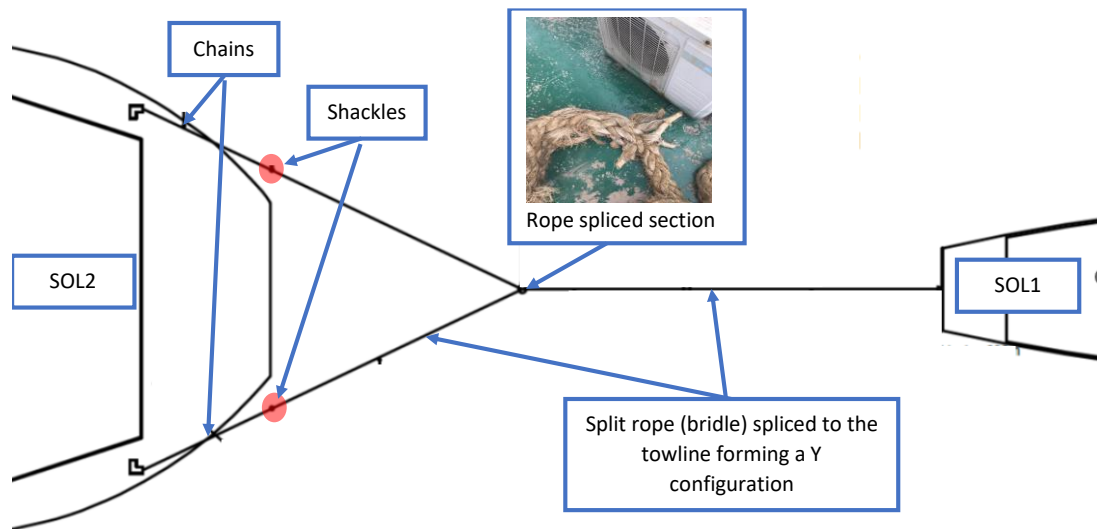
Figure 21 – Towing arrangement (not to scale) (*Source: the Operator and SOL1's Master – annotation by TSIB*)

by shackles to the ends of the split rope (bridle) spliced to the towing rope (towline), forming a 'Y' configuration (see **figure 21**).

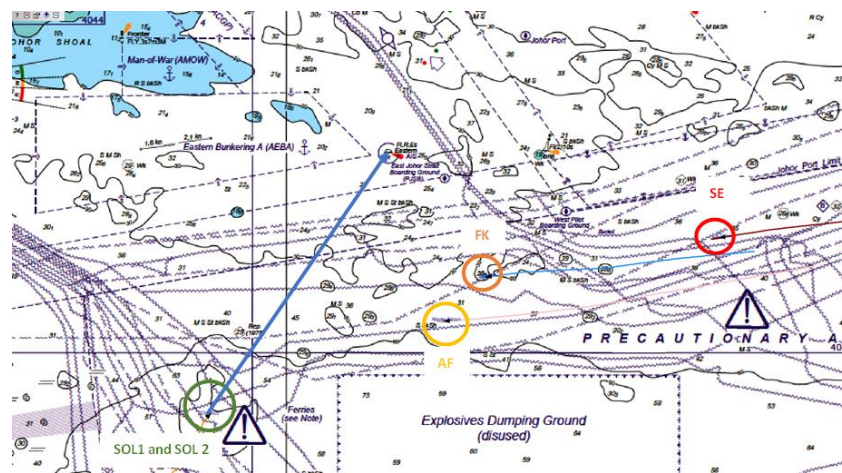
Figure 29 – SOL1 and SOL2 circled green with heading in blue arrow line towards Eastern Buoy (Source: TSIB)

2.4.1 The CO and the Oiler was on the bridge of SOL1 during the crossing of the Precautionary Area towards Eastern Buoy. The CO had reported the crossing to VTIS East and had assumed that SOL1 had been given permission by VTIS East to cross. The CO began the crossing by steering SOL1 and SOL2 in the direction of the Eastern Buoy (see **figure 29**).

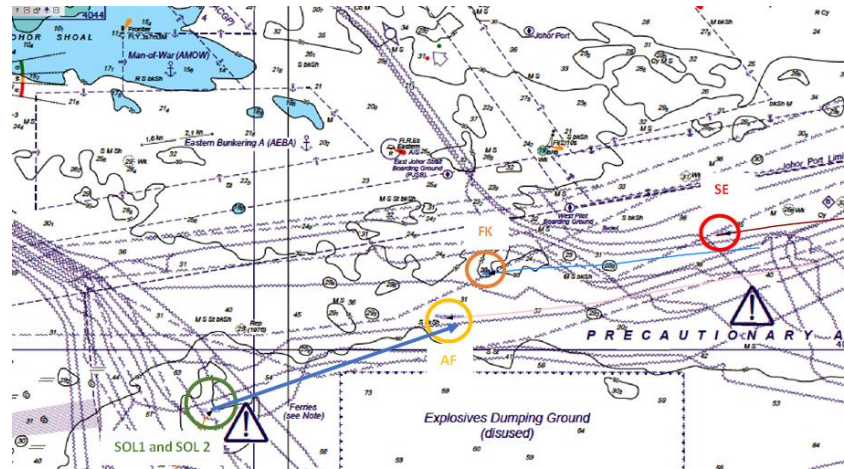
Figure 30 – SOL1 and SOL2 circled green with heading in blue arrow line to pass astern of AF circled yellow (Source: TSIB)

2.4.2 The CO observed three vessels (AF, FK, and SE) proceeding westbound when commencing the crossing of the Precautionary Area towards Eastern Buoy. The CO manoeuvred SOL1 and SOL2 to pass astern of AF (see **figure 30**) and thereafter pass astern of FK (see **figure 31**).
