Final Report

FATALITY OF HARBOUR PILOT AFTER FALLING INTO WATER DURING TRANSFER IN SINGAPORE ON 11 FEBRUARY 2023

TIB/MAI/CAS.139

Transport Safety Investigation Bureau
Ministry of Transport
Singapore

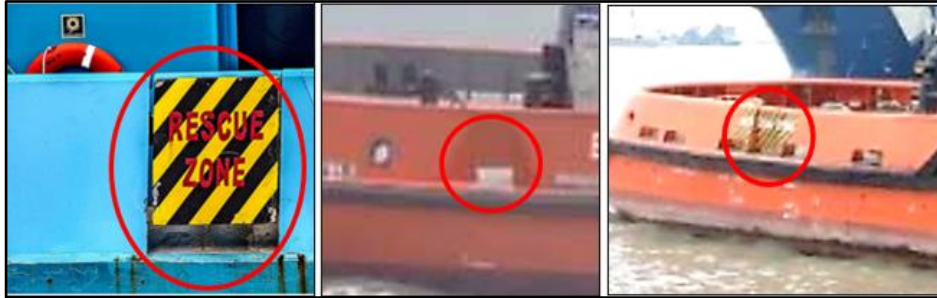
1.3.4 The operator of KR explained to the investigation team that there was no explicit boarding point, material arrangements or required provisions for crew or other personnel including pilots, to board KR. KR was not constructed with bulwark hinged door(s) (see **figure 7**) and access to the deck had to be carried out by climbing/going over the bulwark.

Figure 7: Examples of bulwark hinged doors on some tugboats (of a similar size). Some tugboats demarcated this access area as the rescue zone.
