Final Report

FIRE

ONBOARD X-PRESS PEARL

TIB/MAI/CAS.110

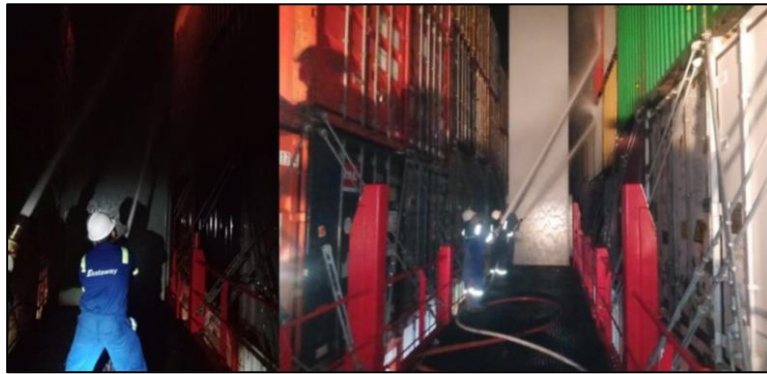
1.2.21.12 The ship's crew fought the fire by directing water jets from the port and starboard sides, and from the cross deck towards the containers on fire. After spraying water from the starboard side for about 45 minutes, noting the starboard side was full of smoke, the A-2E donned a fireman's outfit (without the SCBA sets) near the accommodation and went to the port side in way of bay 10 cross deck and started spraying water towards the starboard side (see **figure 10**⁷⁹).

Figure 10 - Firefighting efforts by the crew - *Source: The Company*

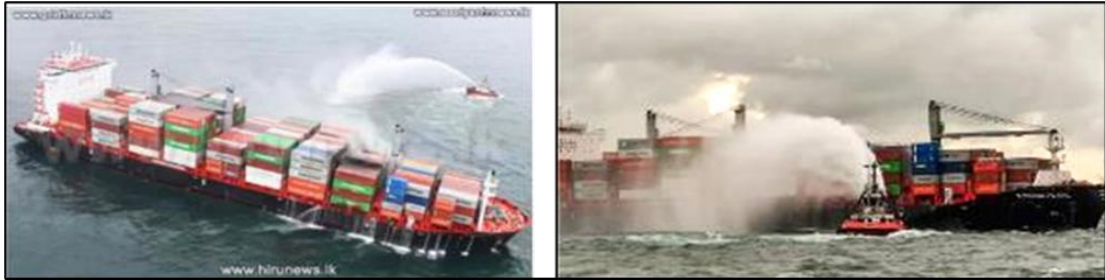
1.3.1.3 By about daybreak, two more tugs “Hercules” and “Maha Wewa” from Colombo Port Control arrived for firefighting. With the firefighting capability increased by the two tugs (see **figure 11**), the Master instructed XP’s crew to return to the poop deck again. In his interaction with the investigation team, the Master commended the ability of “Hercules” in firefighting as the water

Figure 11 - Tug Hercules in the vicinity of XP - Source: www.hirunews.lk (left), Sri Lankan Navy (right)

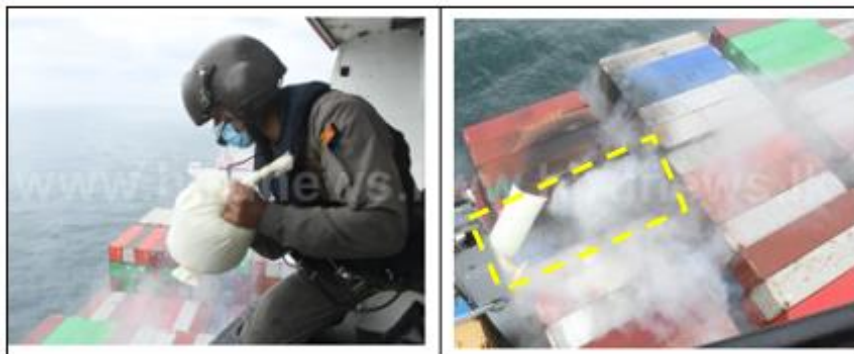
Figure 12 - Bags of DCP being dropped on XP - Source: www.hirunews.lk

- 2.8.5 The flame seen by the Master at the top tier in the region of 110582, which was consistent with the burn marks on the topmost container as seen in **figure 12**, was in all probability due to some contents of containers reacting with the heat in the area to catch fire, which subsequently resulted in an explosion about 24 hours later in the vicinity of bay 10.

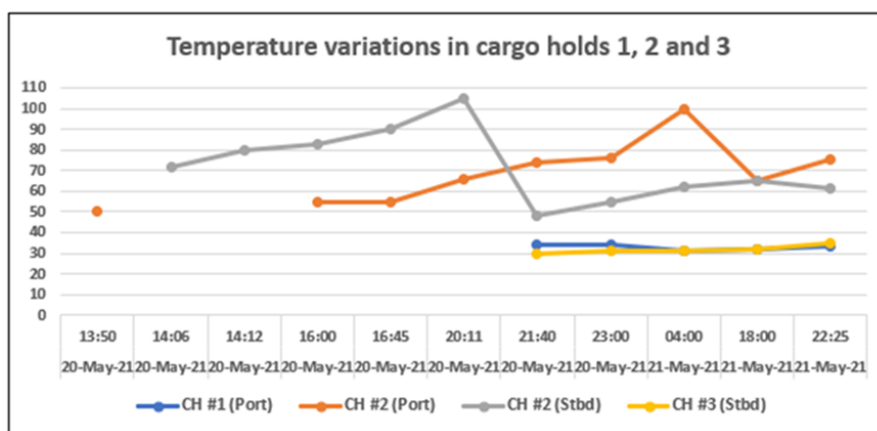
- 1.2.21.6 After about 1.5H had passed, without any updates since the Sri Lankan Navy ship left XP, the Master called Colombo Port Control for the next course of action and was advised to keep monitoring the temperature of cargo hold #2. At that time the temperature readings of cargo hold #2⁷⁶ were 60°C (port side) and 95°C (starboard side). See **figure 13** - for the temperature of the cargo hold).

Figure 13 - Temperature readings collated by TSIB - Source: The Master of XP

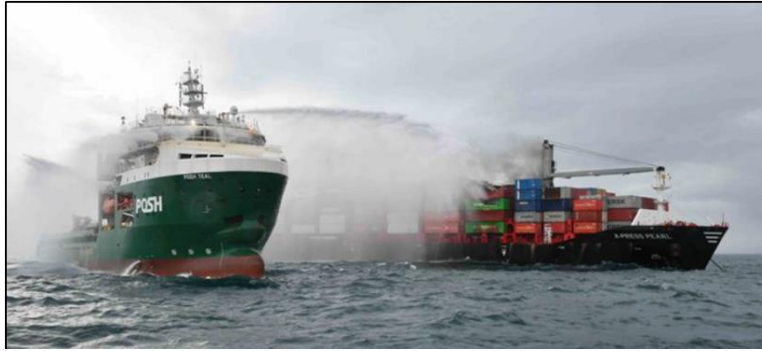
- 1.3.4.6 The salvors noting the four hours’ time taken for “Posh Teal” to be reconnected to XP, called tug “Astro Capella” with an ETA at about 1430H, to connect to XP replacing tug “Posh Teal”. Thereafter, “Posh Teal” was instructed to position itself on XP’s starboard side for firefighting operation (see **figure 14**).

Figure 14 - Tug “Posh Teal” spraying water from XP’s starboard side –
Source: gCaptain as obtained from SLPA

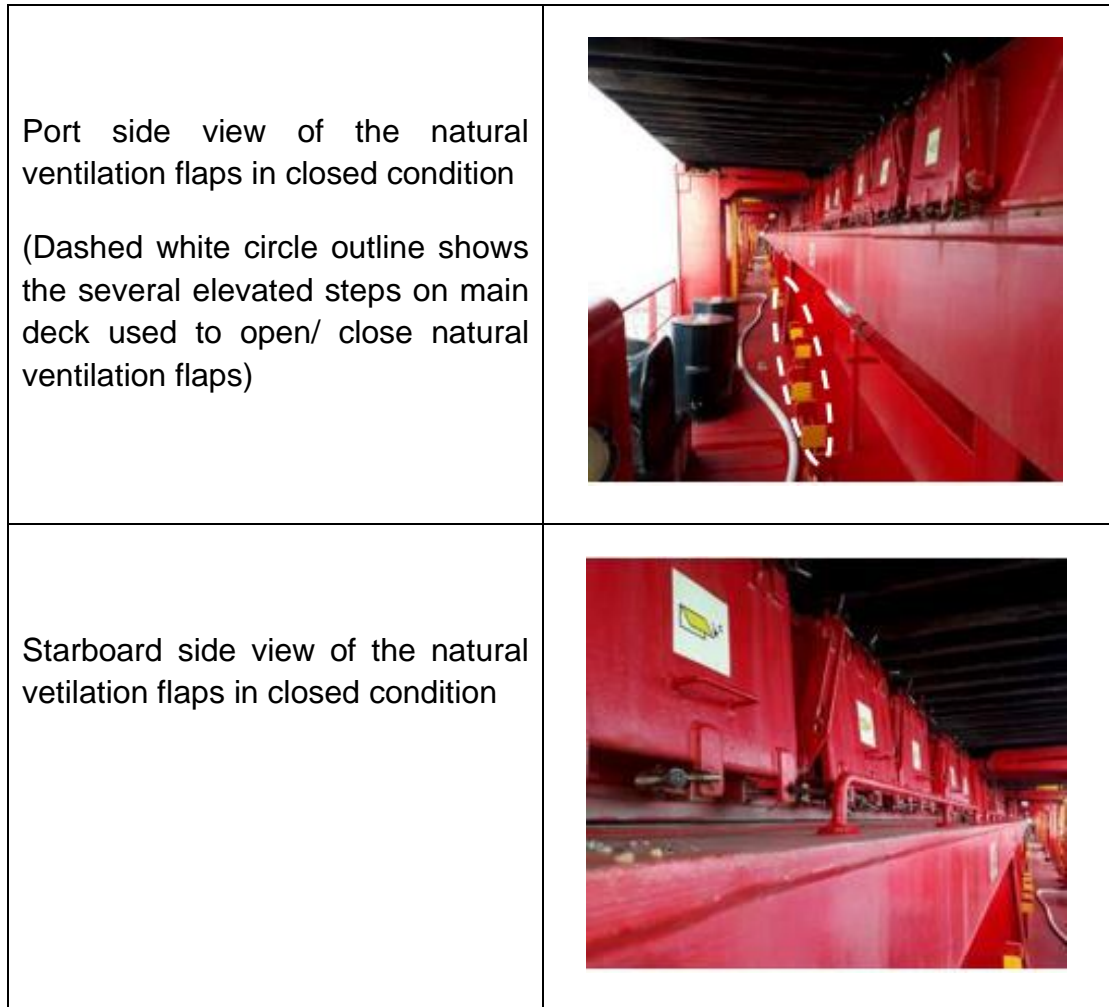
1.4.5.5 A total of 96 reefer containers could be carried inside cargo hold #2. These natural ventilation flaps were required to be kept open¹⁰⁸ when carrying reefer containers. At the time of the occurrence, there was no reefer¹⁰⁹ container inside cargo hold #2. Images of the natural ventilation flaps onboard XM are in **figure 27** -:

Figure 27 - Port and starboard side view of the natural ventilation flaps as seen from deck level - *Source: The Company and XM (annotation by TSIB)*

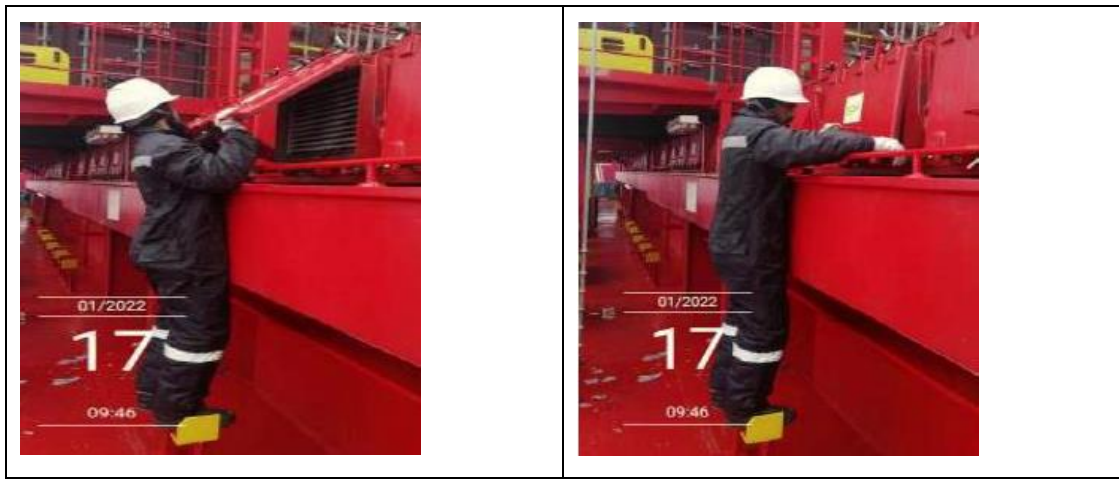
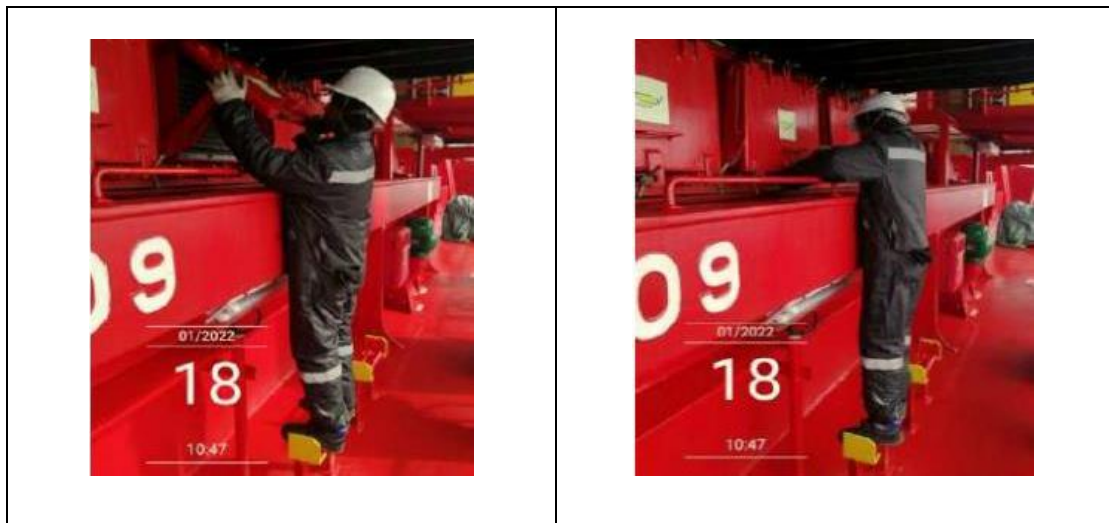
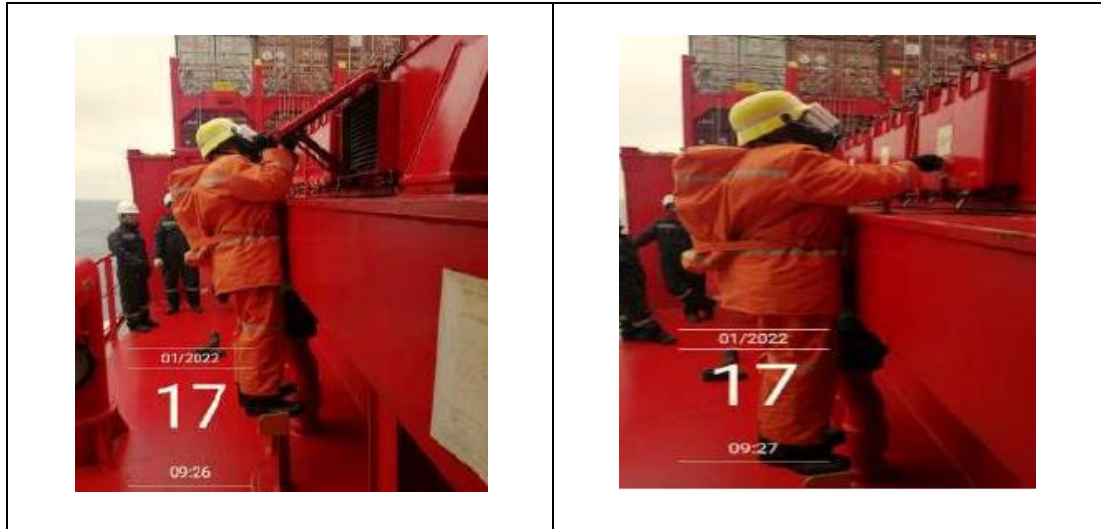
Figure 28 - Simulation of crew closing the natural ventilation flaps (without container loaded at the bay) - Source: The Company

Figure 29 - Simulation of crew closing the natural ventilation flaps (with a container loaded at the bay) - Source: The Company

Figure 30 - Simulation of crew closing the natural ventilator flaps while donning the SCBA set and fireman's outfit (without container at the bay) - *Source: The Company*

- 1.4.6.3 The time taken to close a cluster of five such flaps wearing normal work clothes was about 2.5 minutes and with SCBA set and fireman's outfit was about 5 minutes. The difficulty level according to the crew of XM, on a scale of 1 to 10 (1 being easiest and 10 being most difficult to close a natural ventilation flap), was documented to be a level of 6, due to the vertical lift.

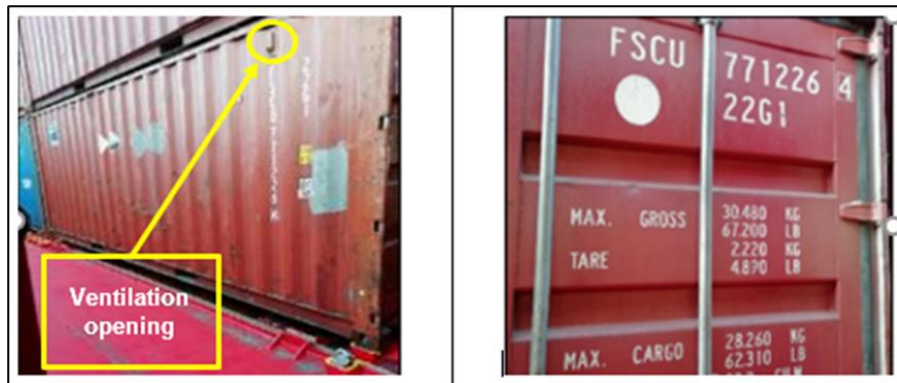
1.9.4.1 Container *FSCU7712264* was of ISO¹³⁹ standard type 2210¹⁴⁰ – 20 feet in length, 8.6 feet in height – general purpose container with ventilation (see **figure 36**). Containers are typically made of Corten Steel which is a copper chromium alloy steel with high concentration of iron and copper.

Figure 36 - (Left) side and (Right) front of container *FSCU7712264* - Source: The Company

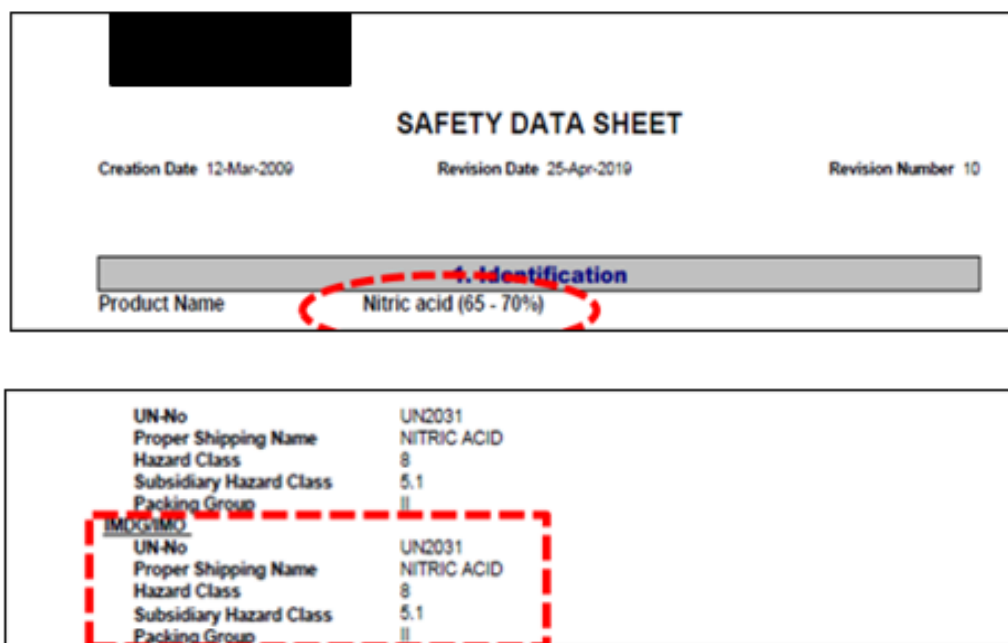
- 1.9.5.2 The actual cargo contained within container *FSCU7712264* was NITRIC ACID *other than red fuming with at least 65% but with not more than 70% Nitric Acid*, (highlighted yellow in **table 11**) with a subsidiary risk of Class 5.1, as obtained by the investigation team from the MSDS provided by the Operator.
- 1.9.5.3 Although MSDS is not a mandatory document for the booking of cargo, the investigation team noted that the MSDS provided by the Shipper to the Operator and the Company (a generic document and not for this shipment) stated that the concentration of Nitric Acid was 65 – 70% (see **figure 37**) below.

Figure 37 - MSDS provided by the Shipper – *Source: The Company (annotation by TSIB)*

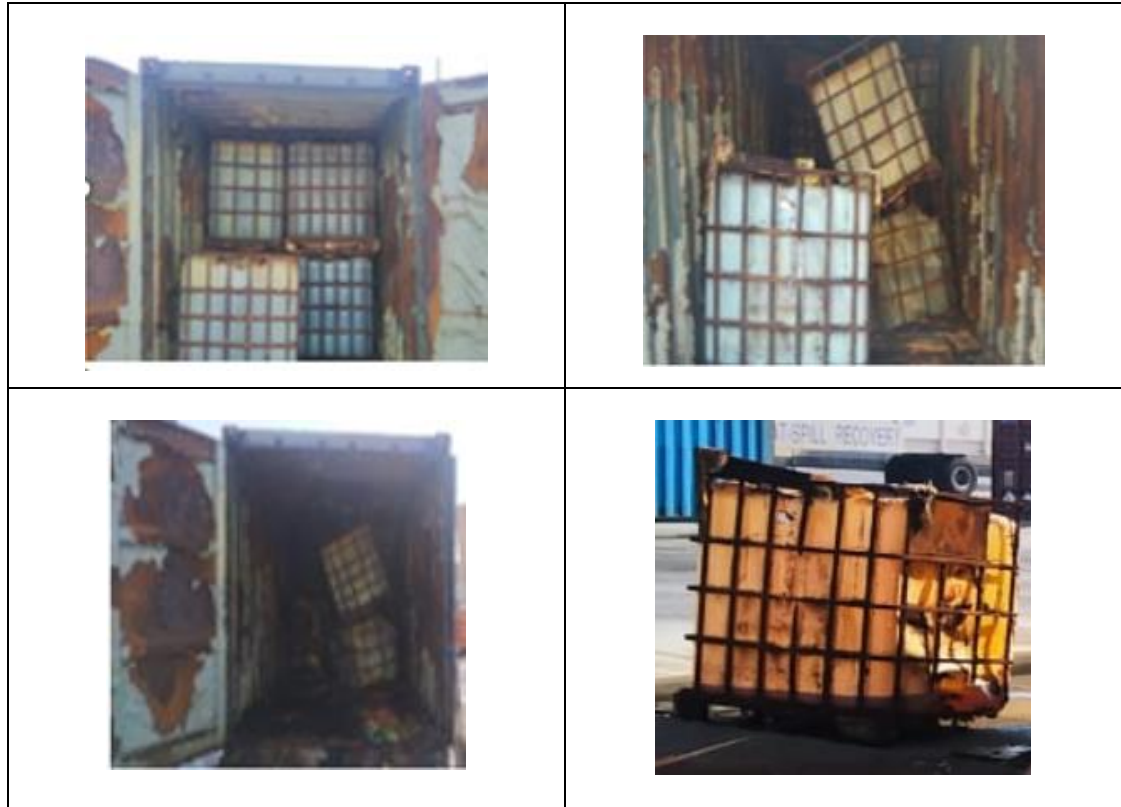
1.9.11.5 As a result of the first inspection which was only around the external structure of container *GESU2837027*, a follow-up inspection and reworking¹⁶¹ was recommended by the inspecting officer. The follow-up inspection and reworking started on 22 May 2021 and was completed on 23 May 2021. The Operator and the Company were not aware of the condition of container *GESU2837027* and its contents until 23 May 2021 (see **figure 38**). The inspection of container *GESU2837027* primarily revealed –

Figure 38 - Condition before reworking - *Source: The Company*

- 1.9.11.6 The inspection report further indicated that due to the powerful oxidising property of Nitric Acid and the ambient temperature conditions, the acid caused a fire with the combustible material inside the container and damaged the container.
- 1.9.11.7 The Operator informed the investigation team that after the reworking of container *GESU2837027*, the Shipper tried to load the reworked container¹⁶³ onboard XM, but the shipment was rejected by the Operator, citing safety concerns.
- 1.9.12 The investigation team noted that one Packing List (see **table 18**) for both consignments of containers *FSCU7712264* and *GESU2837027* was used, which indicated that 36 IBCs were consigned. The Packing List did not indicate

2.2.1 Containers (*FSCU7712264* and *GESU2837027*) arrived at the Port of Jebel Ali on 3 May 2021 and container *GESU2837027* was found leaking on the same day which resulted in it being segregated for reworking. Container *FSCU7712264* was loaded onboard XP. On 22 May 2021 (after the fire onboard XP), inspection of container *GESU2837027* revealed that the protective bands of the IBCs used for the storage of Nitric Acid were badly corroded (see **figure 38**).

- 2.3 Packing requirements of Nitric Acid and Shipper's responsibility
- 2.3.1 According to B15 provisions of the IMDG Code, the IBC intended for the carriage of Nitric Acid (55% concentration or more) shall be no more than two years from their date of manufacture. There is no evidence to indicate that the date of manufacture of the IBCs for container *FSCU7712264* was known to any of the parties involved in the cargo booking process, e.g. the Shipper or the Operator. In all likelihood, considering the condition of the IBCs noted during the inspection of the *GESU2837027* (see **figure 38**), the IBCs used for container *FSCU7712264*, were probably more than two years old.

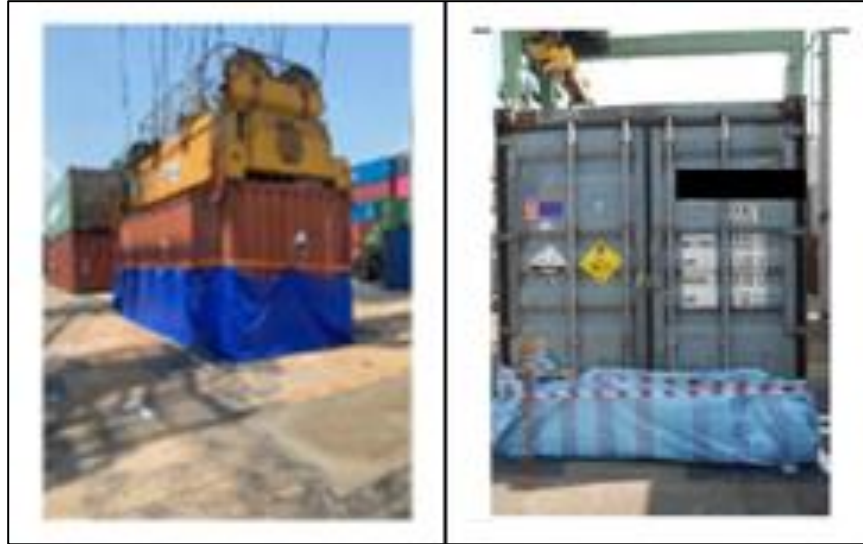
- 1.10.2 Typically, handling of such leakage involved the use of tarpaulin (see **figure 42**) and flushing the leak with copious quantities of water. Inert absorbent pads were used to contain the acid residues.

Figure 42 - Use of tarpaulin to minimise the spread of the leak - *Source:* Regulator of the Port of Singapore

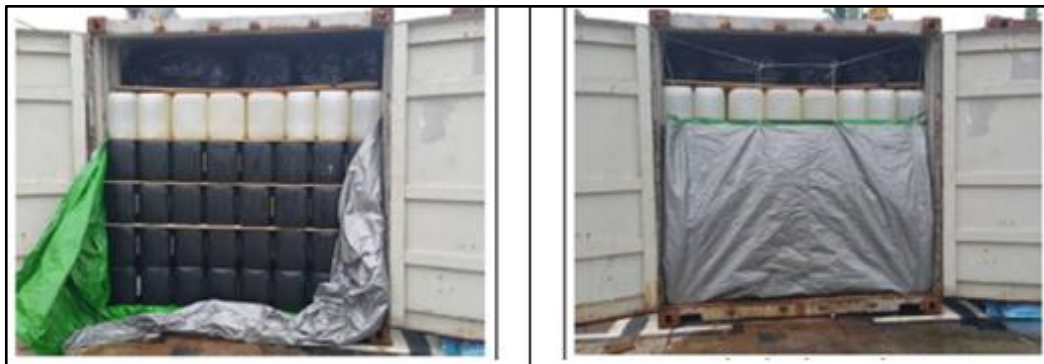
Figure 43 - Recommendations during reworking of Nitric Acid leakage - *Source:* Regulator of the Port of Singapore

- To pack the drums and jerricans without the use of flammable material, such as, wooden pallets, also to minimise the risk of cuts (due to protruding nails from the wooden pallets);
- Minimise the use of plywood between tiers for weight distribution; and
- Lining of container with tarpaulin to contain any residue.

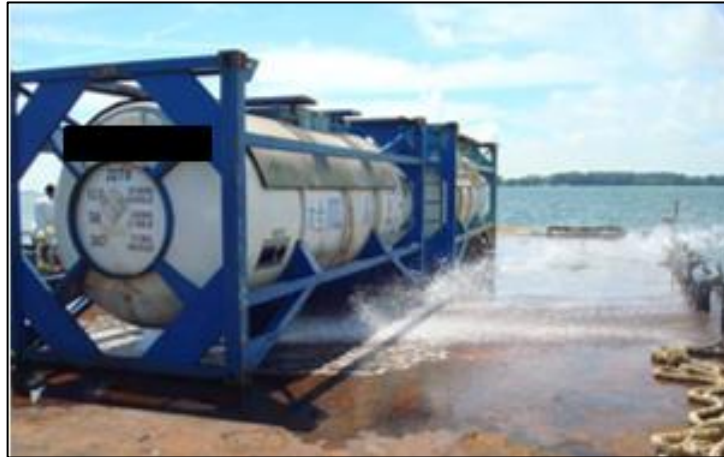
- 1.10.4 The investigation team also noted that one of the cases involving Nitric Acid leaking from an ISO tank (see **figure 44**) was handled at the anchorage, which required the off-loading of the ISO tank onto a barge, and the use of copious quantities of water.

Figure 44 - Leaked ISO tank off-loaded onto a barge - *Source: Regulator of the Port of Singapore*
